Increased number of groundings in the Douala channel

The narrow, shallow and congested Douala Channel presents some challenges

Published 27 May 2015

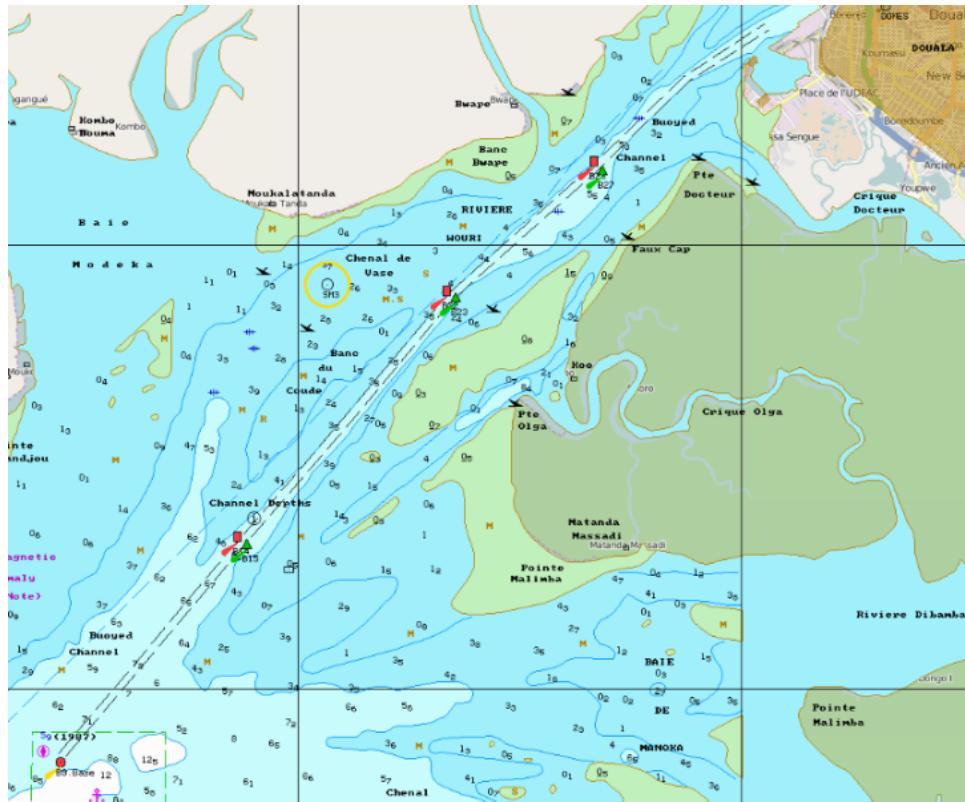
Vessels inbound to Douala must follow a 50 km long and narrow channel on the Wouri River from the coast line before arriving at the port of Douala, Cameroon.

Gard is aware of at least eight groundings in the Douala channel since May 2014. Surveys have revealed some common factors for the groundings. Manoeuvring ships in and out of the port is challenging as the Douala channel is both narrow (150 m maximum) and shallow (6.2 m above chart datum) as well as being congested. The tidal river constantly deposits sediments and is not regularly dredged, leading to sand and mud banks forming within the channel limits. The draft is most likely not in accordance with the official charts. Vessels are often asked to proceed upstream beyond the pilot boarding ground before the pilot boards, resulting in insufficient time for the ship's crew to familiarise themselves with the pilot's intended passage plan. Furthermore, some of the navigation buoys have been unlit, out of position or missing at the time of the incidents.

Chart featured courtesy of Transas, TX97

- have on board a detailed berth to berth voyage plan
- when entering the channel, navigate with extreme caution and stay in the centre of the channel at all times;
- berth on high tide or arrange lightering during periods of port congestion or delays in berthing;
- consider the increased risk of proceeding upstream from the charted pilot ground. Where possible it is always recommended to get the pilot on board at the charted boarding ground. This will help ensure a proper exchange of information between master and pilot; and
- contact the ship's agent or local correspondent for the latest information on unlit navigation lights or any other changes in the fairway going into Douala port. This information should also be included in the information exchange between the Master and the pilot.
