## In this bulletin...

### **MARS 202632**

### **MARS 202633**

### **MARS 202634**

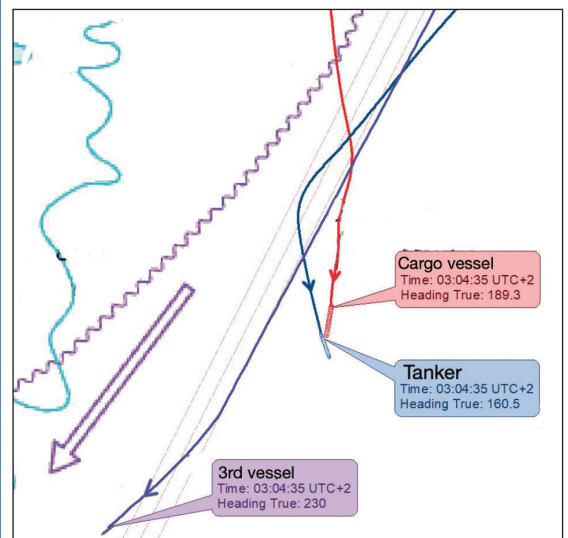
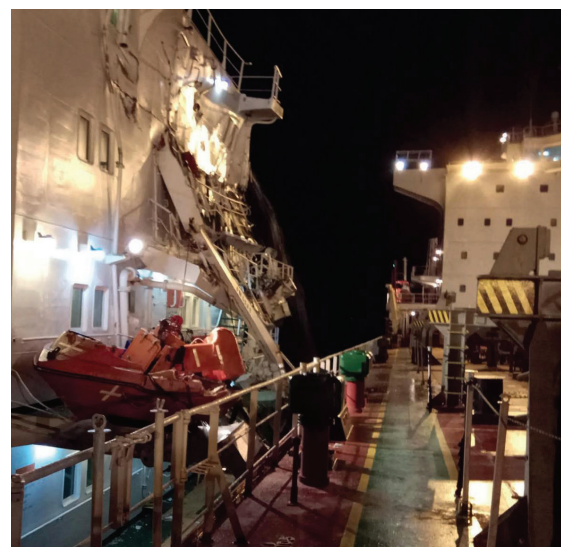
A bulk carrier was overtaking an oil tanker in a Traffic Separation Scheme (TSS) at night, in good visibility. The bulk carrier, moving at over 16 knots, had already passed several slower vessels that evening and was closing on the tanker from astern. A third vessel was also ahead, and was also passing the tanker. The bulk carrier's bridge team – Master, OOW, and a lookout who had briefly left the bridge – had focused on each overtaking situation individually rather than maintaining long-range radar and ECDIS scanning.

As the range to the tanker closed to under a mile, the bulk carrier's Master became concerned about the tightening CPA. He asked the OOW to call the tanker on VHF to establish intentions. The resulting conversation, conducted in English by non-native speakers, was ambiguous and each bridge team came away with opposite understandings. The tanker's Master believed the agreement was that they would ease slightly to port while the bulk carrier passed them to starboard. The bulk carrier's OOW, relaying the conversation in his own language to his Master (who had not listened to the call directly), reported the opposite: that the tanker did not want to be passed to starboard.

small helm movements to port, now intending to pass down the tanker's port side. No sound signals were made, and the manoeuvre was carried out incrementally; it went unnoticed by the tanker's bridge team.

Meanwhile, the tanker's Master – who had been on the bridge continuously for over 14 hours and was probably fatigued – was preoccupied with a separate crossing vessel on their port bow and a narrowing turn in the TSS ahead. Believing the bulk carrier would pass safely to starboard, he ordered hard-to-port to begin a full round turn to increase his sea room with the crossing vessel. Unfortunately, a visual check astern and a sound signal were not made before the turn began.

Only when the tanker's lookout spotted the bulk carrier close on the port quarter did the bridge team realised the danger. Both vessels attempted last-minute avoiding action, but with neither team understanding the other's intentions, a collision ensued. Both vessels sustained significant structural damage but there were no injuries or pollution.

- VHF is not a substitute for compliance with the Collision Regulations. It should only be used, if at all, early enough to allow a resolved, unambiguous plan to be established – not as a late-stage fix for a closing CPA.
- If the officer with the con delegates a VHF exchange to another, they should listen to it directly rather than relying on a second-hand summary, particularly where a language relay is also involved.
- Unambiguous course alterations should be made decisively, not through a gradual series of small helm orders.
- Before any large alteration of course, always check for traffic in the direction you are about to swing into – including astern.
- The Collision Regulations require long-range scanning, not just short-range collision avoidance. This would in this case have allowed earlier, larger, and less ambiguous action.
