Vessel groundings in new Parana channel off Paso Fighiera

Newly opened Parana River channel has seen a spate of groundings since its opening in April 2025.

Published 18 June 2025

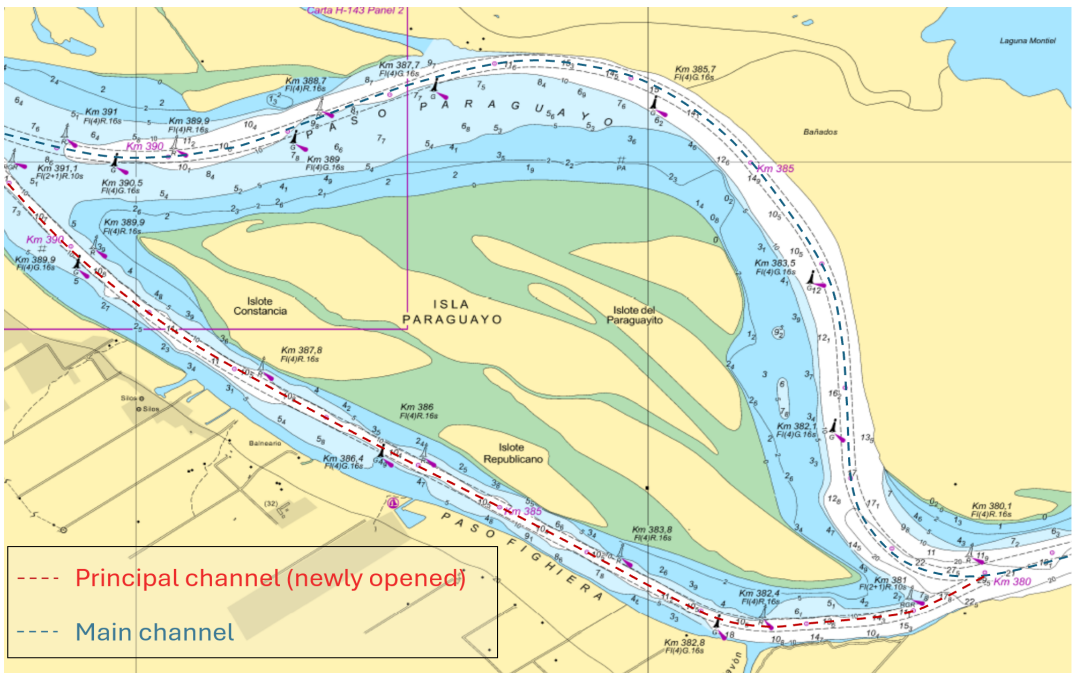
According to our local correspondent in Argentina, Sigvart G.J. Simonsen & Cia. S.R.L., a new channel, the Principal Channel opened along Paso Fighiera in the Parana River. in April 2025. The new channel and its accompanying routing changes are just south of the regularly used 'main channel,' between markers KM 391.7 and KM 380. These changes are illustrated below.

The regularly used ‘Main Channel’ and the newly opened ‘Principal Channel’ along Paso Fighiera.

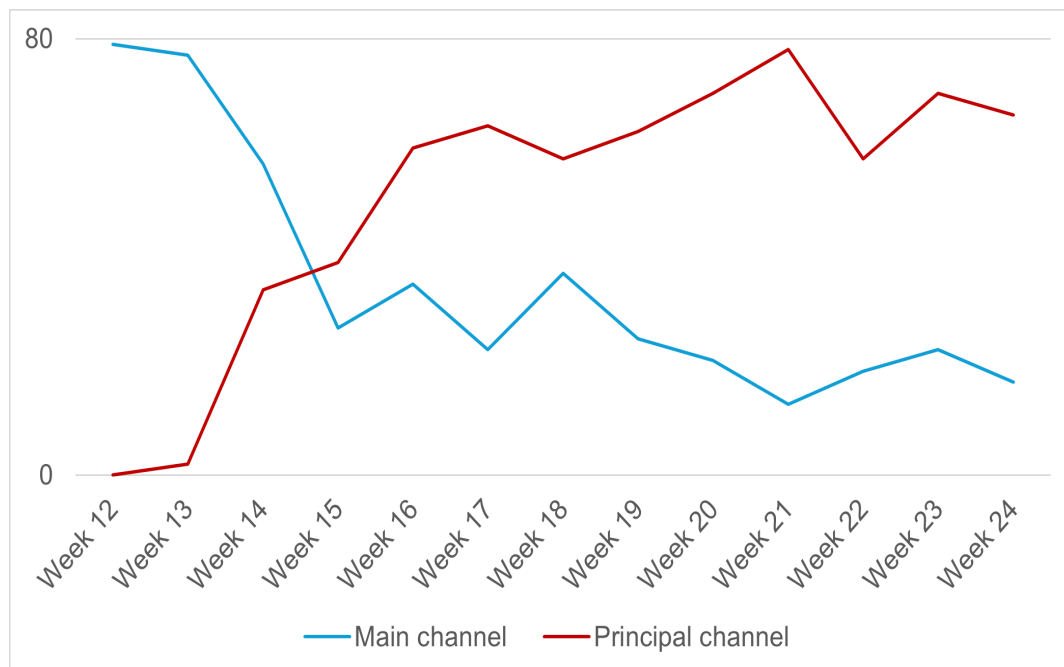
Analysis of AIS data reveals that merchant vessels with a deadweight exceeding 5,000 tonnes commenced transit through the Principal Channel in Week 13 in March 2025. Over subsequent weeks, there was a consistent increase in the number of vessels using the Principal Channel. This period (Week 13 to Week 24) also coincided with a steady decrease in traffic through the Main Channel, as indicated in the below graph.

Number of vessels transiting the two channels. Includes all merchant vessels > 5,000t dwt (Source: Windward Maritime AI TM)

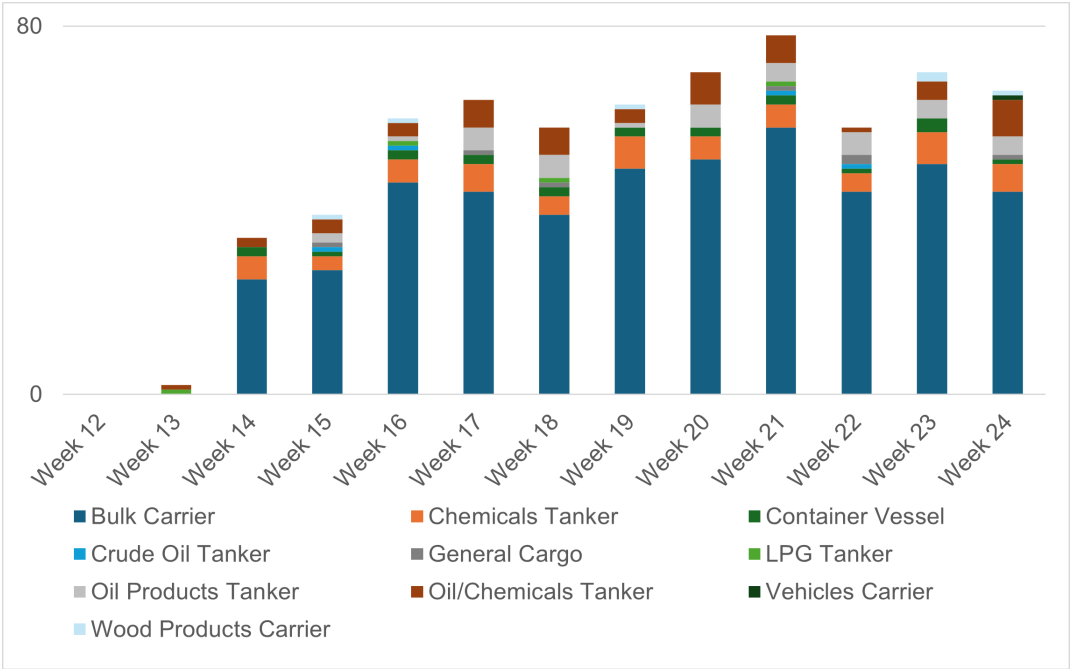
When looking at vessel types using the Principal Channel, bulk carriers - primarily Handysize and Panamax - are the most common, with chemical/oil tankers coming in second, as the detailed chart below illustrates.

Type of vessels transiting the newly opened Principal Channel (Source: Windward Maritime AI TM)
