## Vessel groundings in new Parana channel off Paso Fighiera

Newly opened Parana River channel has seen a spate of groundings since its opening in April 2025.

Published 18 June 2025

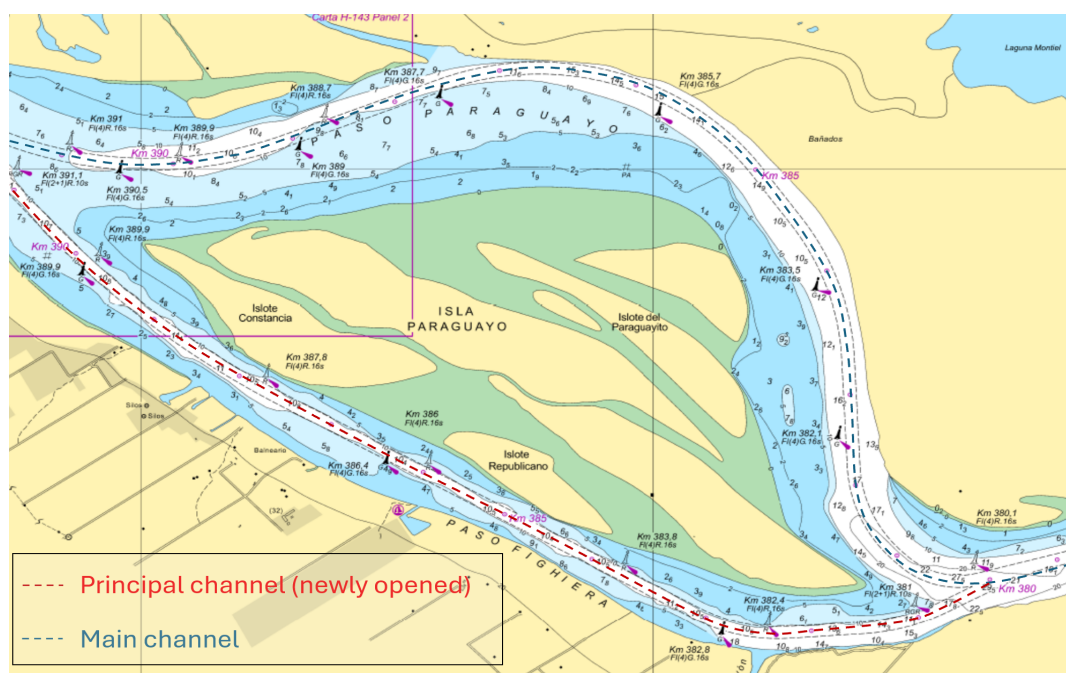
According to our local correspondent in Argentina, Sigvart G.J. Simonsen & Cia. S.R.L., a new channel, the Principal Channel opened along Paso Fighiera in the Parana River. in April 2025. The new channel and its accompanying routing changes are just south of the regularly used 'main channel,' between markers KM 391.7 and KM 380. These changes are illustrated below.

*The regularly used ‘Main Channel’ and the newly opened ‘Principal Channel’ along Paso Fighiera.*

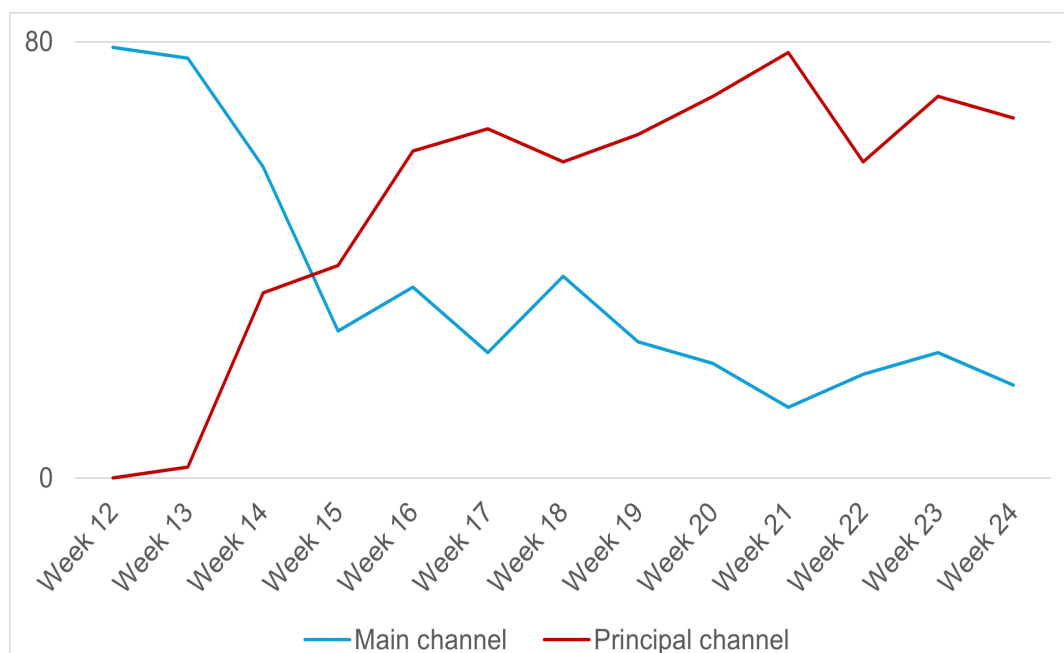
Analysis of AIS data reveals that merchant vessels with a deadweight exceeding 5,000 tonnes commenced transit through the Principal Channel in Week 13 in March 2025. Over subsequent weeks, there was a consistent increase in the number of vessels using the Principal Channel. This period (Week 13 to Week 24) also coincided with a steady decrease in traffic through the Main Channe, as indicated in the below graph.

Number of vessels transiting the two channels. Includes all merchant vessels > 5,000t dwt (Source: Windward Maritime AI TM )

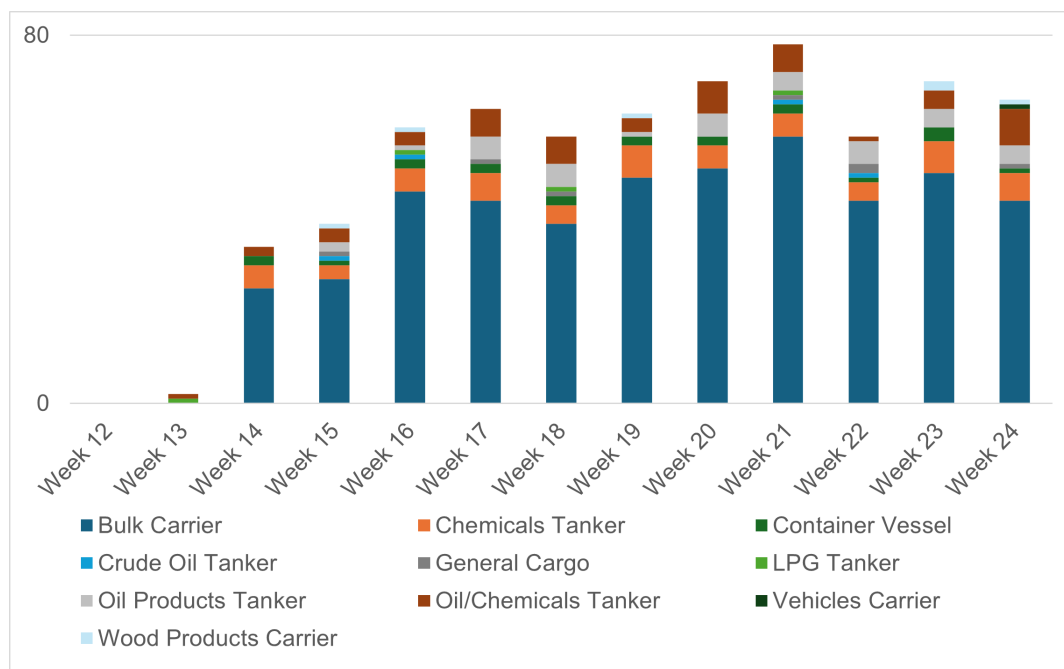
When looking at vessel types using the Principal Channel, bulk carriers - primarily Handysize and Panamax - are the most common, with chemical/oil tankers coming in second, as the detailed chart below illustrates.

Type of vessels transiting the newly opened Principal Channel (Source: Windward Maritime AI TM )
