Vessel groundings in new Parana channel off Paso Fighiera

Newly opened Parana River channel has seen a spate of groundings since its opening in April 2025.

Published 18 June 2025

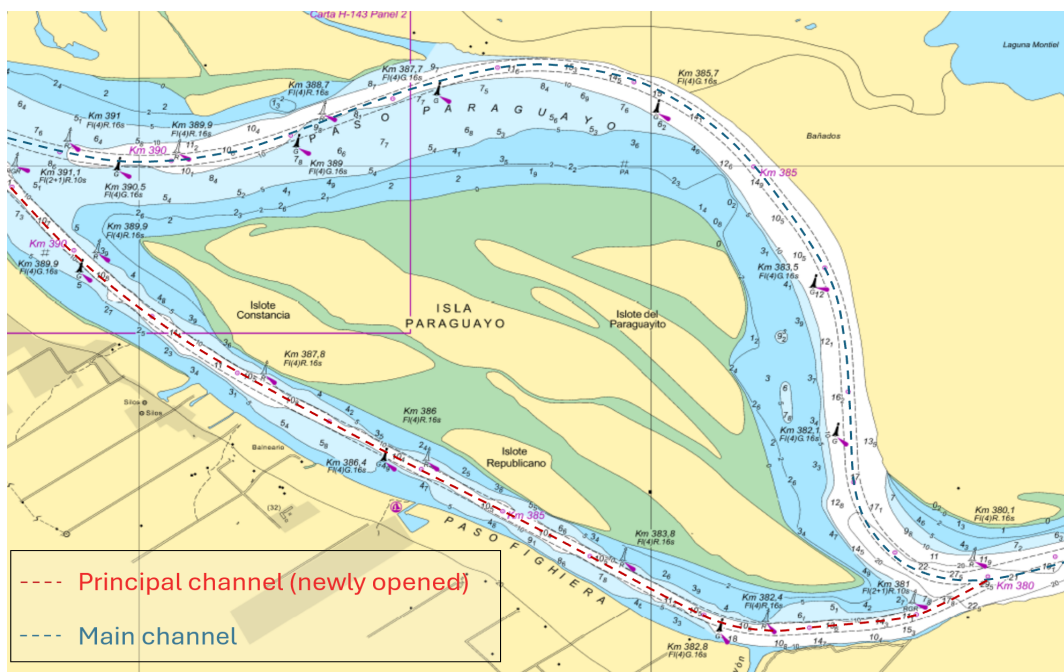
According to our local correspondent in Argentina, Sigvart G.J. Simonsen & Cia. S.R.L., a new channel, the Principal Channel opened along Paso Fighiera in the Parana River. in April 2025. The new channel and its accompanying routing changes are just south of the regularly used 'main channel,' between markers KM 391.7 and KM 380. These changes are illustrated below.

The regularly used ‘Main Channel’ and the newly opened ‘Principal Channel’ along Paso Fighiera.
