Case study for onboard safety meeting - Scrubber fire

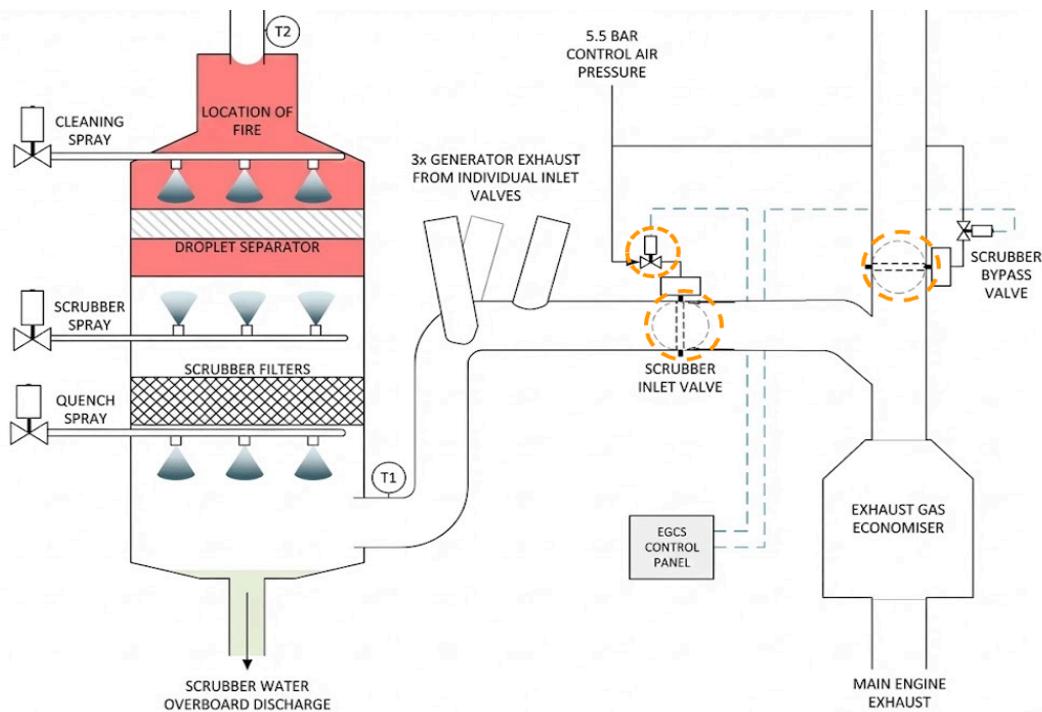
Diagram for illustrative purposes only. To prevent the ingress of high-temperature exhaust gases into the scrubber tower during standby mode, it is critical that the scrubber inlet valve is fully closed and the bypass valve is fully open.

- The main engine exhaust gas inlet valve was not fully closed (possibly due to a malfunction of the pneumatic actuator or a drop in control air pressure), allowing hot exhaust gases to enter the scrubber tower.
- In the absence of cooling seawater, the temperature inside the scrubber tower increased rapidly, igniting plastic components such as spray nozzles and droplet separators.
- EGCS temperature sensors were inactive in standby mode, preventing detection of rise in temperature.
- Design limitations, such as plastic materials used inside the scrubber were not sufficiently heat-resistant.
- No process was in place to verify the position of the bypass and scrubber inlet valves.

- The report indicated a possible malfunction of the pneumatic actuator controlling the inlet valve or a drop in control air pressure, which resulted in the inlet valve remaining partially open.
- There was no process to verify the position of the bypass and the inlet valves after scrubber system was shutdown.
