# MARS – Lessons Learned

MARS Report No 388 February 2025

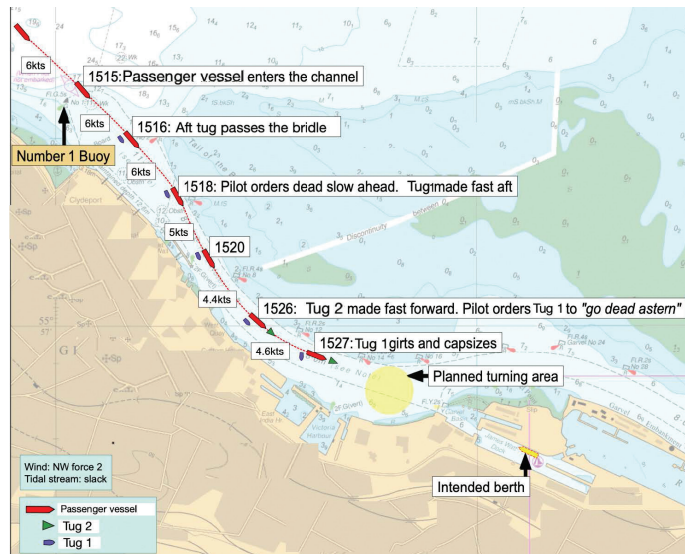
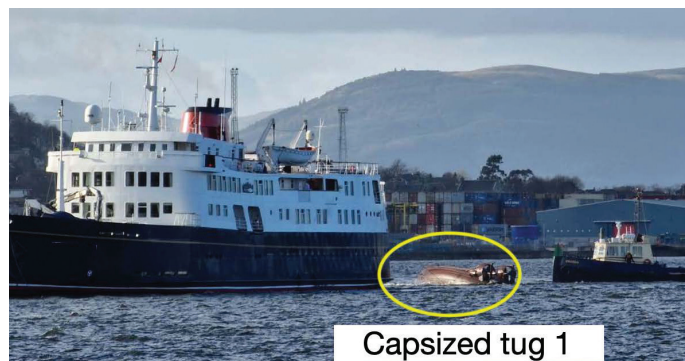
On the aft tug's deck, the starboard bridle became taut. The tug's turn stalled with its heading now approximately 45 degrees to the right of the passenger vessel's track. The tug was quickly pulled sideways by the bridle and almost immediately heeled to port. It capsized within 10 seconds. Some of the aft mooring party on the passenger vessel threw lifebuoys overboard and looked for survivors, while one crew rushed to the galley for a knife to cut the tug's bridle.

The investigation found that, considering the speed (4.6kts), the tug had just over 10 seconds to reverse direction into its new position astern of the passenger vessel before its weight came onto the towlines. Instead, the tug's turn stalled and the bridle came under tension. The tug was using a gob rope, but this did not prevent the tug being towed sideways. The tug's emergency tow hook release was found to be operating correctly after the accident, but it is hypothesised that the crew did not have enough time to operate it before capsizing.

- The gob rope in this case was led through a bow shackle 2.8m behind the towing hook, about 0.5m above the deck and over 1m from the tug's transom. This gob rope arrangement was unlikely to be as effective as one rigged closer to the transom. It is therefore possible that this arrangement left the tug more vulnerable to being towed sideways and girted.

- The passenger vessel's speed at the time of the manoeuvre exceeded the 2-3kts recommended by both industry and the local port towing guidelines.
- Investigations into similar girting accidents found that it was essential that conventional tugs use a gob rope during towing operations to ensure the safety of the tug. To be fully effective, this rope must be correctly set and secured. A gob rope must be as low in the vessel as possible and as close as possible to the tug's transom.

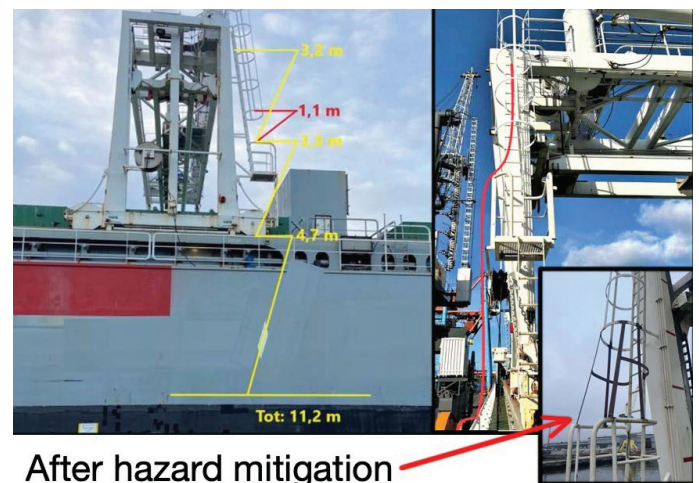
### After hazard mitigation

The ladder in question was equipped with a protective cage and the platform under the ladder was equipped with a railing. Between the platform railing and the ladder's protective cage there was an unprotected space measuring just over 1m. The crew member fell through this space and down onto the quay. The total height of the fall was just over 11m.

- This accident again illustrates the benefit of doing the rounds of your vessel with 'new eyes'. Try and see where hazards exist but have always been in plain sight. We become too accustomed to hazards in plain sight; we see them as 'normal'.
- The victim had used a protective helmet with chin strap. The chin strap, an often-maligned PPE detail, was instrumental in keeping the helmet on their head during the multiple impacts of the fall and may have saved their life.
