In this bulletin...

MARS 202608

Anchor troubles

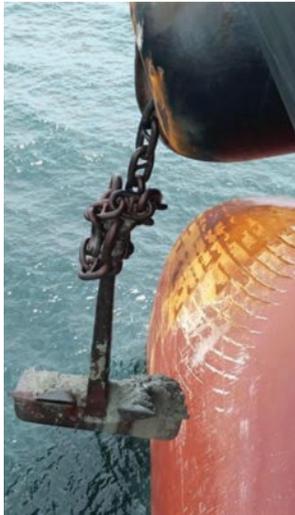
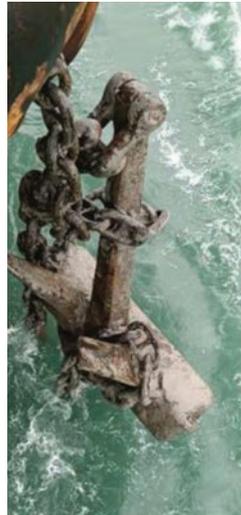
A vessel was picking up anchor after a stay of four days at anchorage, and the anchor chain was found tangled around the shank. A barge was arranged to cut and clear the cable. The incident cost over \$100,000, excluding the off-hire costs.

Similarly, a second vessel had her anchor chain tangled while she was picking up anchor with a pilot on board. The ship needed to be diverted to a port for repairs.

- While dropping anchor, ensure the cable is ranged on the seabed while there is sternway to avoid piling up of the anchor cable.
- Anchor swivels should be checked for free movement during maintenance of the windlass and the anchoring equipment.
- Ensure the anchors are well monitored, especially during the turn of tide.

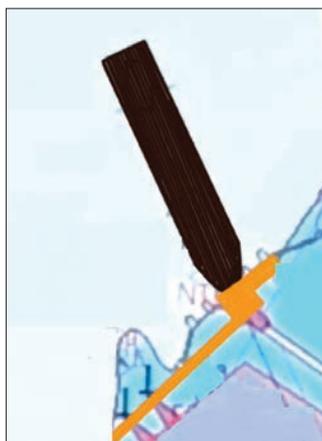
Position at time of contact

At various points of the operation the pilot, Master, and chief officer on the bridge, the second mate on deck forward (but not on the bow), and the operator of the forward tug, all noticed that something was not quite right with the approach. However, none of them signalled their unease. Soon the vessel struck the dock, bow on, at over one knot. Although damage to the vessel was relatively minor, resulting in a hole in the bow, damage to the unloading dock was major.

The investigation found, among other things, that the pilot had assumed his PPU 'recognised' the vessel as a frequent caller and that it had therefore automatically applied the antenna offset for this ship. In fact, the offsets were not loaded, which resulted in the displayed ship position on the PPU being more than 200 metres 'astern' of the true position. This error was not caught during the three hours + transit to the dock. By fixating on the PPU image, which was incorrect, the pilot was working on false assumptions.

- Even with perfect weather conditions and in daylight, a well-maintained ship with tug assistance can still unwittingly be driven into a dock if BRM breaks down or is simply non-existent.
- Notwithstanding experienced officers familiar with the port and a pilot, there was no shared mental model of the berth approach among the bridge team.
- Frequent callers and repetitive operations can, paradoxically, cause a lull in standards and lower levels of vigilance.

- An over-reliance on a single data source, in this case the PPU, can lead operators astray sufficiently to cause an accident, even against what should be overriding visual evidence out of the bridge windows that they are running into danger.
- When setting up a PPU, it is good practice to validate the position of the vessel on the PPU as compared to the vessel's ECDIS, and to confirm all offsets if the pilot has installed a complementary portable antenna.
- With no one stationed on the ship's forecandle or on the berth assigned to monitor progress and call out distances the bridge team lacked another important data input source.

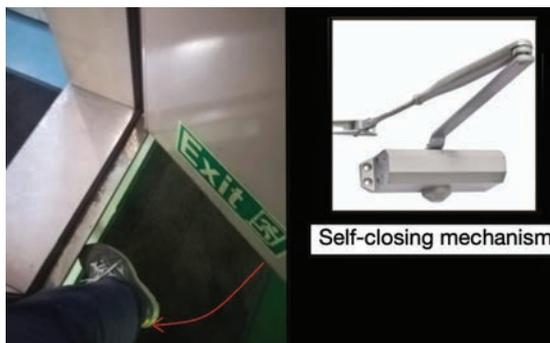
As a crew member was passing through a self-closing fire door into the engine control room, his left foot was caught between the closing door and the door frame. His forward momentum caused him to lurch forward, but his foot was caught and he lost his left shoe. The fire door continued to close and badly pinched his now exposed big toe. He was unfit for work for over a week.

Although the company investigation did not judge the door's closing 'latch speed' to be a factor, they nonetheless found that periodical verification of self-closing devices for all fleet vessels was a worthwhile addition to the vessel's planned maintenance system (PMS).

- In machinery spaces and work environments, well secured protective boots are always recommended.
- Self-closing door mechanisms are adjustable and should be checked from time to time. Door closing speed should be just sufficient to ensure proper closure. Too quick can be a hazard and too slow could mean the door does not have enough energy to catch closed.

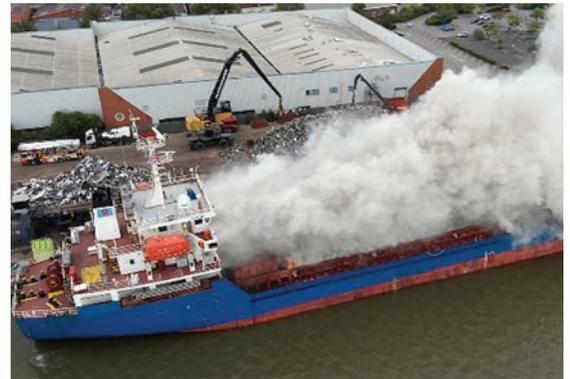
The fire was extinguished the next day. There were no injuries and there was no loss of life. Over several days, crew discharged the contaminated firefighting water from the hold into road tankers for disposal. The scrap cargo was discharged and surveyed to check its composition. The vessel had suffered significant heat damage to structural steelwork in the aft cargo hold.

- The fire was likely caused by an undischarged battery or other ignition source causing a spark during loading, which then ignited combustible material in the scrap cargo.

- The cargo had been classified as group C scrap metal under the IMSBC Code, which did not require the shipper to declare hazard identification and cargo composition. However, the scrap cargo contained hazardous impurities, including batteries, oil drums, and oily residues, which posed a fire risk.

- Appointing a qualified cargo surveying company to assist the vessel's Master before and during loading is a good risk reduction measure.
- Vessels have capsized at berth due to firefighting efforts by shore teams. Close coordination between the Master and fire chief is needed to properly execute the extinguishing effort without further risk to the vessel.
- As seen in MARS reports 202345, 202346 and 202243, while scrap metal may appear innocuous, it is nonetheless a fire risk because of the prevalence of associated combustible materials often present in this cargo.
- Notwithstanding the successful outcome in this case, for a fire in a hold, it may be safer to close the hatches and ventilation and then discharge the fixed CO₂ system than to pour copious amounts of water into the ship, which can negatively affect the vessel's stability.
