# MARS – Lessons Learned

MARS Report No 390 April 2025

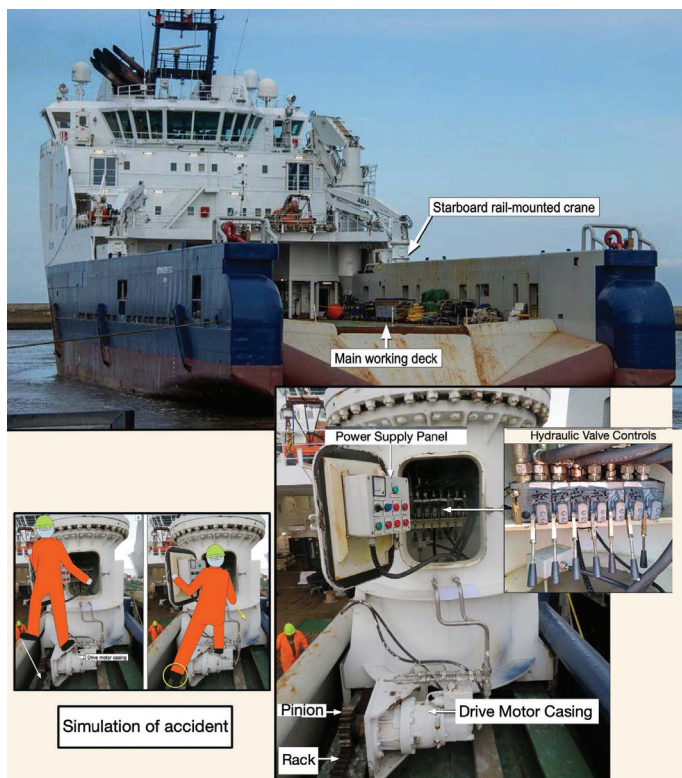
MARS 202515

After repositioning two loads on the main deck, a third lift was initiated. In order to see both the fitter and the load to be moved 4m below on the main deck, the officer stood with his left foot on the inboard bulwark and his right foot on the crane drive. At one point, he shifted his left foot from the bulwark to the crane's travel rack. He felt something pulling at the left leg of his overalls, which unbalanced him.

He held onto the crane travel lever for stability, but this caused him to unintentionally pull it further backwards, which increased the speed of the crane's traverse on the rack, and his left foot and leg were dragged into the rack and pinion drive. He let go of the travel lever, which stopped the crane.

The fitter climbed up to the crane's rail and found the victim lying on his back with his left leg trapped between the rack and pinion. The victim, still conscious, instructed the fitter to move the crane forward; this action freed his leg, which was severely mangled below the knee. The alarm was quickly raised, and the vessel's first aid team was activated. Soon after, a helicopter transferred the victim to hospital, where his leg required amputation below the knee.

The investigation found that the crane manufacturer's operations manual, which was available on board, stated that the local controls in the crane pedestal were for emergency use only. Normal operation was to use either the bridge control station or the crane's remote-control unit. The company's Safety Management System (SMS) made no reference to ship-specific operating instructions as there were none. The practice of operating the crane with no guardrails or restraints while working at height, and near the unguarded rack and pinion gearing, was a clear sign that the process was flawed. The crew indicated that they had the freedom to challenge on board practices, but they did not raise the issue of the operation of the cranes using the local controls as they considered it 'normal'. This demonstrated not only an ignorance of the manufacturer's instructions but a certain blind eye to unsafe acts or unsafe conditions.

- Why is it so easy to see a hazard after an accident? Seeing hazards where you habitually work is not effortless – you have to work at it. Open your mind and look 'with new eyes' at each task. Is there danger?
- Although generic instructions and practices in a company's SMS are a good first layer of protection, every vessel should have ship specific procedures that address the specific hazards of that vessel. No one knows the ship better than the crew, so get to work on your ship specific procedures

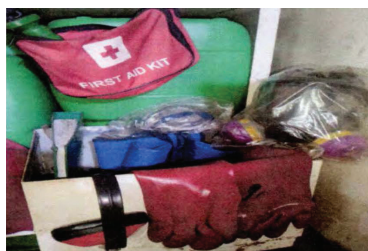
Before

➔ An engineer was inspecting the chemical locker. He found that although there was a notice in place instructing crew to use proper Personal Protective Equipment (PPE) when handling the chemicals stored there, there was no easy access to specialised PPE equipment in place. He advised the Master and Chief Engineer and PPE was placed in easy access to the chemicals.

- This is a good example of seeing a hazard that was in plain view for some time.
- Each chemical has its own specific risks. While specific PPE should be easily accessible, so too should an information matrix that shows what PPE must be worn for each chemical.

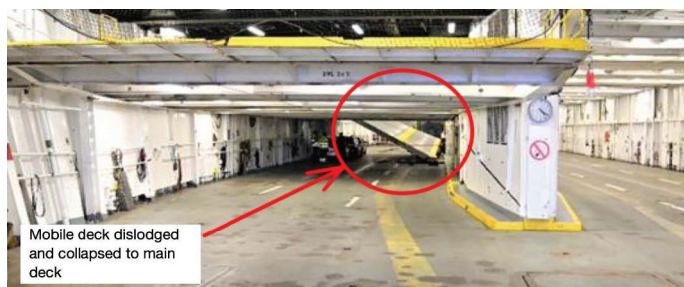
The crew member pulled in the locking wedges for the platform too early, an 'out of sequence' manoeuvre. This resulted in the platform falling freely for a short distance, putting high stress on the lifting cables and mechanism. One of the sheaves of the lifting cables was torn loose by the increased stress. The spacer plates that were supposed to hold the two steel plates of the line sheave together broke under the load. Now, there was nothing to hold the cables in place and one side of the mobile deck fell to the main deck. A car with a trailer was crushed and two people suffered minor injuries.

The investigation showed that there are no requirements for independent inspections of platforms for suspended (mobile) decks. However, requirements do apply to ramps that are defined as 'lifting devices'. Mobile decks have a similar technical design to lifting ramps and the risks associated with construction and use are similar. The disparate regulatory requirements for mobile decks versus lifting ramps do appear to be justified from a safety perspective. Similarly, there was no requirement for protection against wire breakage for suspended decks, whereas there is such a requirement for ramps.

The investigation also found that there were no technical measures to prevent the locking wedges from being pulled in before the platform had been raised. Finally, there was nothing to prevent people from being under the mobile decks during operation. This aggravated the consequences of the accident.

- There is no substitute for good training and complete familiarisation with the equipment being used. In this case the crew member's training in the operation of the mobile deck was less than adequate.
- Allowing people to remain under the mobile decks when the decks were being operated is a sign that better risk assessments are in order on this vessel and possibly others of similar design.

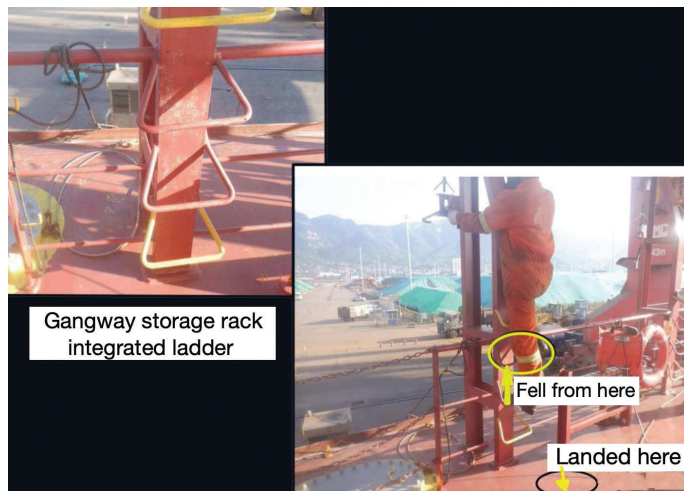
A crew member accomplished this well-established routine, but while stepping down from the ladder he slipped from a height of about 1.2m, falling on the deck and landing on his right leg. The impact caused a fracture of the right knee.

This common and well-practised procedure did not appear to be hazardous. Crew had accomplished this task innumerable times without incident. But after the accident, we can see that the integrated ladder, as installed, poses several 'safety traps'.

- The ladder gives good access to the gangway securing cleats but also gives a false sense of security. One hand is needed to hold yourself steady on the ladder, while one hand is free to work the cleat.
- The relatively low height of the access ladder adds to the false sense of security, after all, what can happen at such a low height? This accident proves that even a fall of 1.2m can cause a serious injury.

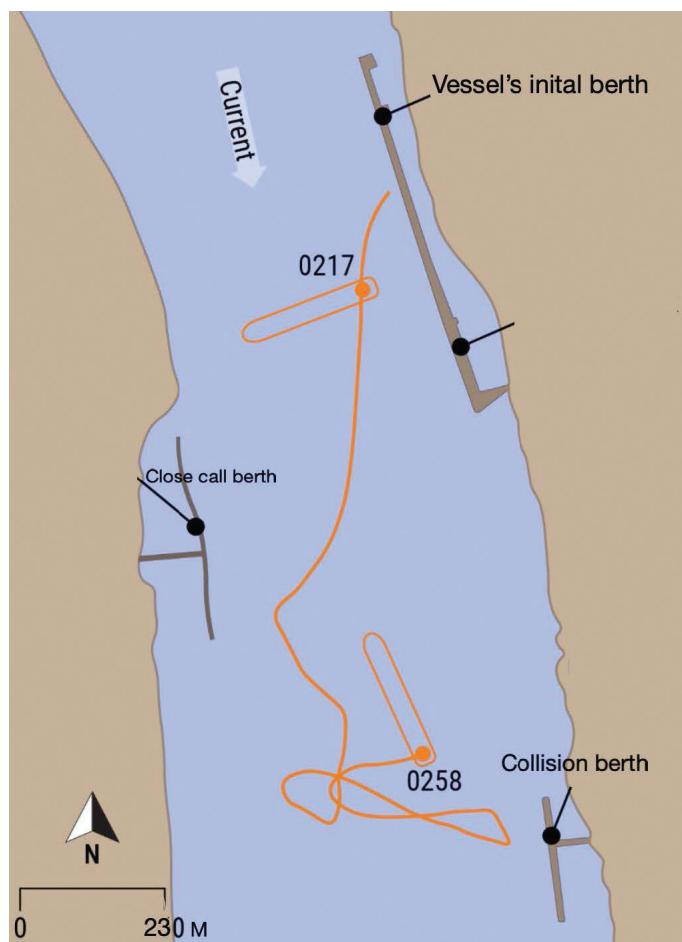
About one hour later, the crew found that the lines forward were very tight, and the bow had come away from the dock slightly. The crew tried to heave on the breast lines, but because the lines were already very tight, the vessel's electrohydraulic mooring winches could not heave in. The Master was informed that the bow had come off the dock by about 1.5 metres and they could not bring the bow back alongside with the winches.

The Master went to the bridge and called for immediate tug assistance. The velocity of the current was now approaching 4.5 knots. Within minutes, the vessel's bow began to move farther to port, away from the dock, while the stern remained alongside. At 02:10, the Master summoned all crew on deck. On his way to the bow, an officer saw the forward mooring lines paying out; smoke and sparks could be seen coming from the port side winches, so he stopped as it was no longer safe forward.

The Master asked for immediate engine readiness, but as the bow continued to move out into the river, greater tension was now being placed on the stern lines which began to part. The vessel then broke away from the dock and the Master ordered the anchors away. At 02:16, main engine propulsion control was transferred to the bridge. Once safe to do so, crew went to the bow and released the starboard anchor, which was already hanging out of the pocket. The anchor was let go to one shot (27.5m) on deck.

The investigation found that the probable cause of the breakaway of the bulk carrier from the dock was the bow coming off the dock during cargo loading, thereby exposing more of the vessel's underwater hull to the strong river current.

- The force of a current on the hull of a vessel increases in a non-linear fashion in relation to the current speed (ie to the square of the velocity). Beware of this hazard!
- It is important to ensure that berthing lines are kept well taut as a vessel loads and sinks lower. This increases the surface area of the hull to the current and hence the force acting on the hull.
- The increase in the force on the hull as the speed of the current increases is non-linear. A reduced UKC adds a multiplying factor to the resultant force. In this case, approximately 1.2X (source: Capt S S Chaudhari at <https://captsschaudhari.com/2020/07/02/how-do-you-go-about-anchoring/>)
- In such conditions, it is good seamanship to keep propulsion, thrusters, and steering systems on short standby and have anchors ready for immediate use, even if not required by the loading facility.
