### MARS 202623

Pilot boat hits rocks

### MARS 202624

### MARS 202625

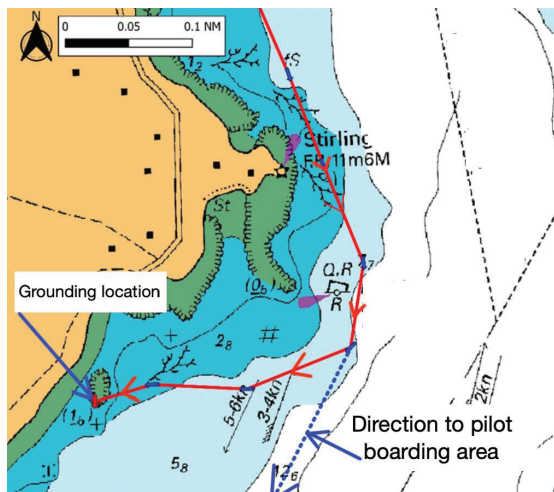
Shortly after the alteration of course to starboard, the deckhand noticed that the chart plotter and radar screens showed the vessel heading towards the land and he told the captain. The captain looked down to check the screens and realised that the vessel was not where it should have been. A few seconds later, the vessel ran aground with both engines still running. The captain attempted to back off by putting both engines astern, but realised that would be ineffective when they saw rocks on both sides of the vessel and astern.

- The Master's situational awareness was significantly reduced by the state of the visibility and their navigation methods. As a result, at a certain point the boat turned too far to starboard and the vessel ran aground.
- The vessel had sufficient electronic navigation instruments to support navigation in restricted visibility. At the time of the accident, these instruments were switched on, but the captain was not using them to verify the vessel's position and progress.
- At the time of the accident, the pilot boat operating company did not require assessment of the ongoing proficiency of pilot vessel captains. This omission meant that there was no formal verification that navigation practices on board the pilot vessel continued to meet industry best practice.

- Navigating using exclusively visual means in reduced visibility, even in well-known waters, is a recipe for an accident. See MARS 202154 for a similar situation.
- Speed through the water should be proportional to the quality of your situational awareness. This accident was in part due to ignoring this rule; that is, proceeding at high speed with a low situational awareness.

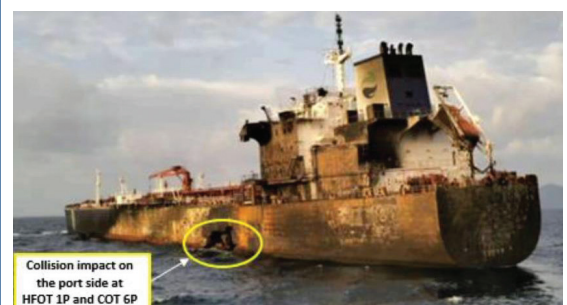
**Damage to the vessel underway after collision and fire**

The investigation found, among other things, that the OOW had had only about two hours of rest in a 38.5-hour period since leaving his home and joining the vessel, and was likely experiencing fatigue. This could have reduced his performance and judgement during the developing close-quarters situation. The investigation also found that the anchored vessel had attempted to warn the oncoming tanker with the ALDIS lamp and sound signals, but these were ineffective. Despite the escalating risk, VHF was not used as an additional means of communication, which could have supported situational clarification.

- Attending to any other duties except navigation while in charge of a watch is a recipe for disaster.
- With only about two hours of rest in a 38.5-hour period before the collision (due to travel to the ship among others), it is almost certain the OOW was experiencing fatigue, which negatively affects performance and judgement. At a minimum, travel time to join a ship should be counted as time on board for the purposes of work/rest calculations.

- Given that:  
ISM requires companies to establish safeguards against all identified risks;  
Sufficient restorative sleep is the only antidote for fatigue;  
It follows that, over and above work/'rest' calculations, companies should endeavour to ensure, through manning levels, procedures and safety culture messaging, that their crew have had sufficient restorative sleep before working.

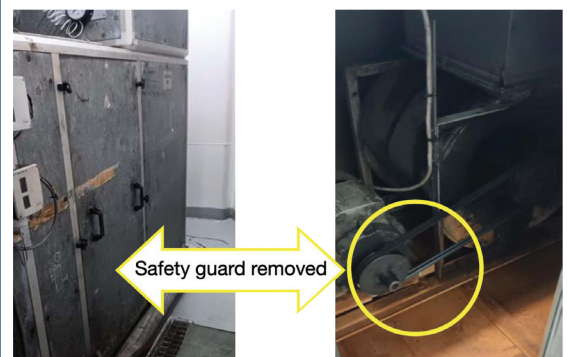
A vessel was underway in bad weather and was pitching and rolling. An engineer was tasked with a routine check of an A/C compressor. He removed the safety guard of the still running compressor, but the motion of the ship caused him to lose balance. He instinctively grabbed forward to steady himself, but his left hand came into contact with the moving belt of the compressor and was badly injured.

- Before any intervention, machinery should be fully stopped and isolated (Lock out/tag out).
- Effective risk assessment, work planning meetings, and toolbox talks are essential. They should include specific consideration of vessel motion, weather conditions, and human factors.
- Crew members shall be encouraged and empowered to exercise Stop Work Authority whenever unsafe conditions are identified.
