## In this bulletin...

### MARS202538

Li-ion battery hazards

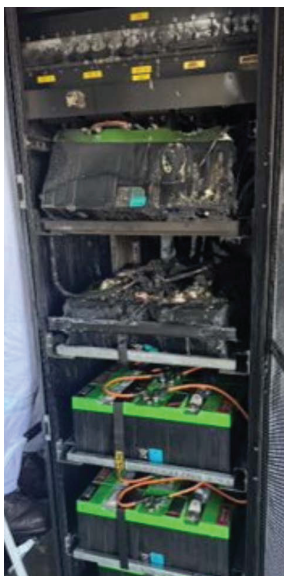
An integrated Li-ion battery bank recently caught fire on board a passenger vessel. It was found that loosely crimped lugs overheated and initiated the fire. No one was injured and the vessel sustained minimal damage, but this casualty highlights the safety hazards posed by Li-ion batteries.

The resulting investigation found, among other things, that all Li-ion installations used for propulsion, control and electrical power must undergo an engineering plan review and be fitted with supporting safety systems. Additionally, these systems should be tested and inspected at installation and periodically afterward, and be properly maintained by competent mariners, regardless of the battery bank size or end consumer.

- Batteries should be visually inspected for signs of deterioration, such as bulging cells or corroded electrical connections. Documentation on the

completion of required maintenance should be maintained.

- Crew members responsible for battery operation and maintenance should be trained in the manufacturer's guidelines and operational procedures and familiar with the functioning of the battery management system.
- Crew should know how to respond to abnormal battery conditions or fires. Safety drills for Li-ion battery fires should be performed, and Li-ion battery system arrangements and risks should be considered when conducting other drills.

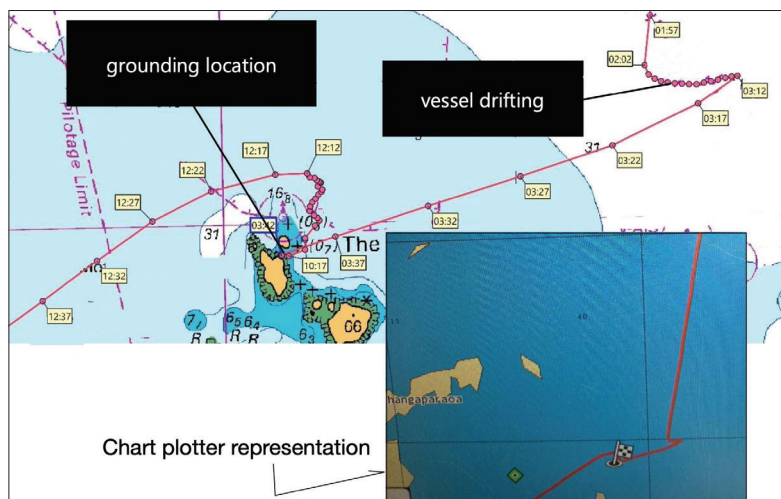
When the Master and the chief officer took over the watch the next morning it was still dark. Using the chart plotter, which was not an ECDIS, the Master set the course straight to the pilot boarding area. About 40 minutes later, the vessel ran aground on charted rocks at the periphery of an island at a speed of about eight knots. The vessel did not have the proper large-scale charts for the area, and the chart plotter did not show the rocks.

A small hole was observed in the bow as well as a damaged propeller. Luckily, the vessel could be refloated at high water and towed into port.

The investigation determined that the Master had based his decision on an incorrect understanding that they had safe water. Had an appraisal been conducted and a formal voyage plan prepared based on the applicable charts and nautical publications, it is virtually certain the navigational hazards would have been identified and a course set that kept the vessel clear of those hazards.

- It may seem like a 'beginner's mistake' not to have a proper passage plan and appropriate scale charts (or ECDIS), but the professional mariners involved in this accident were not amateurs.
- Relying exclusively on a chart plotter for positioning is obviously a mistake but other groundings have occurred while using fully compliant ECDIS. In particular, the safety depths (and/or contours) have been incorrectly entered, among others, thus showing safe water where none was for the vessel in question. See MARS 201505, 200930, 201660, 201875.
