Learning as we go: challenges with the use of exhaust gas scrubbers

Published 17 October 2019

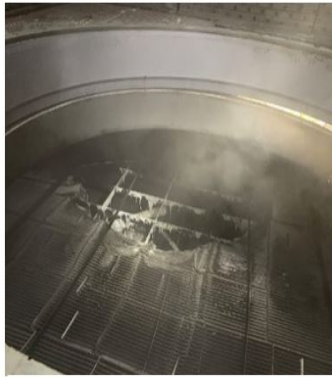
Gard has seen a few fire incidents where sparks from welding, metal cutting, and other hot work activities fell into the inner chamber of the scrubber through uncovered openings, and in one case the fire also spread to the engine room through glass reinforced epoxy (GRE) piping. Heat generated from the steel cutting for the supporting brackets, also contributed to the build up of heat inside the scrubber. In all these cases the yard fire fighting team responded and extinguished the fire with vital assistance from crew.

Burnt mist eliminator

Later investigations revealed that crew had requested that the yard to cover the openings but this was not done. The fire risk to scrubber packing during the hot work activity had not been identified by yard personnel, and many of them were not aware that internal components of the scrubber were combustible. These fire incidents arising from shortcomings in hotwork safety procedures are not peculiar to scrubbers and can occur in any location onboard a ship where welding, cutting or grinding works are undertaken.

Fire risks can be mitigated if hot work safety procedures are followed. The risk assessments carried out prior to the work should cover which parts of the scrubbers are flammable. These should be protected during the hot work by covering any openings to prevent sparks from finding their way to these parts. Measures should also be put in place to prevent transfer of any heat generated during metal cutting, welding, grinding, and other hot work activities. Owners should ensure that yard workers, who will ultimately be undertaking these hotwork activities are aware of these risks and appropriate barriers are put in place to shield these areas. Crew members are advised to not rely solely on the yard safety watchman, but to monitor the hot work activities themselves. Fire fighting equipment should be maintained in a ready to use state and crew should be familiar with how to use them.

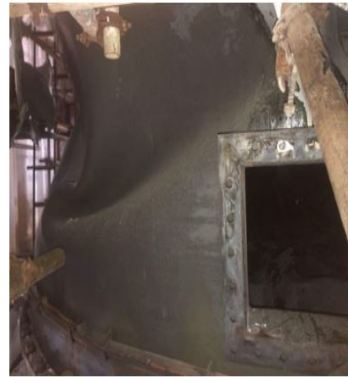
Damaged scrubber

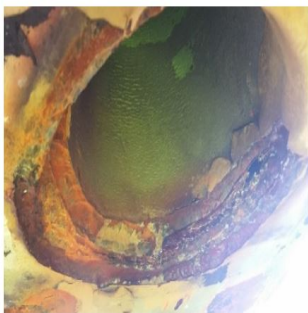
Cracks near distance piece leading to water ingress

Scrubber waste is corrosive, and we have seen a few incidents where within 10-15 months of the open loop scrubber being installed, corrosion of overboard discharge piece or in its immediate vicinity has resulted in water ingress into areas such as the engine room, ballast tanks and cargo holds. Absence of or poor application of protective coatings on the inside of the pipe and at the welds, along with poor application of paint on hull plating near the washwater discharge were identified as the causes of accelerated corrosion. In all these cases, temporary repairs to plug the leak were carried out by divers followed by permanent repairs at a yard.

The metallic distance piece is normally coated for enhanced protection. There should be a regime to measure the wall thickness. For many classification societies, such as

this is a survey item. Any reduction in thickness is indicative of a breakdown of the coating. For leakages from welded joints and holes or cracks in the hull, the quality of workmanship and the paint application should be scrutinised. Also, the bilge alarm and pumping arrangements should be checked regularly so that the crew is alerted of and can respond to any water ingress.

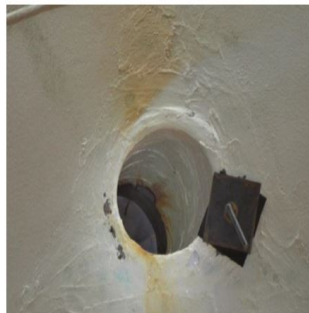
Temporary repairs on hull performed by diver on another vessel

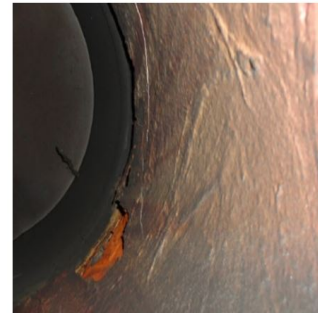
Protective coating inside disch. pipe flaking off at flange

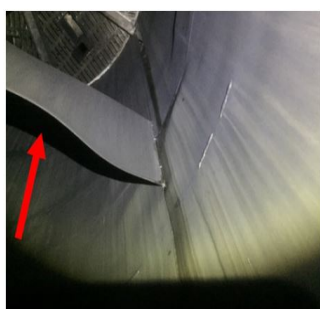
A vessel was regularly trading in Northern Europe and had installed an open loop scrubber. It had to changeover to low sulphur fuel when visiting a port that had regulations in place banning discharge of washwater from open loop scrubbers. It was still required to run the scrubber in dry mode, i.e. with washwater supply pumps turned off, to allow for the passage of hot exhaust gasses with a temperature of nearly 400° C. After departure from port, washwater pumps would be started and cold sea water sprayed through the nozzles inside the scrubber. During inspection of the scrubber by crew, damage was noticed to the nozzles, demister housing and the drains.

Deformed plates and buckled scrubber housing

A survey was carried out and indicated a variety of concurrent causes, such as thermal shock, poor workmanship by the yard, for example, only spot welding done on demister supporting plates; and poor design. The scrubber had been in service for nearly two years.

When in operation, the scrubber unit will be subject to different types of stresses, which will test the quality of the welding and housing structure. Supervision by owners during the time of installation can help mitigate this risk. With regards to design related issues, owners are recommended to have a dialogue with manufacturers to mitigate such risks. In this particular case of thermal shock, as preventive action, shipowners changed the design and installed a water cooling system for the scrubber which will continuously run in a closed loop when the scrubber is operating in dry mode.

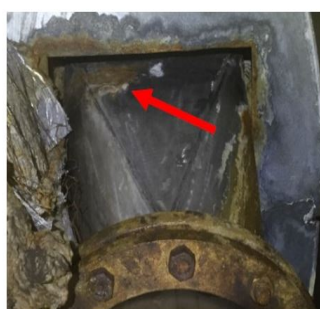
Cracks on water drain outlet (viewed from outside) with signs of leakage

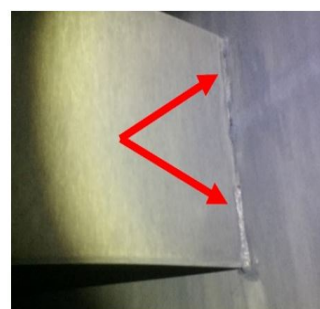
Poor workmanship: Support plates only spot welded by yard
