## Learning as we go: challenges with the use of exhaust gas scrubbers

Published 16 October 2019

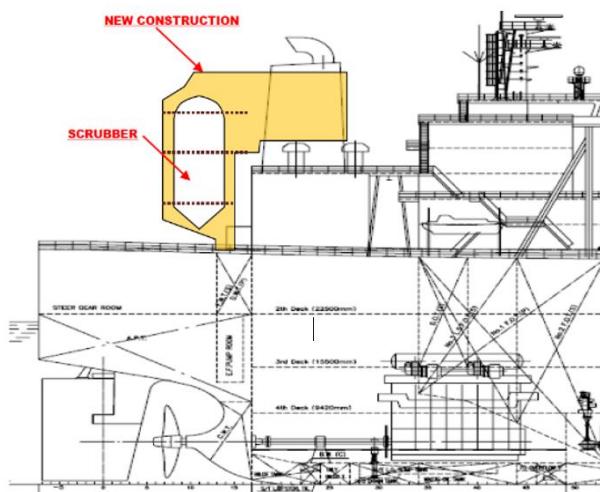
General view of scrubber retrofitting area

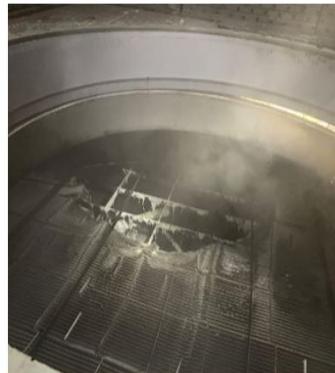
Gard has seen a few fire incidents where sparks from welding, metal cutting, and other hot work activities fell into the inner chamber of the scrubber through uncovered openings, and in one case the fire also spread to the engine room through glass reinforced epoxy (GRE) piping. Heat generated from the steel cutting for the supporting brackets, also contributed to the build up of heat inside the scrubber. In all these cases the yard fire fighting team responded and extinguished the fire with vital assistance from crew.

Burnt mist eliminator

Later investigations revealed that crew had requested that the yard to cover the openings but this was not done. The fire risk to scrubber packing during the hot work activity had not been identified by yard personnel, and many of them were not aware that internal components of the scrubber were combustible. These fire incidents arising from shortcomings in hotwork safety procedures are not peculiar to scrubbers and can occur in any location onboard a ship where welding, cutting or grinding works are undertaken.

- **Fires during retrofitting:** Fire risks can be mitigated if hot work safety procedures are followed. The risk assessments carried out prior to the work should cover which parts of the scrubbers are flammable. These should be protected during the hot work by covering any openings to prevent sparks from finding their way to these parts. Measures should also be put in place to prevent transfer of any heat generated during metal cutting, welding, grinding, and other hot work activities. Owners should ensure that yard workers, who will ultimately be undertaking these hotwork activities are aware of these risks and appropriate barriers are put in place to shield these areas. Crew members are advised to not rely solely on the yard safety watchman, but to monitor the hot work activities themselves. Fire fighting equipment should be maintained in a ready to use state and crew should be familiar with how to use them.

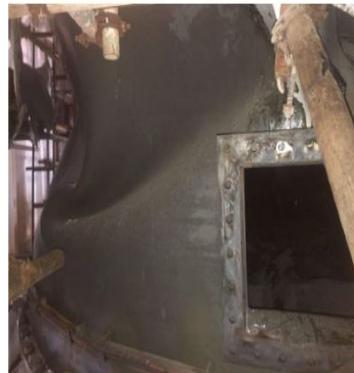
Damaged scrubber

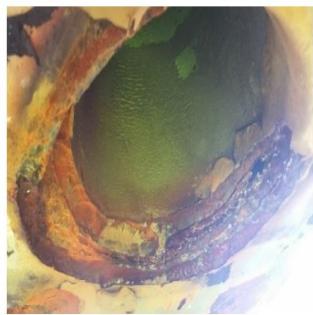
Cracks near distance piece leading to water ingress

Scrubber waste is corrosive, and we have seen a few incidents where within 10-15 months of the open loop scrubber being installed, corrosion of overboard distance piece or in its immediate vicinity has resulted in water ingress into areas such as the engine room, ballast tanks and cargo holds. Absence of or poor application of protective coatings on the inside of the pipe and at the welds, along with poor application of paint on hull plating near the washwater discharge were identified as the causes of accelerated corrosion. In all these cases, temporary repairs to plug the leak were carried out by divers followed by permanent repairs at a yard.

- **Ingress of water due to corrosion:** The metallic distance piece is normally coated for enhanced protection. There should be a regime to measure the wall thickness. For many classification societies, such as [DNV-GL \(Class rules, Part 7, Ch. 1, Section 2, pt.3.1.9\)](#) this is a survey item. Any reduction in thickness is indicative of a breakdown of the coating. For leakages from welded joints and holes or cracks in the hull, the quality of workmanship and the paint application should be scrutinised. Also, the bilge alarm and pumping arrangements should be checked regularly so that the crew is alerted of and can respond to any water ingress.

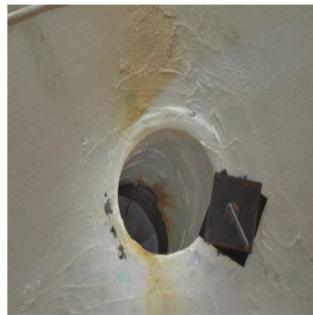
Temporary repairs on hull performed by diver on another vessel

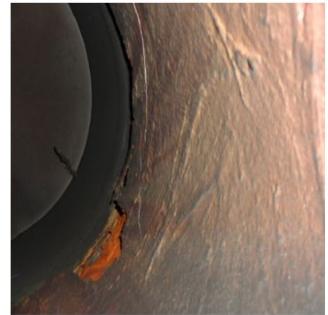
Protective coating inside disch. pipe flaking off at flange

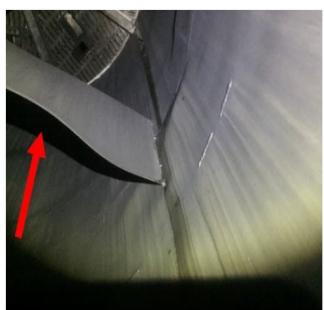
A vessel was regularly trading in Northern Europe and had installed an open loop scrubber. It had to changeover to low sulphur fuel when visiting a port that had regulations in place banning discharge of washwater from open loop scrubbers. It was still required to run the scrubber in dry mode, i.e. with washwater supply pumps turned off, to allow for the passage of hot exhaust gasses with a temperature of nearly 400° C. After departure from port, washwater pumps would be started and cold sea water sprayed through the nozzles inside the scrubber. During inspection of the scrubber by crew, damage was noticed to the nozzles, demister housing and the drains.

Deformed plates and buckled scrubber housing

A survey was carried out and indicated a variety of concurrent causes, such as thermal shock, poor workmanship by the yard, for example, only spot welding done on demister supporting plates; and poor design. The scrubber had been in service for nearly two years.

- **Damage due to poor workmanship and thermal shock:** When in operation, the scrubber unit will be subject to different types of stresses, which will test the quality of the welding and housing structure. Supervision by owners during the time of installation can help mitigate this risk. With regards to design related issues, owners are recommended to have a dialogue with manufacturers to mitigate such risks. In this particular case of thermal shock, as preventive action, shipowners changed the design and installed a water cooling system for the scrubber which will continuously run in a closed loop when the scrubber is operating in dry mode.

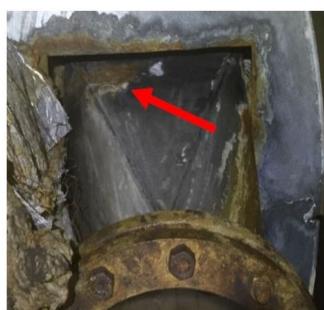
Cracks on water drain outlet (viewed from outside) with signs of leakage

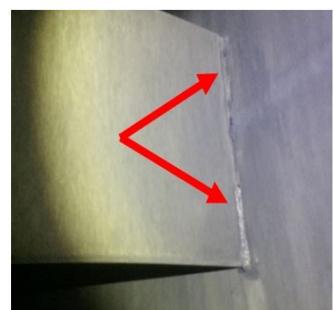
Poor workmanship: Support plates only spot welded by yard
