## Learning as we go: challenges with the use of exhaust gas scrubbers

Published 17 October 2019

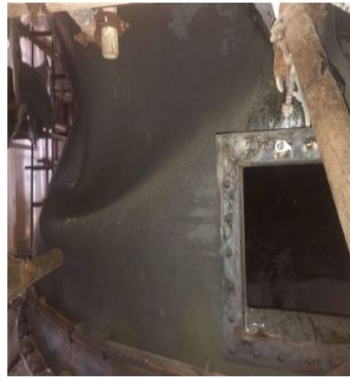
Gard has seen a few fire incidents where sparks from welding, metal cutting, and other hot work activities fell into the inner chamber of the scrubber through uncovered openings, and in one case the fire also spread to the engine room through glass reinforced epoxy (GRE) piping. Heat generated from the steel cutting for the supporting brackets, also contributed to the build up of heat inside the scrubber. In all these cases the yard fire fighting team responded and extinguished the fire with vital assistance from crew.

Damaged scrubber

Later investigations revealed that crew had requested that the yard to cover the openings but this was not done. The fire risk to scrubber packing during the hot work activity had not been identified by yard personnel, and many of them were not aware that internal components of the scrubber were combustible. These fire incidents arising from shortcomings in hotwork safety procedures are not peculiar to scrubbers and can occur in any location onboard a ship where welding, cutting or grinding works are undertaken.

- **Fires during retrofitting:** Fire risks can be mitigated if hot work safety procedures are followed. The risk assessments carried out prior to the work should cover which parts of the scrubbers are flammable. These should be protected during the hot work by covering any openings to prevent sparks from finding their way to these parts. Measures should also be put in place to prevent transfer of any heat generated during metal cutting, welding, grinding, and other hot work activities. Owners should ensure that yard workers, who will ultimately be undertaking these hotwork activities are aware of these risks and appropriate barriers are put in place to shield these areas. Crew members are advised to not rely solely on the yard safety watchman, but to monitor the hot work activities themselves. Fire fighting equipment should be maintained in a ready to use state and crew should be familiar with how to use them.

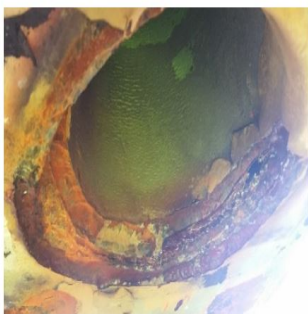
Cracks near distance piece leading to water ingress

Scrubber waste is corrosive, and we have seen a few incidents where within 10-15 months of the open loop scrubber being installed, corrosion of overboard discharge piece or in its immediate vicinity has resulted in water ingress into areas such as the engine room, ballast tanks and cargo holds. Absence of or poor application of protective coatings on the inside of the pipe and at the welds, along with poor application of paint on hull plating near the washwater discharge were identified as the causes of accelerated corrosion. In all these cases, temporary repairs to plug the leak were carried out by divers followed by permanent repairs at a yard.

- **Ingress of water due to corrosion:** The metallic distance piece is normally coated for enhanced protection. There should be a regime to measure the wall thickness. For many classification societies, such as [DNV-GL \(Class rules, Part 7, Ch. 1, Section 2, pt.3.1.9\)](#) this is a survey item. Any reduction in thickness is indicative of a breakdown of the coating. For leakages from welded joints and holes or cracks in the hull, the quality of workmanship and the paint application should be scrutinised. Also, the bilge alarm and pumping arrangements should be checked regularly so that the crew is alerted of and can respond to any water ingress.

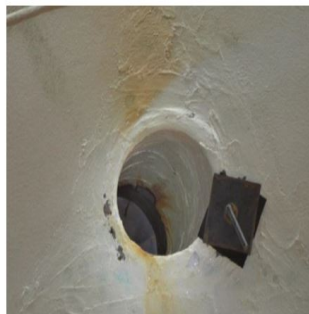
Temporary repairs on hull performed by diver on another vessel

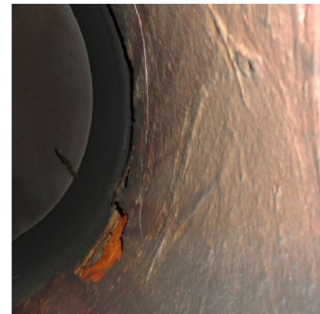
Protective coating inside disch. pipe flaking off at flange

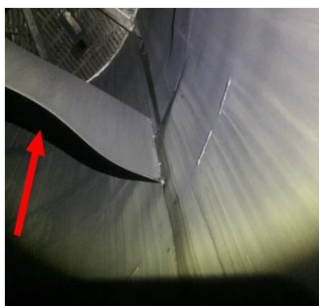
A vessel was regularly trading in Northern Europe and had installed an open loop scrubber. It had to changeover to low sulphur fuel when visiting a port that had regulations in place banning discharge of washwater from open loop scrubbers. It was still required to run the scrubber in dry mode, i.e. with washwater supply pumps turned off, to allow for the passage of hot exhaust gasses with a temperature of nearly 400° C. After departure from port, washwater pumps would be started and cold sea water sprayed through the nozzles inside the scrubber. During inspection of the scrubber by crew, damage was noticed to the nozzles, demister housing and the drains.

Deformed plates and buckled scrubber housing

A survey was carried out and indicated a variety of concurrent causes, such as thermal shock, poor workmanship by the yard, for example, only spot welding done on demister supporting plates; and poor design. The scrubber had been in service for nearly two years.

- **Damage due to poor workmanship and thermal shock:** When in operation, the scrubber unit will be subject to different types of stresses, which will test the quality of the welding and housing structure. Supervision by owners during the time of installation can help mitigate this risk. With regards to design related issues, owners are recommended to have a dialogue with manufacturers to mitigate such risks. In this particular case of thermal shock, as preventive action, shipowners changed the design and installed a water cooling system for the scrubber which will continuously run in a closed loop when the scrubber is operating in dry mode.

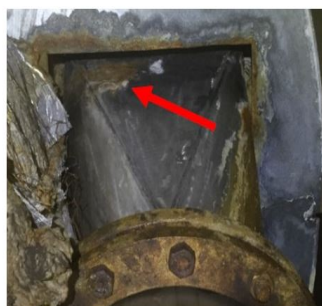
Cracks on water drain outlet (viewed from outside) with signs of leakage

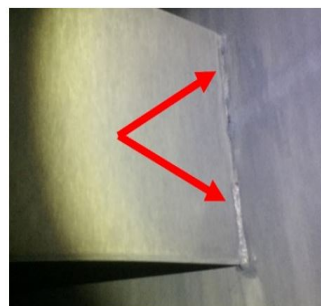
Poor workmanship: Support plates only spot welded by yard
