MARS 202528

One grounding not enough to warrant attention

MARS 202529

Wake up with a bump

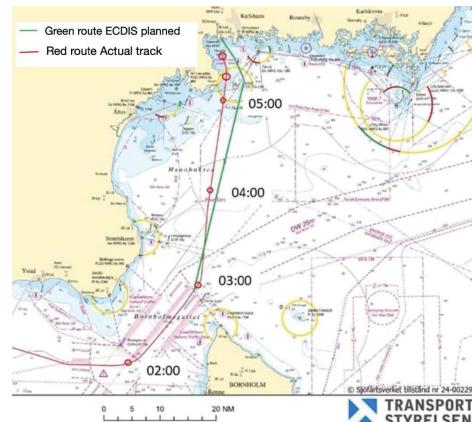
As the vessel came onto a course of 010°, the vessel's true drift of two to three degrees to port of the course was not showing. Instead, the ECDIS showed that the vessel was sailing with a drift of two degrees to starboard, as it was on DR mode. This meant that the vessel was gradually moving to the west of the planned route. The deviation between the planned route and the actual route is shown on the chart overleaf. The OOW was oblivious of this variation because his attention was exclusively on the ECDIS display.

At 05:13 the vessel passed on the wrong side of an eastern cardinal mark that marks a shoal. The first grounding took place at this time. As the vessel passed over the shallow area, its speed decreased from 17 knots to 9 knots and there were strong vibrations, which continued for around 20 seconds. The chief officer, now on the bridge, observed that the X-band radar was missing a GPS signal and the OOW responded that this issue had persisted since the watch change. Once the vessel had passed the shoal and entered deeper water, speed increased again to 17 knots. The crew made no adjustments to the engine controls during the grounding because they did not realise they were off track and had touched bottom.

When the vessel entered shallower water, the vessel speed decreased and a second grounding occurred at 05:24, with strong vibrations again occurring. The vibrations ceased when the vessel came to a stop, but the bridge team were still unaware that the vessel had grounded. The engine controls were reduced to slow and the engine room crew assured the bridge team that the engines were functioning normally. The Master decided to continue the voyage into port, so he increased the engine control, but the speed remained at zero. He interpreted this as the vessel having lost propulsion, but the chief engineer assured him that the engine was functioning as expected.

The Master called the coastal Joint Rescue Coordination Centre (JRCC) to inform them of the situation. The JRCC operator checked the vessel's AIS track and realised there was an error. He informed the Master of the vessel's true position. After a second call, the Master checked and found they were truly aground and not in deep water.

- OOW handover must be complete and detailed. In this case an important navigation alarm was not properly investigated nor communicated to the handover watchkeeper.

- Never rely on a single navigation appliance! The bridge team, even the Master, were fixated on the ECDIS display. A simple position check, ideally using two distances on a radar, would have shown their true position.

- If you see a 'dead reckoning' notification appear on your radar or ECDIS, immediately do a position check.
- Navigate your ship! In this case the vessel grounded twice; the first time 11 minutes before the second. Vibrations were felt and a large reduction in speed experienced, yet these unusual signs were not enough to convince the Master or OOW to verify their position by alternative means. Had they done so the second grounding (and the third, and the pollution) could have probably been avoided.

- 12-hour navigation watches are, by any standard, much too long for safety.

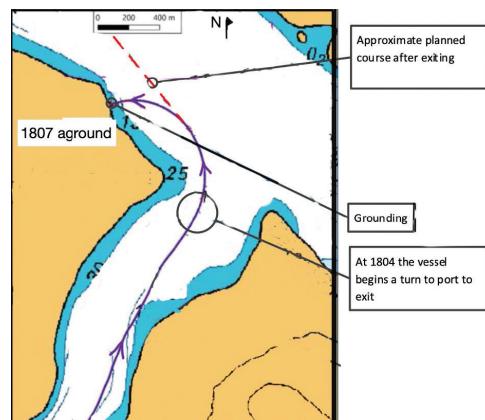
At approximately 1804 the Master began a turn to port. Three minutes later the vessel ran aground while at a speed of about 10 knots. Sitting in the conning chair, the Master woke from a micro-sleep when the vessel came to a sudden stop. The situation was quickly assessed and emergency response was begun; passengers were mustered using the public address system and the onshore manager was called to alert them to the accident.

had roles mustering passengers and assessing them for injuries. The vessel damage included a small hole below the waterline, but the rate of water ingress was not a material threat to the safety of the vessel. The use of a small bilge pump was enough to clear incoming water.

The investigation found, among other things, that the Master was very likely suffering from workload-induced fatigue that had not been recognised or mitigated by the operator's safety management system (SMS). The fatigue may have been compounded by a potential drowsiness side effect from a prescribed medication the Master was taking, but it was not possible to make a positive determination on this hypothesis.

- Micro-sleep exists, even while undertaking an active manoeuvre. If you can fall asleep at the wheel of a car, you can fall asleep at the con of a vessel.
- Sitting while navigating is one step towards further relaxation. Standing and moving (between navigation instruments?) means you are unlikely to experience a micro-sleep and may help your situational awareness.
- 'Sleep hygiene' is a critical element of safety in the transportation industry, yet one that is mostly self-managed. Take it seriously.
- Be aware of the potential side effects of certain prescription medications and how they can affect your performance.
