# ANCHOR AWARENESS

**Jarle Fosen**  
Senior Loss Prevention Executive  
17 November 2021

# ARE MORE ANCHORS LOST NOW THAN BEFORE?

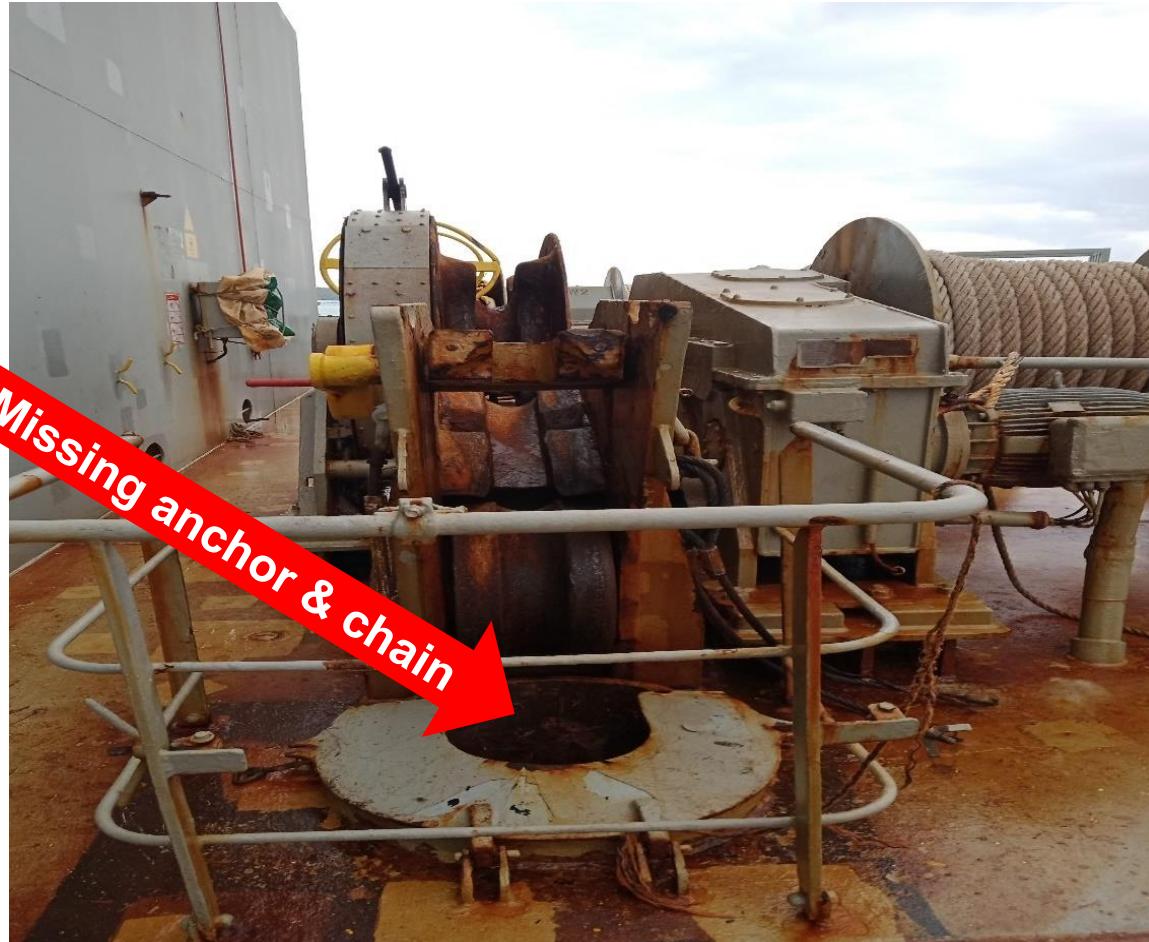
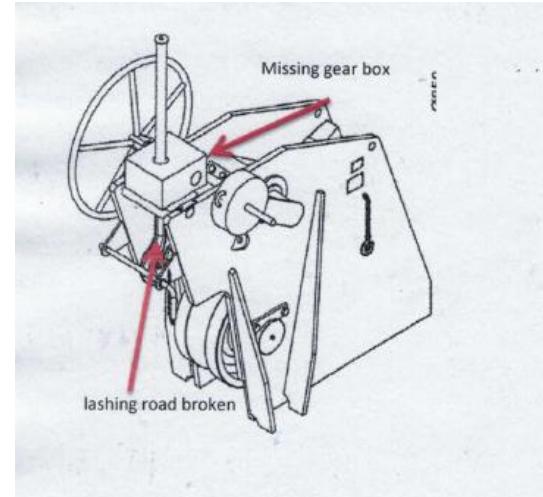
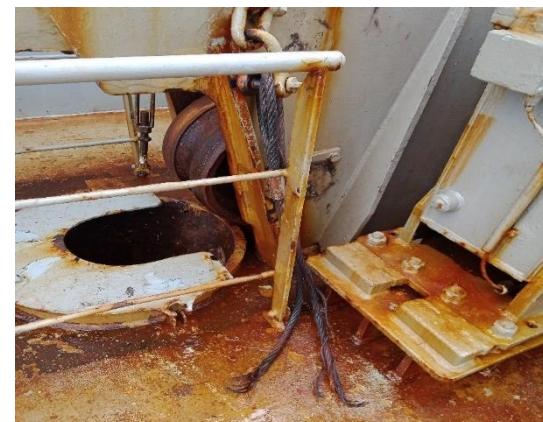
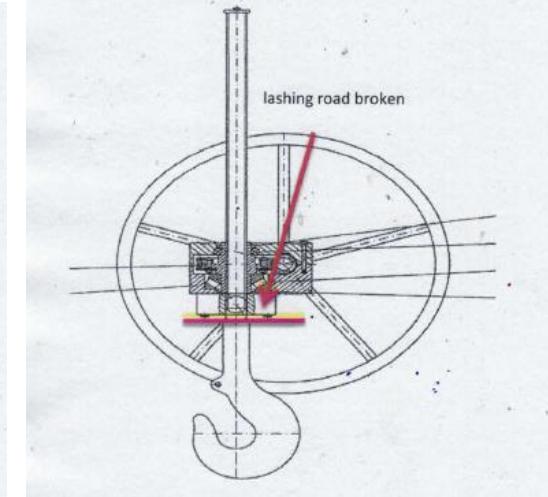
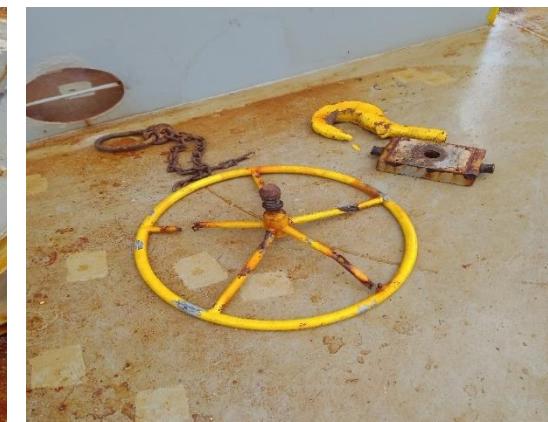
## EXTENT OF THE DAMAGE

Was the chain stopper and break engaged during the voyage?

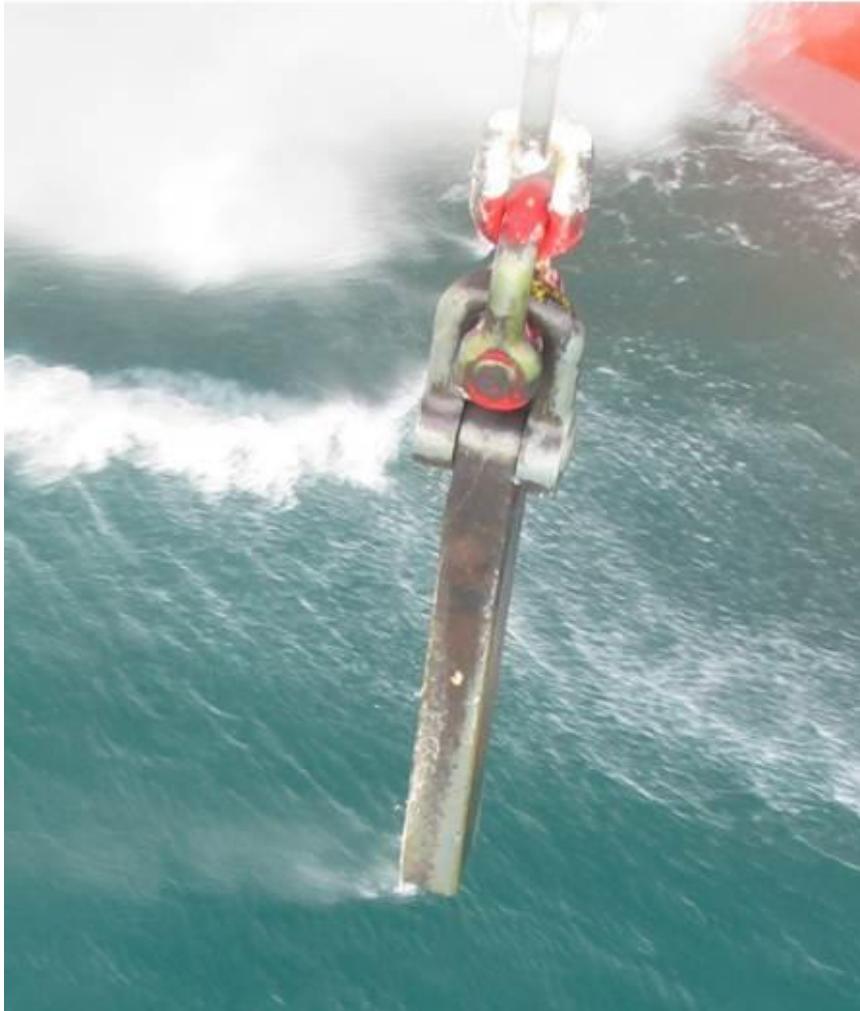
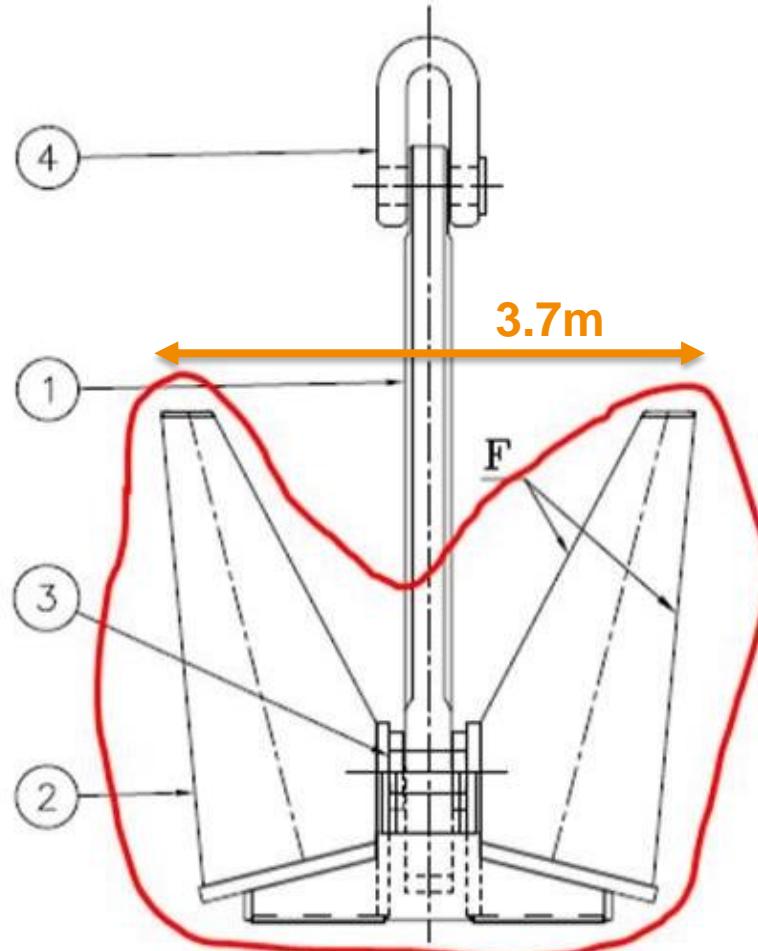
MISSING ANCHOR HEAD AND FLUKES

The circled in part is missing

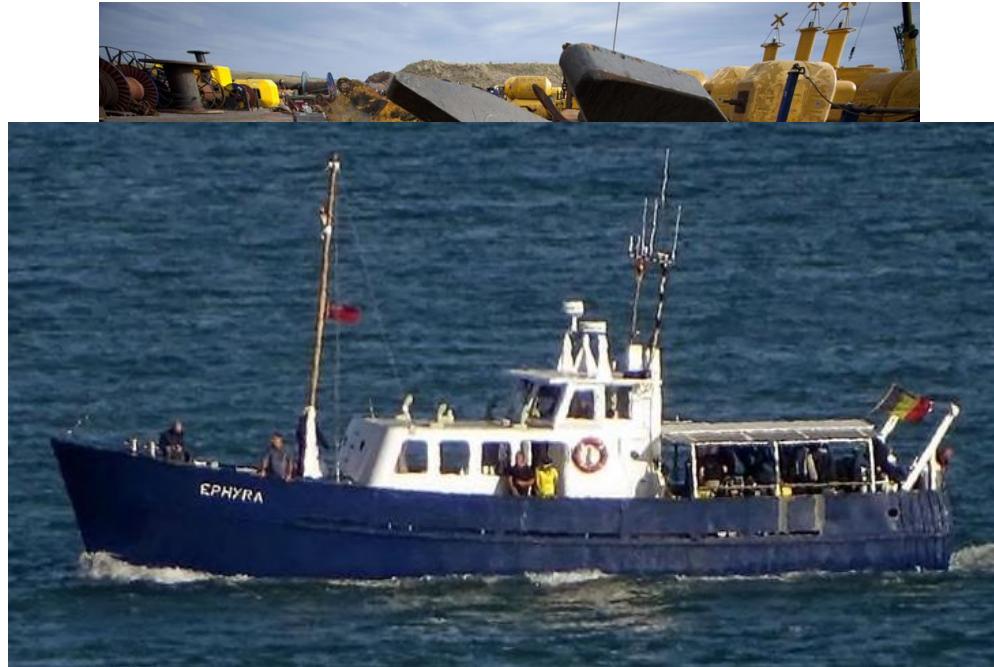
**Not possible to identify the contours of the anchor. Can only be verified by further diving works**

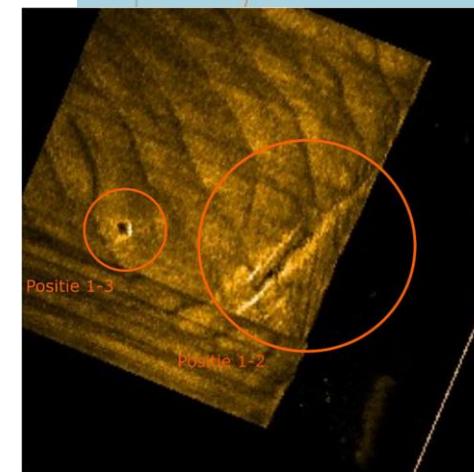
**Two possible spots identified using side scan sonar and magnetometry**

Object with dimensions approx.  
3.4m x 1.5m

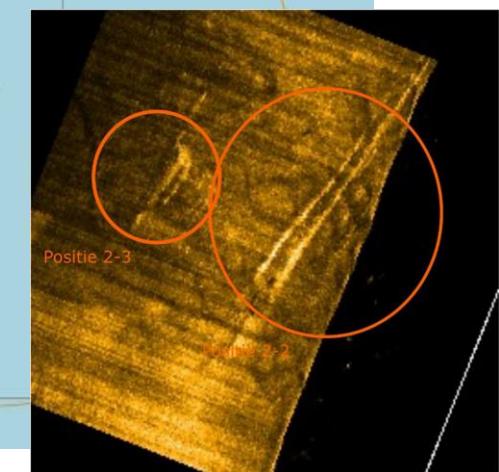
Object with dimensions approx.  
6.0m x 1.5m

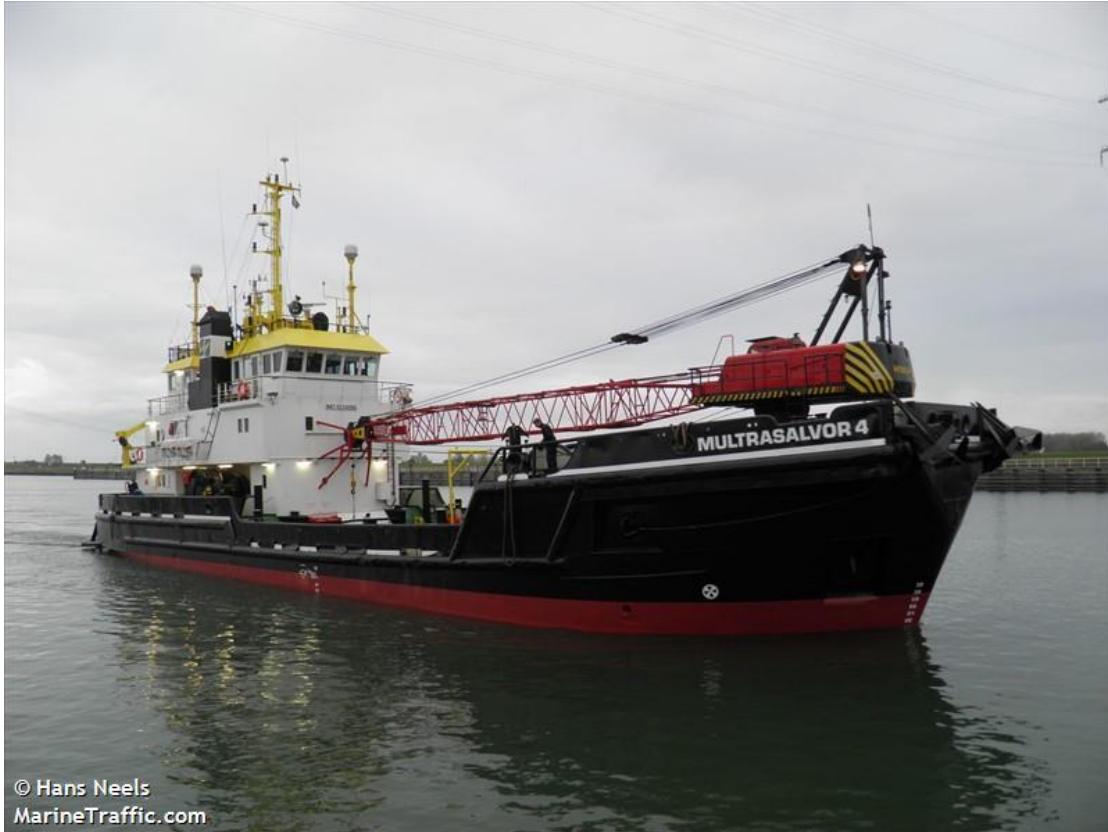
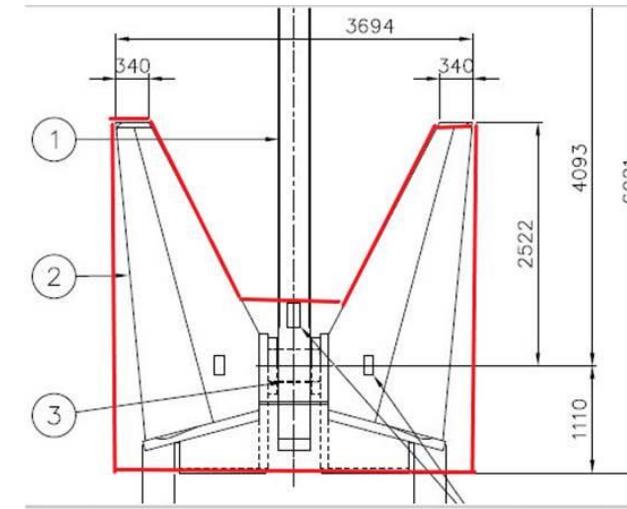
SEARCH AND RETRIEVAL OPERATIONS - DIVING WORK

The lost anchor  
was not found

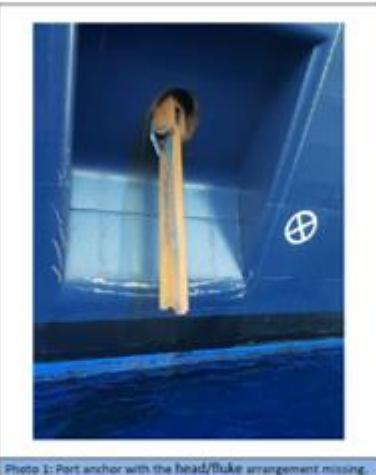
In the morning of [REDACTED] 2020, the captain of the above vessel reportedly decided to heave the anchor (port side) due to dragging. When heaving the last shackle, the crew discovered that the anchor shank appeared with the head/fluke arrangement missing.

Photo 1: Port anchor with the head/fluke arrangement missing.

It is difficult to come up with an unambiguous conclusion regarding the exact cause of the missing head/fluke arrangement, however, based on what can be observed in Photo 1 above, it seems that the anchor shank is broken in way of the connecting arrangement (head pin area) to the head/fluke. Our opinion is that the two most probable causes may be:

- the anchor has been exposed to forces beyond the design strength during dragging, or
- unfavourable handling by the crew during anchor heaving operation.

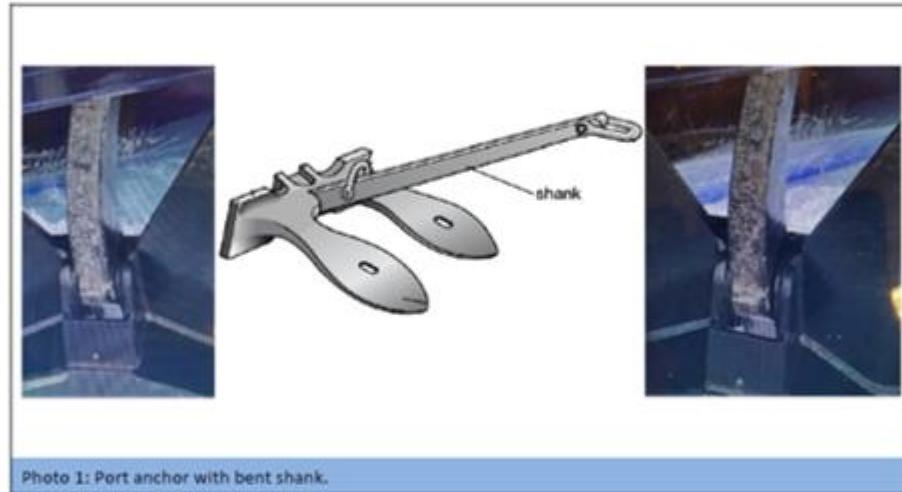
On [REDACTED] 2020, whilst anchored in the [REDACTED] the vessel reportedly encountered "some pretty strong winds". Due to the unfavourable weather conditions the ship, reportedly, started a swinging motion, which put perpendicular force onto the anchor. Propulsion and thrusters were connected, anchor was heaved up and the vessel proceeded to drifting position, however, when the anchor had been heaved, the crew observed the anchor shank to be bent – see photo below.

Photo 1: Port anchor with bent shank.

It is difficult to come up with an unambiguous conclusion regarding the exact cause of the bent anchor shank, however, based on the presented information, our opinion is that most probably the anchor shank has been exposed to forces beyond the design strength – most probably due to exposure to the heavy weather conditions as described in section 6 above.
