# MARS – Lessons Learned

MARS Report No 387 January 2025

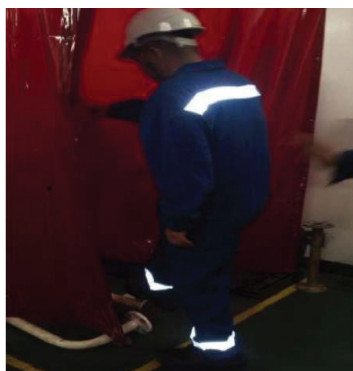
➔ An engineer was conducting a safety round in the engine room workshop welding area while the vessel was underway. Some welding had been done earlier but was not yet finished and the welding curtain was still in place. As he walked, he hit his foot on a loose pipe on the deck that had been hidden by the welding curtain.

The engineer lost his balance and fell on the deck, with the left side of his back hitting the flange of the pipe. He was able to stand back up and immediately informed the chief engineer. The victim was given preliminary first aid and 10 days later sent ashore for an examination. He was diagnosed with bruised ribs and was proactively repatriated five days later.

Simulation of the accident

- Every close call or incident/accident should immediately be reported, as in this case.
- Simple good housekeeping habits can help avoid such tripping accidents.
- Even mundane trips can cause injuries severe enough to lead to repatriation.
