## In this bulletin...

### **MARS 202612**

Finger crush incident

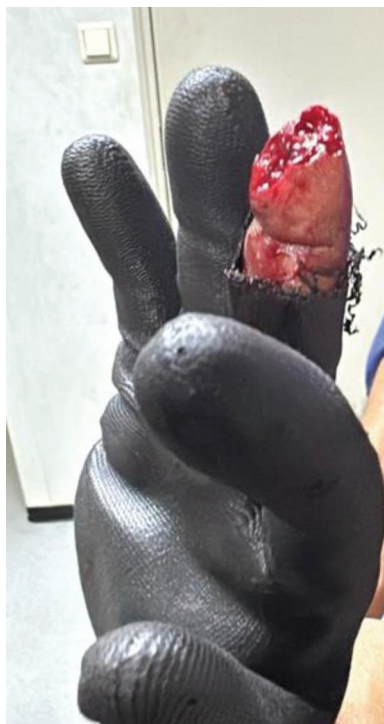
An engine crew member was assembling the sewage air blower motor back into position after maintenance. He had to lower the motor vertically to align with the shaft below. Since it was a small motor, he thought it safe to align it with his hands while wearing gloves.

Once the motor was aligned, he had to lower it into the slot. While doing this, his grip loosened, and the motor slid down under gravity. The victim's right forefinger was severely pinched between the motor body and base plate. He was able to remove his finger, but the fingertip was badly mangled.

- When deciding how to do a job, bear in mind all the hazards and the worst-case scenario. An informal way of doing this is called **take five**. That is, take five minutes to review the task in your mind's eye. Ask yourself 'What could go wrong here?'
- Proper tools or engineering controls are your first line of defence. Personal Protective Equipment (PPE) is the final barrier and may ultimately fail to protect.
- Even the most mundane of tasks can leave lasting scars if proper methods of work are not adopted.

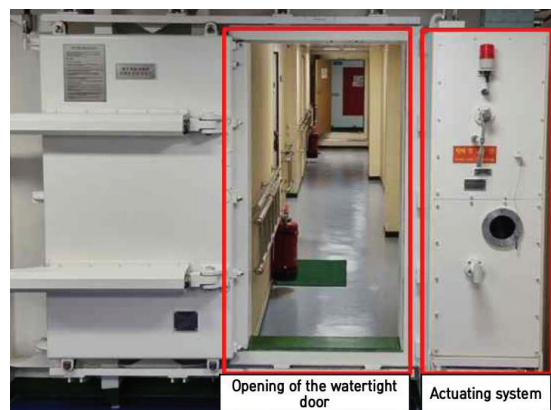
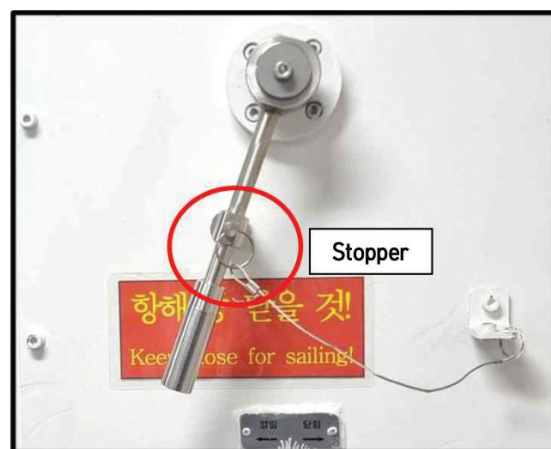
The crew member took out the stopper and opened the watertight door by turning and holding the lever to the right – the opening direction. Since the power switchboard for the watertight door was turned off, the door was operated by residual hydraulic pressure in the accumulator. Normally an alarm signal and visual strobe would sound/flash when opening or closing but since the power was off, there was no signal.

He probably intended to pass through the door, then close it while simultaneously putting the stopper into the control lever. While standing in the middle of the watertight door frame, he pushed the corridor-side control lever in the closing direction with his left hand. The residual hydraulic pressure then caused the door to return to the closing direction.

As the door was closing, he tried to put the stopper into the control lever, but somehow got trapped in the closing door. The watertight door pressed down on him powerfully from behind. The force of the closing door would have been weaker than the normal set pressure, but it was strong enough to trap him in the door.

The investigation found that the stopper on the actuating system had been installed in case the door needed to remain open for a long time during inspection or while work was being carried out. When the door is opened, its control lever is in neutral. As long as the lever is not turned to the closing direction, the door remains opened. The stopper is intended to prevent the door closing if the lever is activated due to negligence or malfunction.

The vessel's crew did not clearly understand the function of the stopper. They believed, incorrectly, that it was a safety pin which had to be inserted so that the control lever could not move. The victim probably also regarded it as a safety pin that should remain inserted. In other words, the victim's belief that he had to insert the stopper is likely to have contributed to this accident, along with his decision to pass through the door.

- It appears the crew were not very familiar with the use and operation of the watertight doors, and specifically the rationale for the 'stoppers'.
- It should be second nature to use Lock out tag out (LOTO) procedures for any machinery that has stored potential energy, to ensure safe operations. If you don't buy your LOTO ticket, you will never win!
- Watertight doors are an integral part of the safety of the ships that are fitted with them. Yet the doors themselves contain stored energy and potential for great harm. All crew on ships with watertight doors should be completely conversant with their operation.
