## In this bulletin...

### MARS 202629

## TSS collision in fog

#### Finger trap/Stop Work Nap

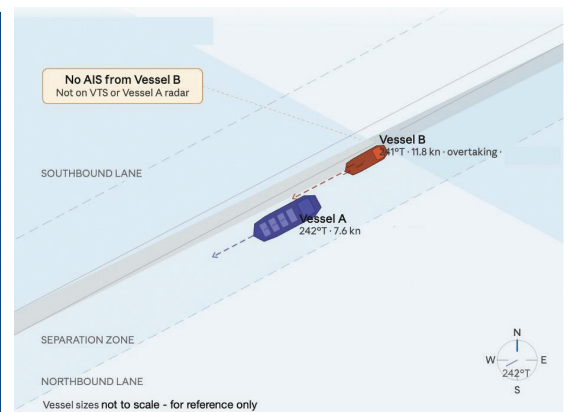
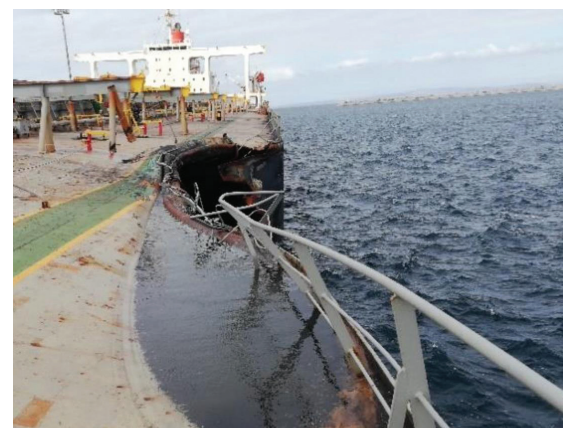
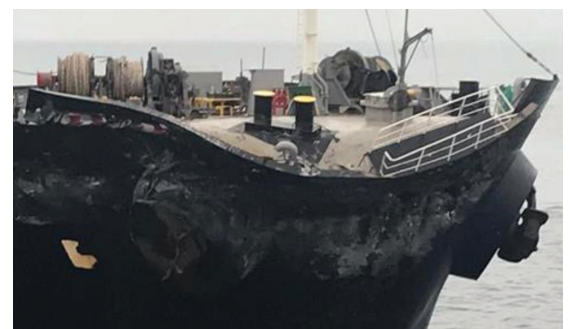
Despite these precautions, the bridge team of vessel A were not aware that they were being overtaken by vessel B, behind them. Vessel B's radar return was intermittent, and Vessel A had not plotted it as a radar target. Vessel B was not emitting an AIS signal. Neither vessel was sounding the one long blast every two minutes required in restricted visibility by the collision regulations.

Vessel A

Vessel B

and called vessel A on the VHF. Vessel A responded but there was no follow-up conversation. Within seconds the two vessels were in sight of one another. The Master of vessel A, now realising that vessel B was close behind, ordered hard to starboard to avoid a collision. On vessel B, the OOW put the helm hard to port, but a collision was now inevitable, and they struck vessel A on its port side. Damage was important on both vessels.

- AIS is an important watchkeeping tool but not foolproof. Overreliance on AIS targets on your radar can damage your situational awareness.
- ARPA and AIS are complementary systems, and in restricted visibility all contacts – whether AIS-equipped or not – must be tracked on radar.

- Speed in restricted visibility must reflect the stopping capability relative to visible range. Vessel B was making 11.8 knots in dense fog in a congested TSS. At that speed and at close range to another vessel, minimal time for collision avoidance was available.

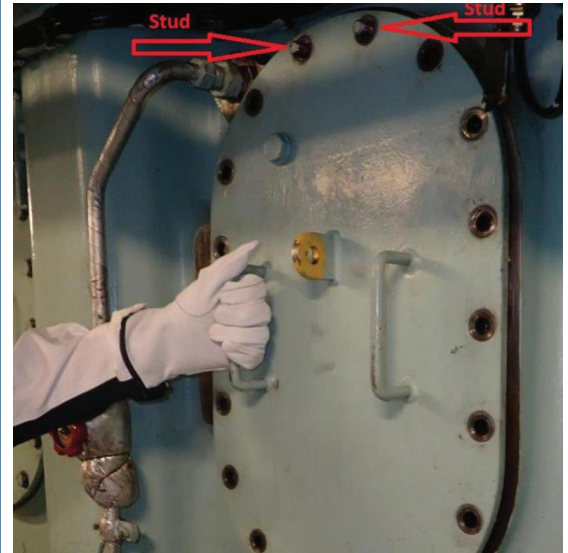
The company investigation found, among others, that the hazard posed by the heavy inspection cover was not identified in the risk

assessment or toolbox talk. The requirement for two-person lifting was not specified. Lack of warning signage near the cover contributed to unsafe practices.

**Suggested risk reduction measure –  
upper studs as anchors**

- Heavy covers always should be dismantled and mounted by two persons, regardless of whether crewmembers are using a chain block or not.
- Ideally, there should be two long studs mounted at the top position of every cover to keep it in position during dismantling/mounting.
- Work permits and toolbox talks should reinforce safe lifting techniques and roles to prevent solo handling.
- Stop Work Authority should be exercised by all crew if perceived unsafe actions are observed.
- Supervisory presence is crucial during potentially hazardous tasks.

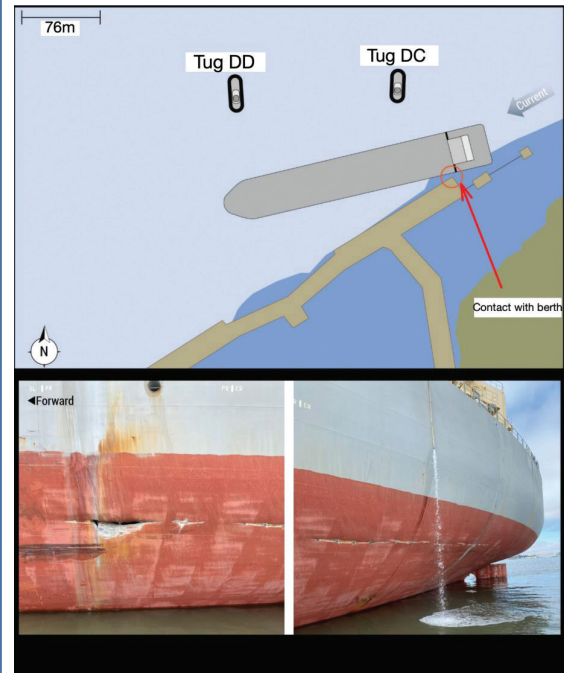
The official investigation found, among other things, that the pilot had transposed the names of the tugs on his 'radio card'. As such, orders intended for the tug aft were given to the tug on the bow and vice versa. The result was the bow being

rapidly pulled away from the pier, causing the stern of the ship to move toward the pier in a 1.9-knot quartering current. This was contrary to the plan to pull the vessel's stern off the pier quicker than the bow.

- Every member of the bridge team should have the same mental model of the manoeuvre so that an inconsistency can be detected early enough to avoid negative consequences. While the manoeuvre was understood by all, the vessel's officers did not detect the pilot's error in tug orders. This may have been due to the use of tug names as opposed to tug position (fore and aft) or number (tug 1, tug 2, usually from forward).
- Using tug names for vessel manoeuvres introduces a weak link in a multi-person operation. Everyone on the assisted vessel's bridge must remember what tug, by its name, is where to have a correct mental model of the developing situation.
