### **MARS 202605**

Alone on the bridge, asleep  
and full speed ahead

## **Alone on the bridge, asleep and full speed ahead**

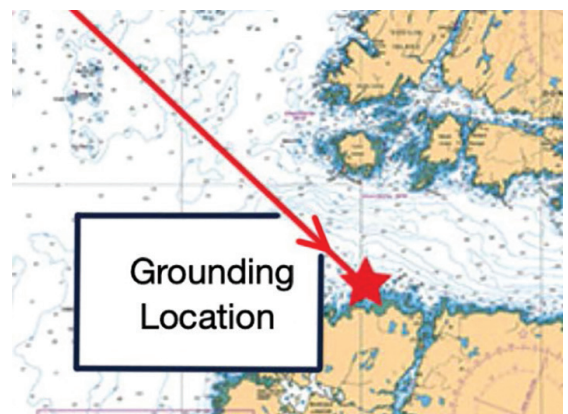
A few minutes after 01:00, the ATB struck a charted reef. The impact woke the OOW. He immediately reversed both engines and placed the rudders hard to port. The Master, awoken by the impact, went to the wheelhouse and took over the watch. The tug’s starboard engine was disabled, so the Master attempted to reverse off the reef with the port engine while moving the rudder hard over, port to starboard. The ATB pivoted but remained aground.

The Master reported the casualty to shore authorities. Sea conditions worsened and some fuel from the tug was leaking into the sea. The tug's crew was evacuated some eight hours after the grounding due to the worsening situation. Clean-up and tug salvage operations continued for the next 40 days. The tug was declared a total constructive loss while the barge was salvaged and repaired.

The investigation found, among other things, that the OOW suffered from several fatigue-inducing factors at the time of the grounding, including sleep disruption both acute and chronic, circadian rhythm disruptions, and individual factors (ie his inability to nap during 'off' hours). In other words, he was fatigued.

- 'Sleep hygiene' is a critical element of safety in the transportation industry, yet one that is mostly self-managed. Take it seriously.
- Sitting while navigating is one step towards further relaxation. Standing and moving (between navigation instruments?) means you are unlikely to experience a micro-sleep and may help your situational awareness.
