## Is your cargo too wet?

## Gard warns Members to remain vigilant about liquefaction risk

Published 26 April 2022

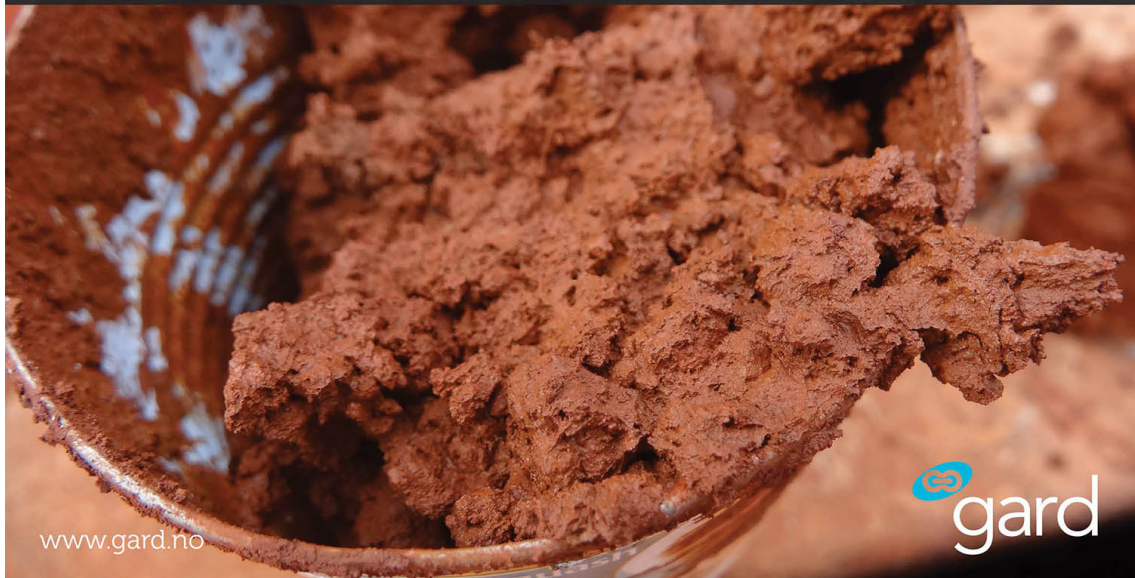
Many fine particle cargoes are liable to flow if sufficiently wet.
