Scrubber risks: Lessons from six years of claims

With nearly 7,000 vessels worldwide now equipped with scrubbers, adoption continues to rise. While the technology offers clear compliance and commercial advantages, six years of Gard's claims data reveals specific patterns of corrosion, fire, and flooding.

Published 12 March 2026

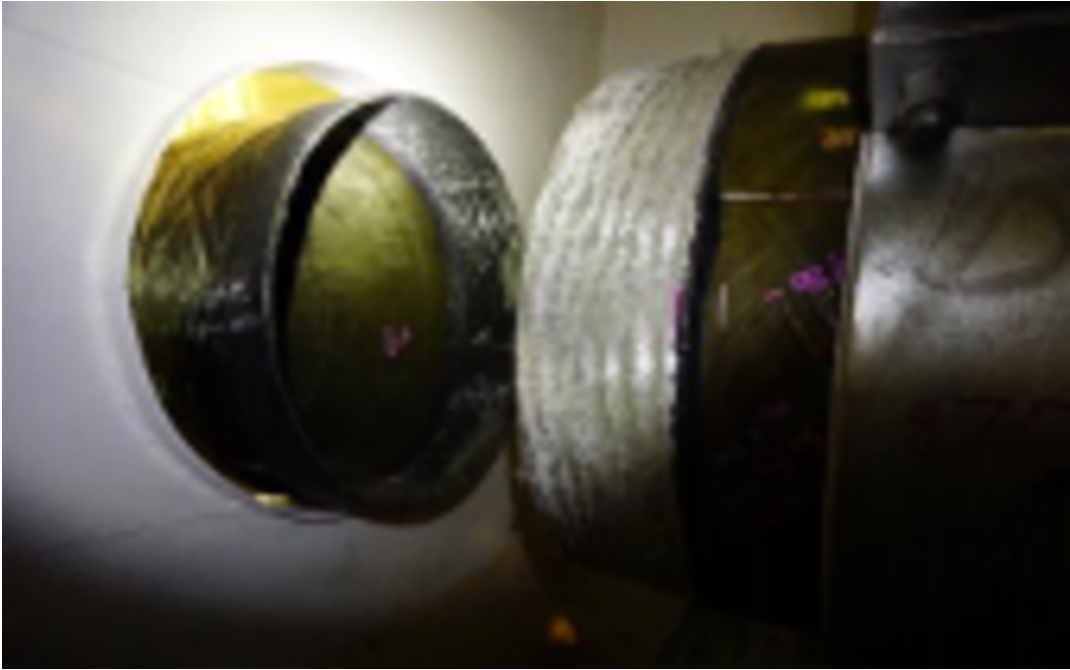
Structural failures also extend to new installations like scrubber sea chests, which act as weak links when shipyard workmanship or oversight fails during hull penetrations and reinforcements. Beyond general structural deficiencies, damage can also occur during pressure testing of glass reinforced epoxy (GRE) scrubber piping. These systems rely critically on precise bonding, controlled curing, and stable support; deficiencies in any of these can cause sudden joint failure under load. For example, a container vessel's GRE outlet failed during pressure testing due to dislocated joints and inadequate support arrangements, demonstrating how localized installation flaws can lead to flooding.

Detached seawater outlet pipe

- Damage due to poor workmanship and thermal shock: Closely supervise scrubber installation and maintain dialogue with manufacturers regarding design and installation requirements.

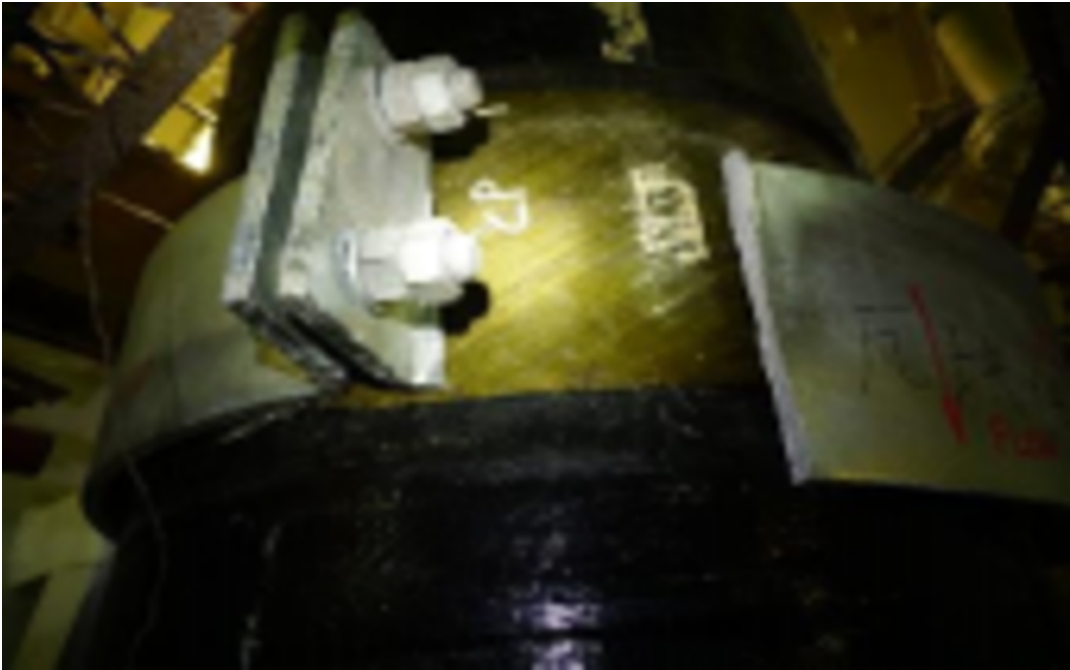
Broken pipe support
