## Scrubber risks: Lessons from six years of claims

With nearly 7,000 vessels worldwide now equipped with scrubbers, adoption continues to rise. While the technology offers clear compliance and commercial advantages, six years of Gard's claims data reveals specific patterns of corrosion, fire, and flooding.

Published 12 March 2026

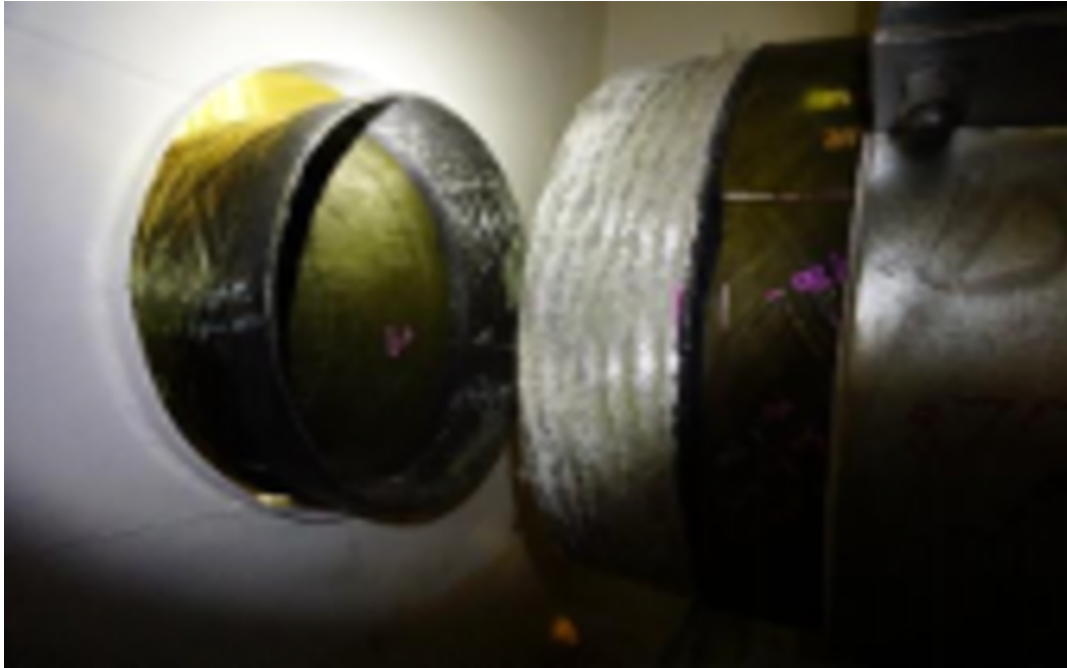
Structural failures also extend to new installations like scrubber sea chests, which act as weak links when shipyard workmanship or oversight fails during hull penetrations and reinforcements. Beyond general structural deficiencies, damage can also occur during pressure testing of glass reinforced epoxy (GRE) scrubber piping. These systems rely critically on precise bonding, controlled curing, and stable support; deficiencies in any of these can cause sudden joint failure under load. For example, a container vessel's GRE outlet failed during pressure testing due to dislocated joints and inadequate support arrangements, demonstrating how localized installation flaws can lead to flooding.

Detached seawater outlet pipe

- Damage due to poor workmanship and thermal shock: Closely supervise scrubber installation and maintain dialogue with manufacturers regarding design and installation requirements.
