## In this bulletin...

### **MARS 202524**

Docking difficulty

## **Challenging berth location and questionable tug services adds to docking difficulty**

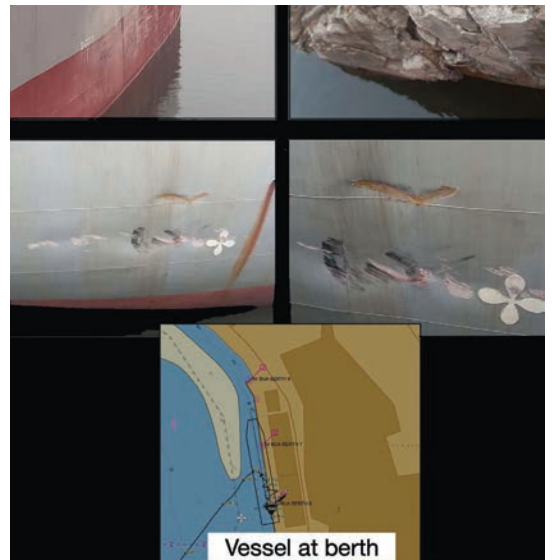
Damage to the vessel was concentrated at the starboard bow and the aft starboard quarter. The company investigation found, among other things, that a combination of environmental, operational, and systemic factors contributed to the incident. Strong currents and shallow waters were significant contributors, impeding the vessel's manoeuvrability and amplifying the challenges posed by the angular design of the pier. These natural challenges were compounded by local regulations, which restricted tug operations to push-assist only, eliminating their ability to provide 'pull' support.

Communication gaps between the vessel's bridge team, the pilot, and the tug operators were also identified as a critical factor. Additionally, the delayed deployment of the port anchor limited its capacity to counteract the vessel's swing to starboard during the final moments of the approach.

- The importance of comprehensive pre-berthing planning and preparation should not be underestimated.
- Open and continuous communication between the Master, pilot, and tug operators is essential for addressing the dynamic challenges associated with berthing operations.
- Regular drills focusing on emergency responses, such as timely anchor deployment and adaptive manoeuvring, are vital to ensuring that crews are prepared for similar scenarios.

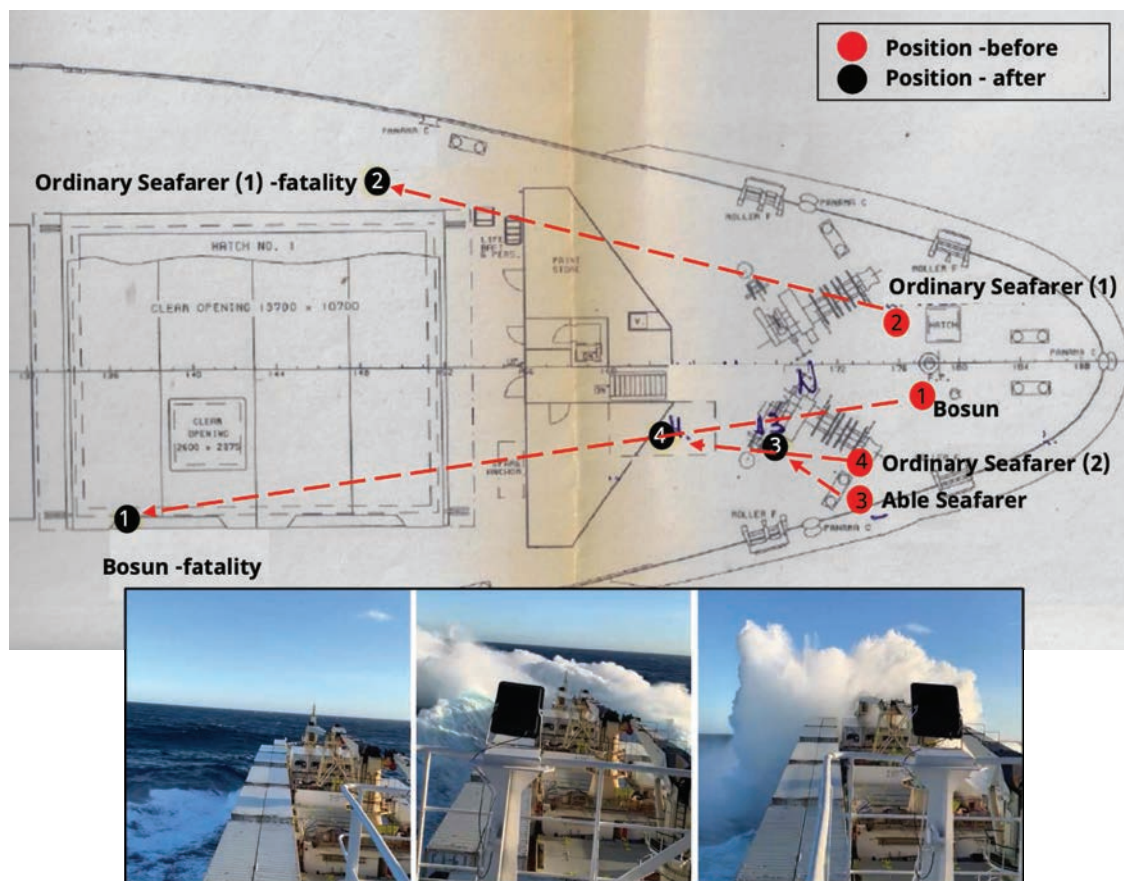
View of seas encountered (one hour after accident)

The vessel encountered increased swell activity, causing it to slam. This woke the Master, and he instructed the officer of the watch (OOW) to reduce speed and alter course to minimise the slamming effects. By midday, the swell had increased. Wave heights were now more than three metres.

After lunch, the chief officer informed the OOW that he was going on deck for a safety check. At around the same time, the bosun and some deck crew, having slept through the morning to recuperate, made their way forward to finish the job of securing the forward mooring station. The vessel was struck by a series of large waves, breaching the forecastle and washing the crew off their feet.

Measures were taken to mitigate the slamming, but at no point was the company's heavy weather checklist used, nor was access to the open deck restricted.
