### MARS 202627

Tug connection gone wrong

### MARS 202628

BRM under pilotage takes a dive

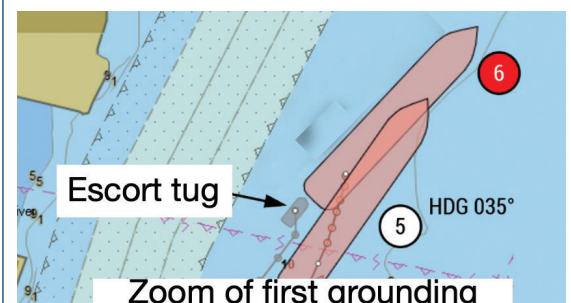
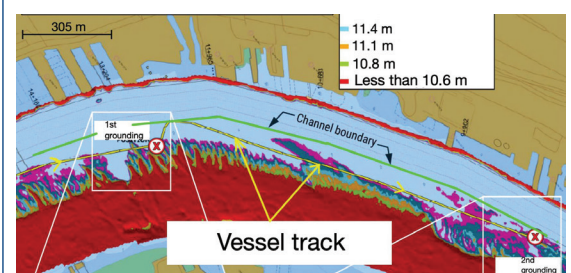
As the vessel passed under the bridge its centreline drifted about 42 metres outside the channel to starboard. Despite issuing some port rudder commands to correct the course, pilot B also compensated with starboard rudder orders to prevent what he expected to be a sharp port swing.

Two and a half minutes later, the vessel's bow was now some 88 metres outside the channel

to starboard when, suddenly, its speed dropped (position 6 below). The crew felt a jerk and heard a rumble; the vessel had touched bottom. The Master pointed out that they were out of the channel. The pilot used a series of aggressive engine and rudder manoeuvres and assistance from the escort tug pushing on the starboard bow to free the vessel and resume moving forward. This 'refloating' took about six minutes.

Once back underway, the pilot continued navigating roughly parallel to the dredged channel, keeping the bulk carrier about 75 metres to starboard of the channel limit. As the ship accelerated, the Master repeatedly voiced concerns regarding their position, but the pilot reassured him that they were returning to the channel and that everything would be fine. About 8 minutes after coming free from the first grounding, the Master pointed out a red channel buoy nearly dead ahead on the starboard bow; they were running directly into shallow water. At about 6.5 knots, vibrations were heard and felt throughout the ship and the Master told the pilot that the ship needed to come to port. The pilot responded yes, but he was 'running out of room'. Moments later, the crew heard air rushing from the bilge tank vents as the bottom shell plating ruptured on underwater shoals. Some two minutes later the vessel came to a complete stop, hard aground and listing to starboard due to the flooding of multiple ballast and fuel tanks. The vessel remained aground for three days before being refloated.
