In this bulletin...

MARS 202619

MARS 202620

MARS 202621

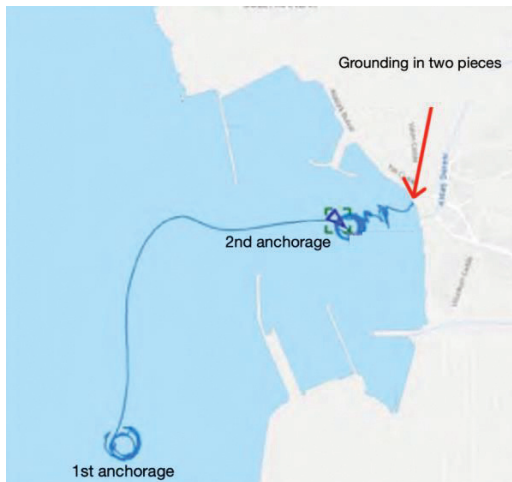
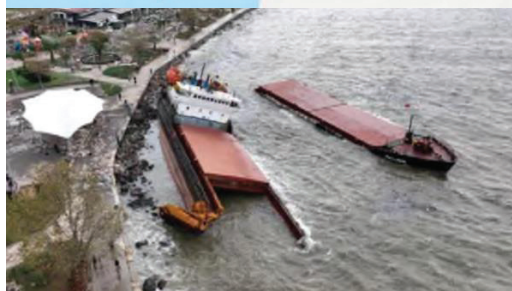
The Master called for tug assistance but due to the dangerous weather the tugs could not leave their berths. It was now too late for a plan B. With the shifting winds and waves, the vessel was exposed to gales and very large waves. Suddenly, with the hull stressed beyond its limits, the vessel broke in two and drifted ashore. Thankfully, all 13 crew were rescued.

- Even within the confines of port, weather-related wind and waves can affect your anchorage or berth.
- Keep one step ahead of events by having your Plan B ready. In this case, and in retrospect, the only option was to have berthed before the storm.

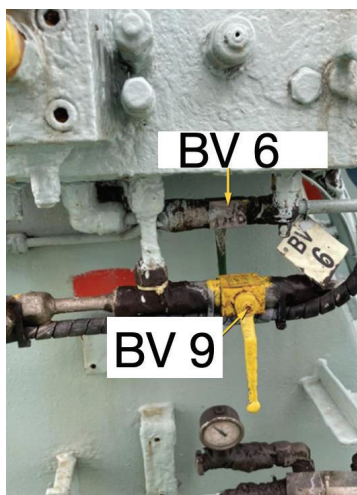
The FRC was recovered and the launch system inspected. It was found that a valve for draining pressure from the hydraulic system was mistakenly left in the open position. The preliminary investigation found, among other things, that ball valve 9 (BV9) had been mistaken for BV6. The operation of BV9 was not included in the procedure for launching the FRC using stored power. Once BV9 was put in the open position, there was no hydraulic oil pressure available in the system to arrest the fall of the FRC once the launch cable was pulled.

- Ideally, a procedure should fit on one page and be as simple as possible.
- In this case, the two valves were close together and the identification label for BV6 was sideways, so that it was not clear which valve it referred to (see photo - labels added to image). 9 and 6 can be confused when the orientation of the sign is not made clear.
- The BV9 valve was in the foreground and painted yellow, thus attracting more attention than the BV6 valve, which was in the background and more restrained in colour.

The stored power launch system was subsequently tested using the documented procedure with the correct valve sequence and proven to work without incident.

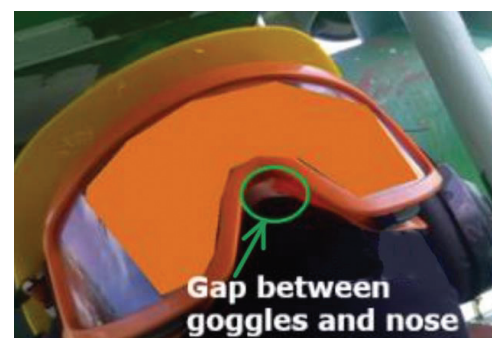
A crewmember was assigned to perform chipping on deck near the cargo manifolds crossover area. While chipping, a particle of rust passed through a gap near the nose in his goggles and into the eye. He did not go directly to flush the eye, hoping that the particle would come out by itself.

- Any incident involving an eye should be immediately reported and attended to.
- As a general good practice, always check your PPE before each use.
- When wearing safety goggles for chipping, there should be absolutely no gap between the skin and the glasses.

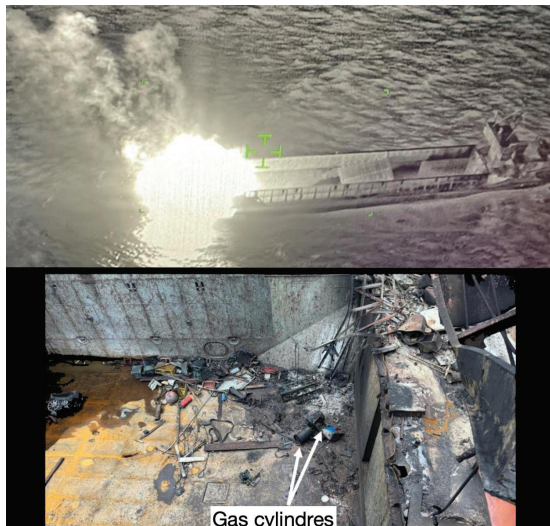
The explosion tore open parts of the forward mooring deck. All five cargo hatch covers were dislodged; two hatch covers fell into the sea, while the remaining three collapsed into the empty cargo hold. Simultaneously, the vessel suffered an electrical power outage, but the main engine continued to function.

The investigation revealed that the explosion was caused by propane gas leaking and igniting in a forward compartment. The general lack of space on the vessel meant that any available space was used on an ad hoc basis, and this compartment had been gradually converted into a workshop and paint storeroom. Several different products ended up in the same forward space, including two cylinders of propane with a total of 22 kg of gas.

The investigation found, among other things, that neither the crew nor the shipping company had identified that the space was unsuitable for these purposes, since it lacked proper ventilation and appropriate access routes. The space was also connected to the cargo hold, which meant that if oxygen depleting cargo was carried, the space could have been rendered oxygen deficient and so become a lethal trap for crew.

- Propane and other flammable gases must never be stored in makeshift workshops or paint lockers. Hazardous materials require dedicated, certified storage areas that are physically isolated from potential ignition sources.

- Ventilation is non-negotiable. Any compartment used for chemical or gas storage must have adequate, independent ventilation to prevent the buildup of explosive atmospheres or oxygen-depleted air.

- Changing the use of a compartment (eg, converting a void space into a workshop) requires a formal management-of-change process to identify new risks, such as lack of access routes or connection to cargo holds.
