Watch out for open manholes and displaced deck gratings

Open manholes and displaced gratings pose considerable hazards to crew on offshore installations as evidenced by two recent incidents reported by the US Bureau of Safety and Environmental Enforcement.

Published 01 August 2019

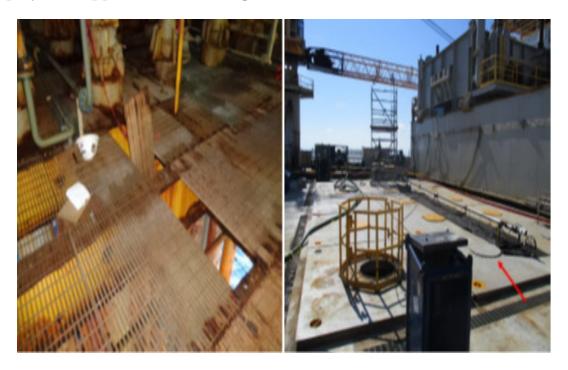
In the second incident a crew member had completed work on a well which was properly barricaded. At nighttime two employees went to replace the well access hatch cover over the well on the drill deck. It appears that each of the two employees inadvertently picked up the wrong hatch cover (identified in the second photograph below with a red arrow). Each employee grabbed one handle of the cover, which was the same color as the deck and had no well identifying information on it. This action unknowingly created an open hole; and as the employees moved the hatch, one of the employees stepped and fell through the hole to the deck below.
