Increase in stern tube damages - a concerning new trend?

Published 12 October 2023

Written by John Balaouras, Svend Leo Larsen

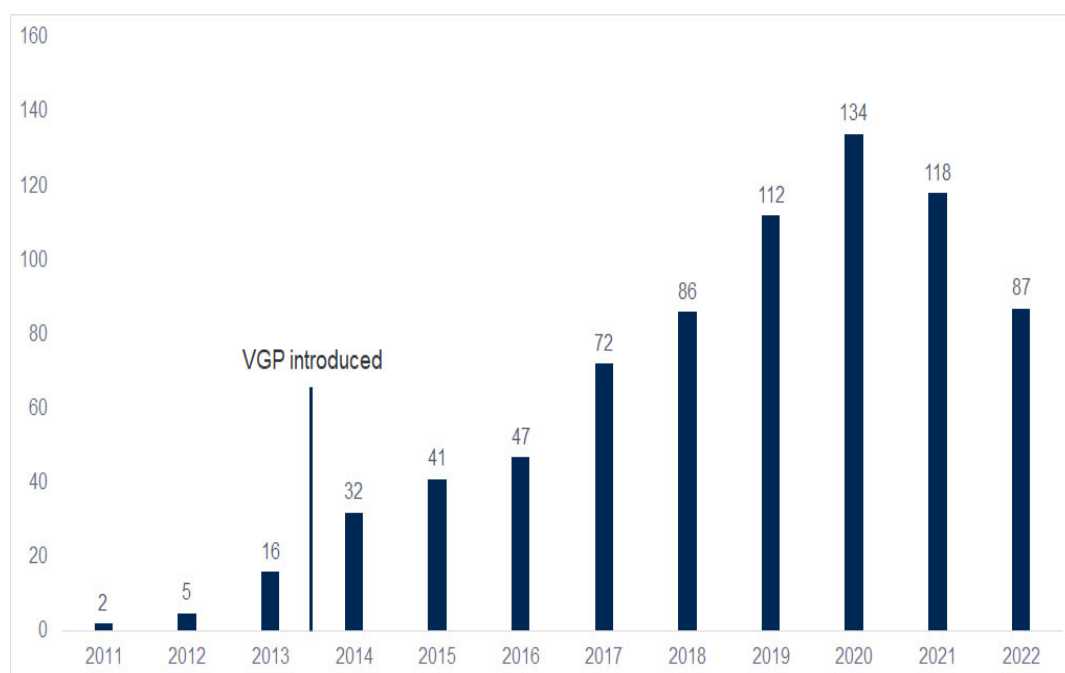
Total stern tube-related claims in Gard in excess of USD 5,000

As shown in the first bar graph, the significant increase in claims seems to have followed the introduction of the revised Vessel General Permit (VGP) requirements in 2013 by the U.S. Environment Protection Agency (EPA). These require all vessels over 79 feet trading in U.S. waters to use Environmentally Acceptable Lubricants (EALs) in all oil-to-water interfaces.

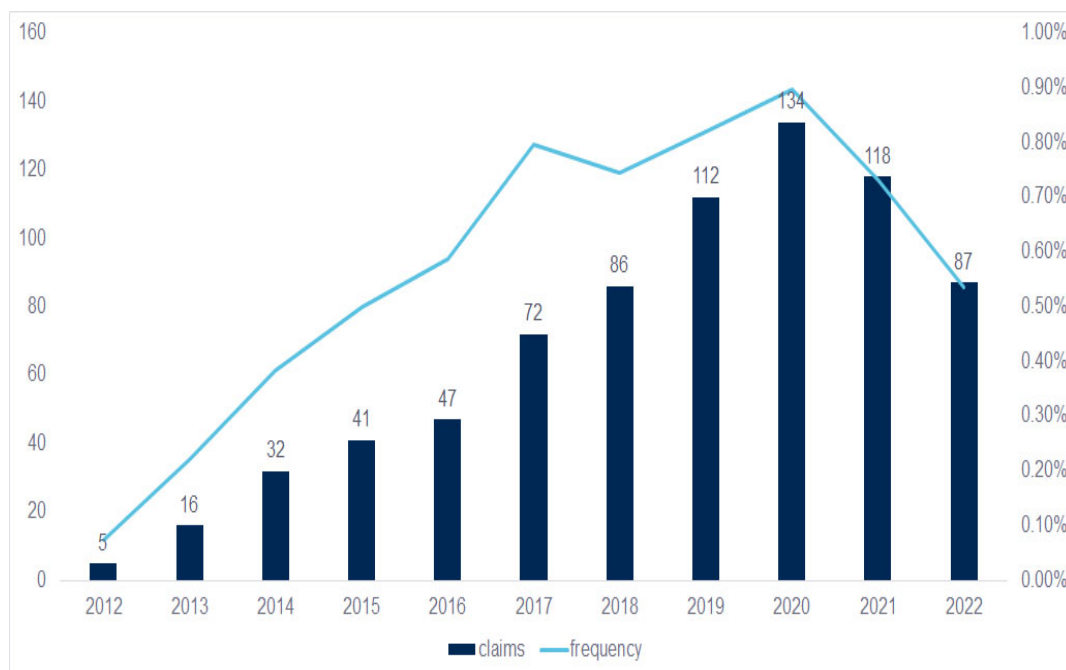
To be clear, over this same period of time, the number of vessels insured with Gard has also increased. So, is the increasing number of claims just reflecting the higher number of vessels insured? No. Even when taking into account the total number of vessels covered, we still see that the share of stern tube-related damages is

increasing (see chart below).
The information provided in this article is intended for general information only. While every effort has been made to ensure the accuracy of the information at the time of publication, no warranty or representation is made regarding its completeness or timeliness. The content in this article does not constitute professional advice, and any reliance on such information is strictly at your own risk. Gard AS, including its affiliated companies, agents and employees, shall not be held liable for any loss, expense, or damage of any kind whatsoever arising from reliance on the information provided, irrespective of whether it is sourced from Gard AS, its shareholders, correspondents, or other contributors.

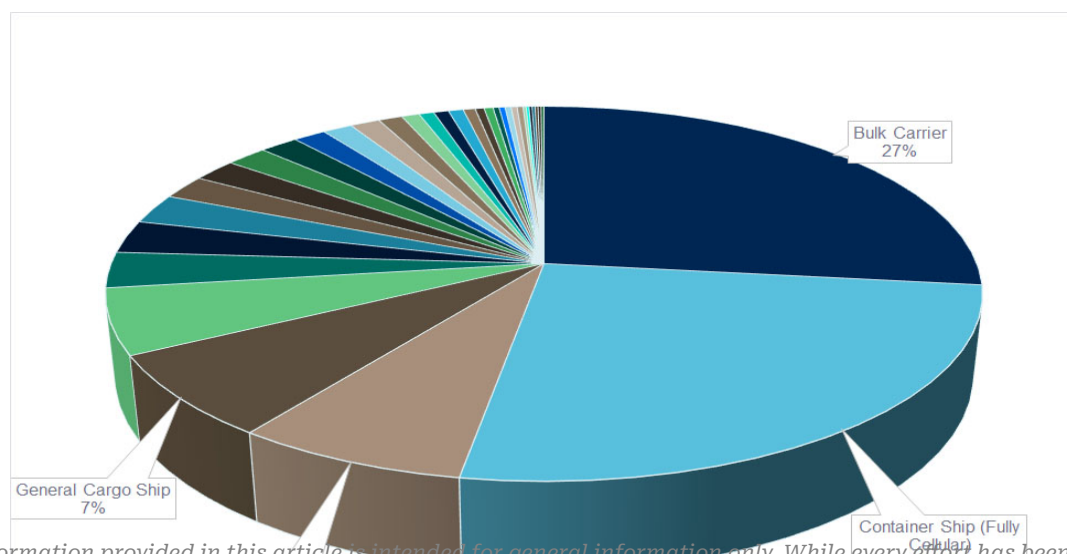
Stern tube-related claims in Gard, by vessel segment

It was evident from the start that the type of vessels that suffer most from such damages are Bulk and Container Carriers, accounting for 53% of the occurrences. In total, these segments make up 44% of Gard’s Hull and Machinery portfolio (see pie chart below).

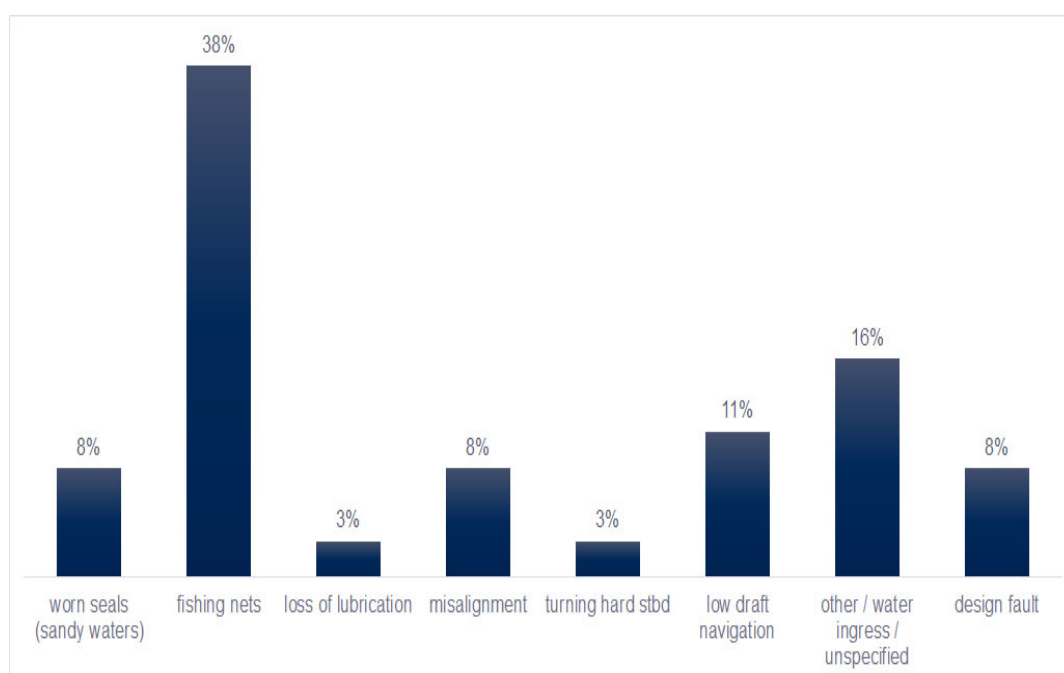
The root cause investigation was thus narrowed down to focus on Bulk and Container Carriers, with the reported causes categorized as follows:

As seen above, a large number of the incidents were attributed by the surveyors to fishnet/ropes entering the stern tube seal area causing seawater to contaminate the stern tube oil and accounting for 38% of the cases. Indeed some 500,000 – 1 million tons of fishing gear is lost or abandoned at sea every year, according to World Wildlife Fund (WWF). However, we believe that the “fishing nets causation” may have been overrepresented as the main explanation, leaving little room for further investigation into other possible factors.
