## Loss of bridge control: Calling on back-up modes

Published 04 September 2026

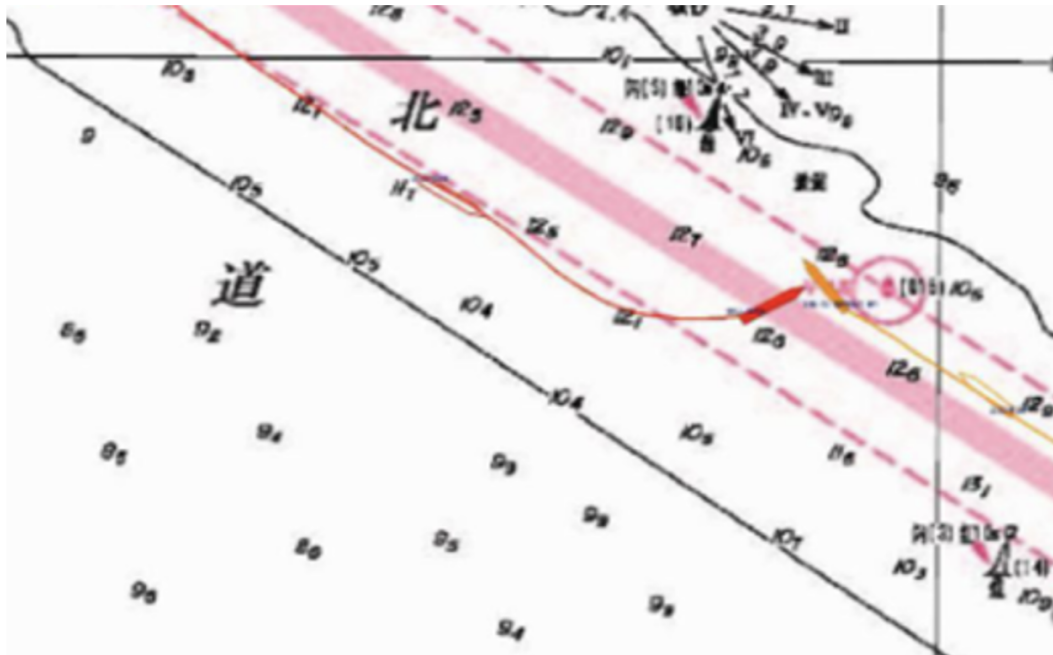
The [investigation](#) found that the steering failure arose on one vessel when port helm was being applied, with the rudder becoming stuck at port 20°. The fault was a displaced locating pin in one of the potentiometers used in FU mode. The failure occurred when the vessels were only half a mile apart. A 22-knot closing speed meant there was only 1 minute and 30 seconds to act before the collision. The master immediately ordered the switch to NFU mode and hastily operated the NFU lever. However, there was no change to the rudder angle so the master diagnosed a further malfunction and ordered emergency steering at the steering gear room. By then it was too late and - as shown in the image below - the vessel continued to veer across the channel striking the other vessel broadside.

The force of the collision ultimately caused the other vessel to sink with her 16 crew. Fortunately, seven survived. The investigation found that in panic the third officer did not confirm that he had activated the NFU switch and that, in haste, the master used the NFU lever before the third officer had completed the switch to NFU mode. NFU steering was found to be functioning normally and the master had made an incorrect diagnosis that there was also a problem with the NFU mode.

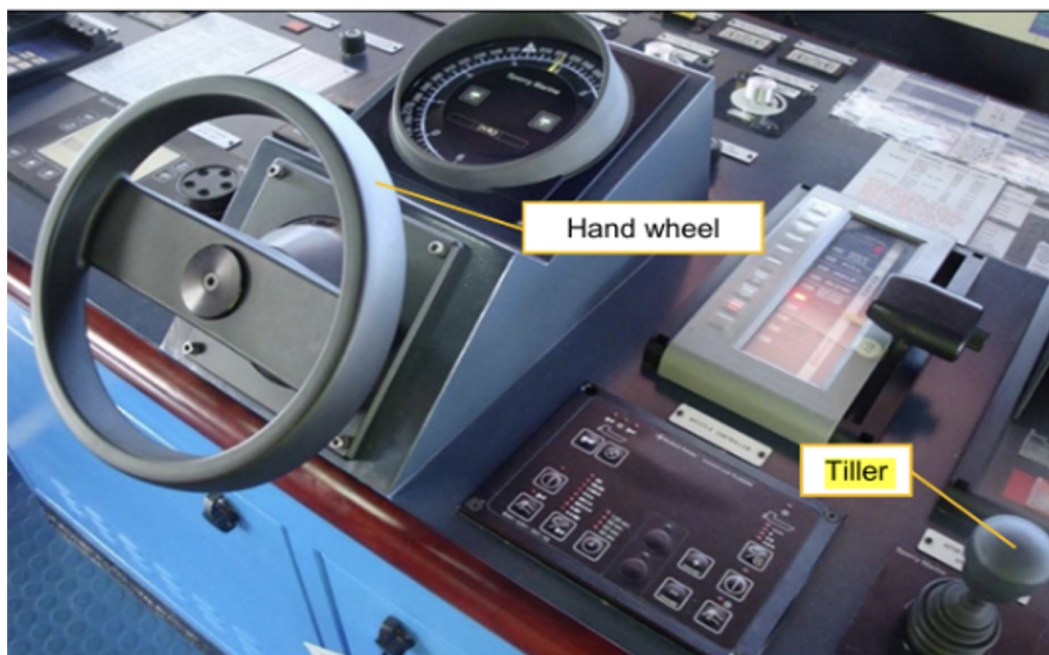
In another accident involving an undetermined technical failure there were two and a half minutes between the failure of the rudder to respond and the grounding. Despite the stressful situation and a multitude of alarms, the immediate actions on the bridge were found to be correct – the helmsperson immediately reported the problem and steps were taken to prepare the anchors.

However, the [investigation](#) revealed that the crew were unaware of an automated override when the steering failure occurred. Unlike, in previous accident, where NFU mode had to be selected, the control system in this case automatically disabled the FU mode and engaged the NFU mode. Helm orders to rescue the situation therefore had no effect through the hand wheel and there was no attempt to use the separate NFU tiller joystick that had taken control of the rudder.

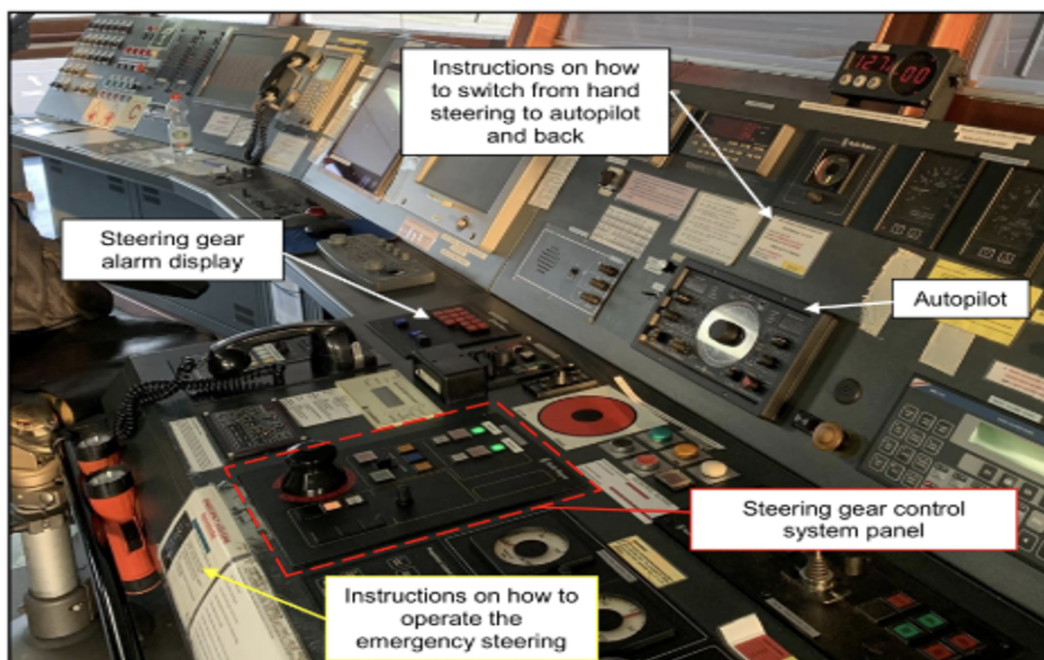
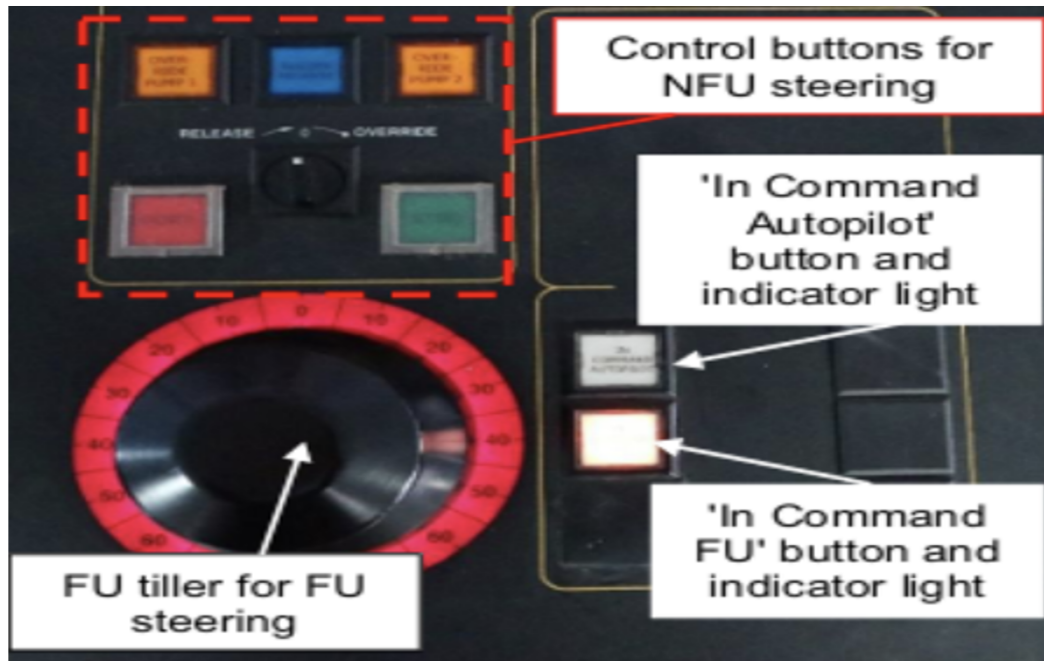
Strangely in one accident that caused significant damage to the vessel and a quay, the transfer from manual to autopilot occurred during a river transit. This was at the request of the pilot with the vessel proceeding at 10 knots and a few hundred meters away from the riverbank. A fault with an electrical relay component caused the rudder to take a sudden and strong deflection to starboard, before moving back towards midships.

Attempts were made to switch back to manual FU mode, but this required the wheel (a rotary dial rather than a classic steering wheel) to be sufficiently aligned with the actual rudder position. The [investigation](#) found that the bridge team was not fully aware of this requirement, nor was it reflected in written transfer instructions posted on the steering console.
