### MARS 202534

Not so slow crane wreck

### MARS 202535

### MARS 202536

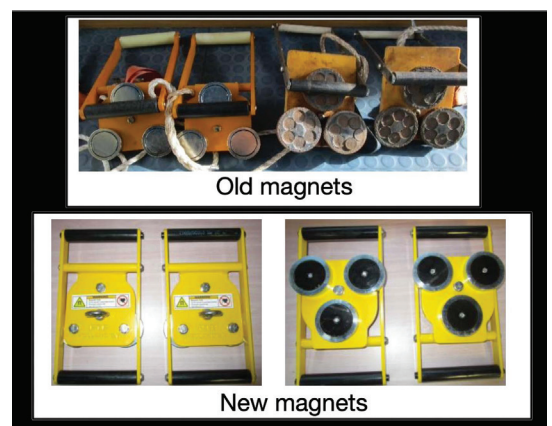
Departure and outbound voyage were without incident but at the pilot disembarkation area the vessel was rolling so heavily that the magnets for the accommodation platform released from the hull. The disembarkation of the pilots was postponed to re-secure the ladder. The magnets were re-attached to the vessel's hull, the accommodation ladder was secured, and one pilot disembarked safely to the pilot boat. The second pilot could not disembark as the magnets were again dislodged from the hull due to rolling. The disembarkation of the second pilot was postponed and the vessel headed towards an area where the weather conditions were deemed more suitable for disembarkation.

The Master subsequently ordered new magnets for the vessel.

- Corrosion: Magnets made of iron can rust if not coated or protected. Over time, corrosion can compromise their structure and reduce their magnetism.
  - Keep ladder magnets in a protected environment and if possible one with stable temperature control.
  - Maintain ladder magnets by eliminating rust and protecting them from impacts.
  - When in doubt, since judging magnet strength is difficult under operational conditions, replace old pilot/accommodation ladder magnets with new ones.

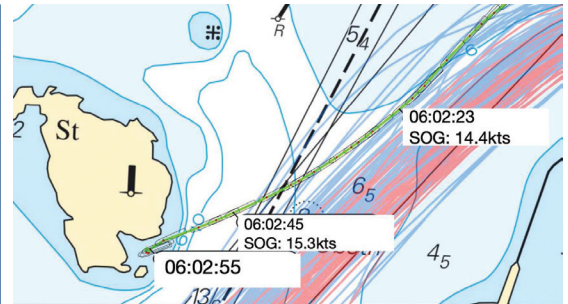
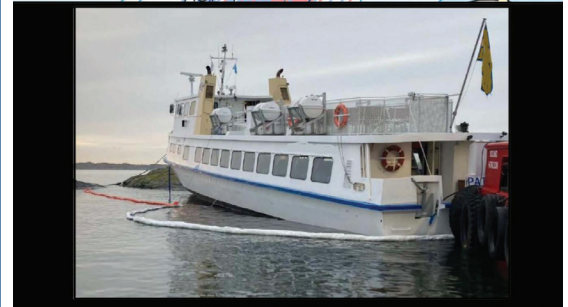
To dim the light on the displays, two buttons had to be pressed simultaneously. The buttons were not backlit, so the captain took out his mobile phone and activated the flashlight function to see better. With the phone in one hand, he pressed two buttons simultaneously with the other hand. On his first attempt the display went completely black instead of dimming. Concentrating on this task for a second time, he saw something appear in front of the ship. With no time to turn away the ferry ran aground on an island at a speed of almost 16 knots.

The investigation found, among other things, that the autopilot's 'change in operating mode' warning was not effective. The autopilot probably became disengaged when the armrest was raised to give the captain access to the engine monitoring displays, without him being aware of this. At nearly 16 knots, it only took a few seconds for the ferry to veer off course and run into danger while the captain was preoccupied with dimming the panels.

- Poor design and ergonomics are nefarious unsafe conditions that often go unnoticed until it is too late.
- In darkness and navigating the vessel in a restricted waterway, the captain was trying to undertake an adjacent task that takes both hands and both eyes.
- Once again speed is an issue. At 16 knots the captain did not put chance on his side when deciding to attend to an adjacent task.
- A seaman was sitting in the aft part of the wheelhouse without duties. He would have been more useful as lookout.
