## In this bulletin...

### **MARS 202520**

### **MARS 202521**

### **MARS 202522**

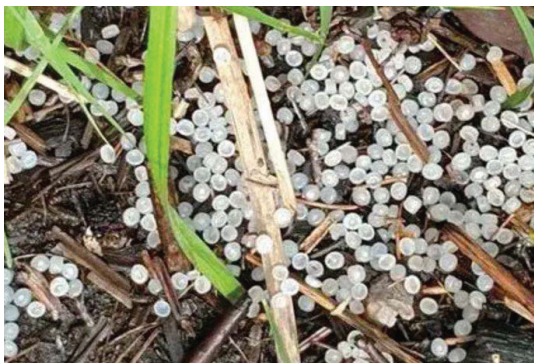
Cargo stows on container, bulk, vehicle and general cargo vessels are particularly vulnerable to more extreme rolling and pitching. Stowage failures can lead to more than cargo damage. They can result in structural damage, fires and may also cause the ship to list, compromising stability and potentially disabling the ship.

environmental impact from cargo that sinks or ends up washing ashore as debris. Gard has seen clean-up costs in several cases running into many millions of dollars, particularly if plastic nurdles (below, left) are involved.

- It is a good investment to refresh and update the skills of navigators in storm avoidance, weather analysis, and routing strategies.
- Lashings may need checking as they may have slackened during the voyage. However, it is important that such checks are done in good time and safe conditions. If a stow failure does occur it may also be unsafe to send the crew into cargo areas to try and re-secure it until better conditions permit.

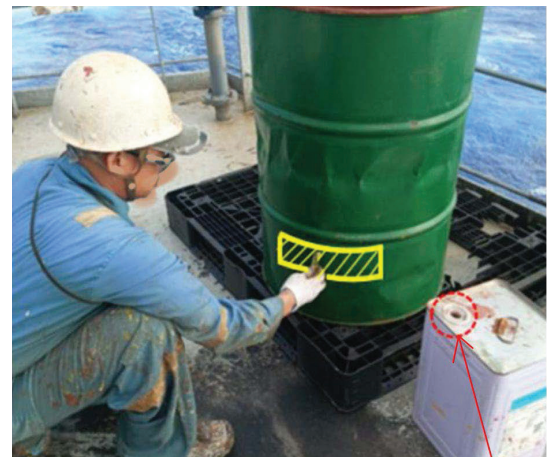
The victim explained that he had placed plastic waste inside the empty drum in preparation for burning, poured paint thinner over it, and placed the uncapped paint thinner tin beside the drum. He then ignited the plastic waste from the access hole at the bottom of the drum with a lighter (as in the re-enactment photo), resulting in an explosion which covered him in flames.

The investigation revealed critical lapses in communication between the vessel leadership and crew. The Master's plan had been to dispose of the plastic waste at the next port. Although the Master had informed the Chief Engineer of this, other crew members, including the Chief Mate were not informed. The Chief Engineer had rejected a request to burn plastic waste using the shipboard incinerator, but did not provide a reason for doing so. The Chief Mate then felt obliged to find an improvised solution – by burning it on the poop deck in a barrel.

The burning of waste on an exposed deck was not approved by the Company's SMS. Despite this, the Chief Mate instructed the crew to carry out the task, revealing a gap in adherence to established procedures. The crew did not question nor challenge this instruction despite knowing that the company SMS forbids burning on the exposed deck.

**Reconstruction: note yellow rectangle showing access hole and open can of paint thinner**

No substance should ever be burnt on an open deck. Always use the vessel's incinerator for such tasks or, if the incinerator is unserviceable, store on board for shore disposal.

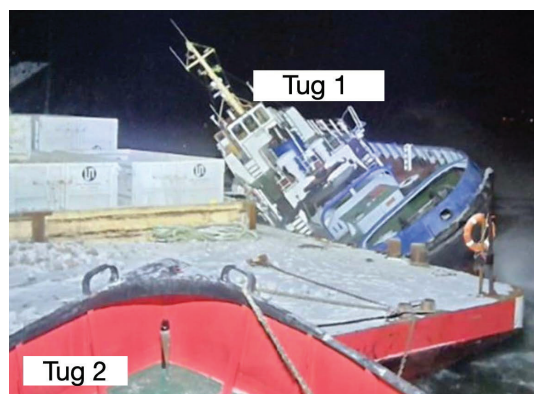
Within seconds tug 1 ran hard aground at a speed of 11 knots. The grounding was violent, and the ship immediately listed heavily to port some 40 degrees. Both the master and the crewmember fell out of the wheelhouse and landed on the port bridge wing. To avoid being exposed to the cold water, the Master released the ship's life raft.

The investigation subsequently found that tug 1's ENC did not meet the standards for an approved electronic chart, and lacked information on the quality of the depth data. Additionally, the ENC's setup made use of the same colour palette for depths between 3m and 10m. Because the tug's draft was 4.2m, this setup gave no colour indication of the shoal danger. Another weakness in tug 1's ENC was that it had no limit on how far it could zoom in. Electronic nautical charts that are over-zoomed can lead a user to believe that the

Tug aground and listing

- In this occurrence, the tug crew's concentration on one task, that of breaking ice and visually following the ice channel, blinded them to the impending danger. They ran aground at full speed.
- Situational awareness is the critical factor for a navigator. It cannot be repeated enough: Use all possible means to determine your position.
- The proper use of ENC's or ECDIS is critical to sharpen your situational awareness and risk appreciation. The correct safety depth and/or colour palette selection can make the difference in grounding your vessel, or not.

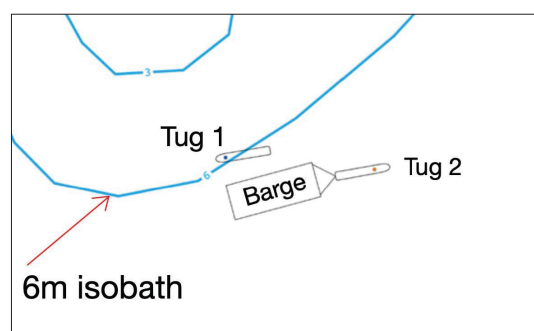
accuracy is increased to the same extent, which is not the case.
