## In this bulletin...

### MARS 202601

### MARS 202602

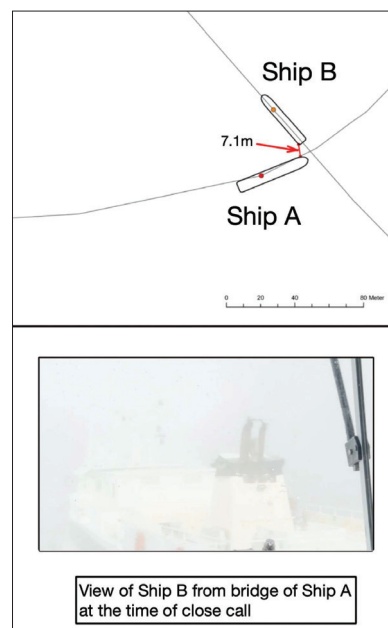
Ship B's crew saw that Ship A was on a southerly course and assumed that Ship A would pass port-to-port and then astern of them. But then, Ship A turned to port to an easterly course at about 35 knots, bringing it on a collision course with Ship B. When the Master of Ship B saw that Ship A was heading directly towards them, he turned to starboard in an attempt to avoid collision. The bridge team on Ship A saw Ship B at the last minute and were unable to make any changes to their speed or direction. They passed astern of Ship B at about 7 metres distance.

The investigation found, among other things, that the reason the speed was not reduced on Ship A was that the bridge team felt the conditions were excellent for radar, where even echoes from small objects appeared clearly on the screen. The bridge team thus felt that they had control of the situation despite the dense fog. However, the high

speed meant that the OOW and the Master had very little time to perceive, discuss, and analyse the radar image. They did not understand that they had lost their situational awareness of the surrounding traffic.

- Only good fortune prevented this close call from being a disaster. Given the high speed of Ship A and the fact that there were passengers on the foredeck, an impact with Ship B would probably have resulted in multiple fatalities.
- Once again, high speed in reduced visibility created a dangerous situation. Slow down in fog!
- Using a telephone app to help identify other vessels is not professional nor a recommended practice. Use proper navigation instruments to their utmost.

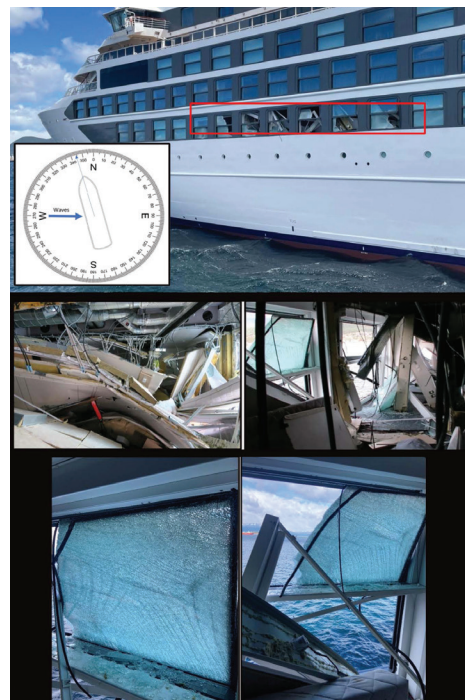
A clearer picture of the extent of the damage became evident, and as the damage appeared to be limited to a relatively small area and the emergency was considered under control, a general muster was not initiated. Passengers were instructed to remain in their cabins, except for the passengers in the damaged area, who were instructed to proceed to deck A. It was later found that seven cabin windows on the port side of deck 2, approximately 8 metres above the waterline, had shattered when the wave struck the ship.

Onboard medical personnel confirmed that eight passengers had suffered minor physical injuries. One other passenger was found deceased in an affected stateroom. The victim was found on the deck under various parts of the damaged stateroom.

The investigation found that the sea conditions at the time of the accident were within the sea states defined in the specifications to which the ship was designed, yet the wave forces acting on the windows were significantly higher than their design state.

- At the time of the accident, the crew did not have sufficient information to predict the risk associated with a strong breaking wave reaching high up on the ship side.
- The current design pressure requirements for windows on a ship's side appear to yield values that are too low to withstand real-world pressure loads from breaking waves.

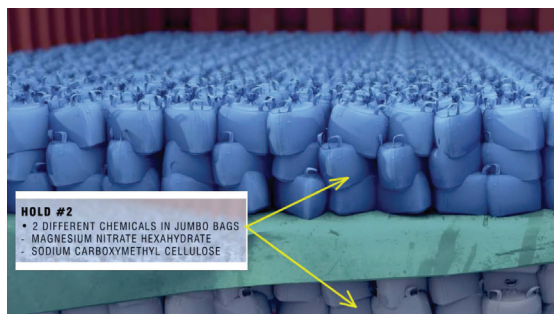
Screen capture from London P&I Club video

Serious problems can also occur when FIBCs are stored incorrectly with breakbulk or steel cargoes, which can damage the integrity of the jumbo bags and cause significant spillage. Steel cargo can also

be damaged by exposure to spillage from the jumbo bag.

- When developing stowage plans for FIBCs and other big bags, consider requesting advice from P&I's so that qualified industry experts can be consulted before loading.
- These cargoes may look harmless, but they can be potentially very dangerous if not stowed and handled appropriately.
- The London P&I Club made an interesting video on this topic that can be viewed here: <https://youtu.be/e0SEQkCFIbo>
