## Engine room fires are still a major concern

Published 13 February 2025

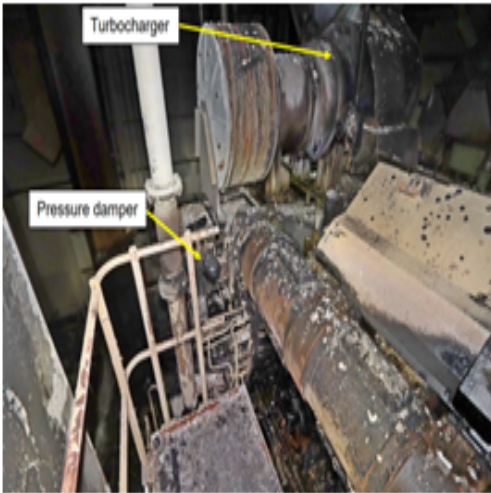
Case study	
A copper pipe that was part of the fuel oil pressure gauge supply pipework for one of the auxiliary engines fractured due to a missing metal spray shield. The fuel oil sprayed onto this unprotected hot surface of the turbocharger and the previous system which had a temperature of more than 400°C. The fuel ignited on the engine block.

Fire damaged area of auxiliary engine	Fractured copper pipe

Referring to our initial case study above, making sure that the piping met the original specs, reinstalling the spray shield after maintenance, and using thermography to identify the exposed sections in the insulation around the turbocharger and exhaust manifold of the auxiliary engine would have prevented the fire from occurring.

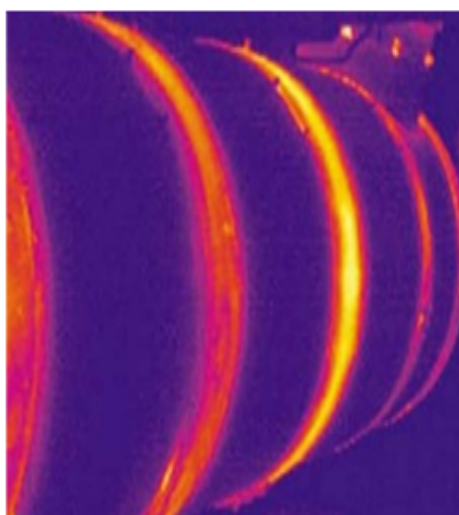
Thermo of the exhaust manifold of the main engine shows a max. temperature of 250°C.

Owners/managers should incorporate the use of thermography onboard for detection of hot surfaces and for checking insulation during normal operations. Owners should consider including thermographic examinations in new building specifications and have such tests carried out during sea trials. A thermographic examination of the engine room and the vessel's electrical installation should be carried out periodically with engines and electrical equipment running. It is important to note that spot thermometers have limited effectiveness, as they only measure the temperature at a single point.

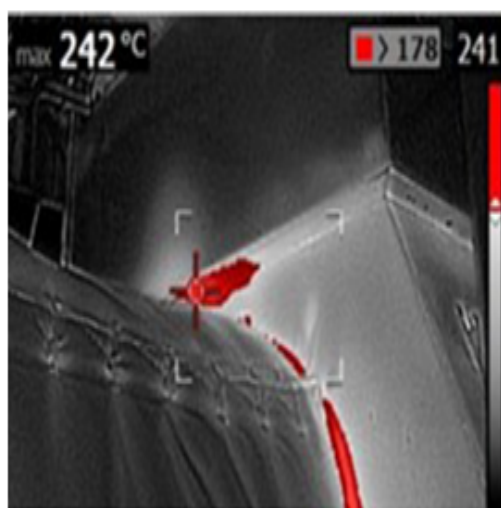
Exhaust manifold showing a max. tempetuare of 242°C.

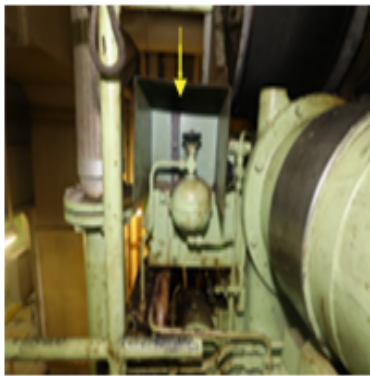
Spray shield around the pressure damper on auxiliary engine

**Spray shields :** The position and condition of spray shields for both high- and low-pressure flammable oil lines should be checked regularly, as should the drainage arrangements for jacketed fuel oil pipes. Where spray shields are not included in the original design and the area has been identified as a potential source of oil leakage, then the installation of spray shields should be considered. Particular attention

should also be given to the immediate and proper refitting of spray shields and insulation materials upon completion of maintenance.

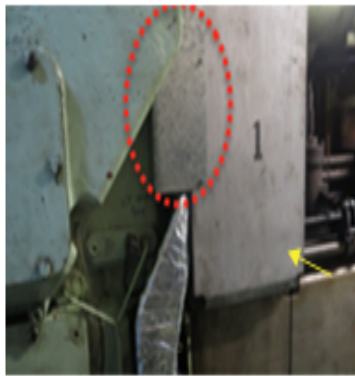
Shielding to protect the turbocharger

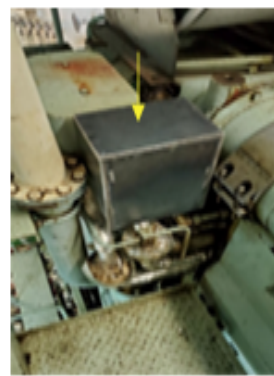
Guard fabricated to cover fuel system buffer (damping) tank
