## Engine room fires are still a major concern

Published 13 February 2025

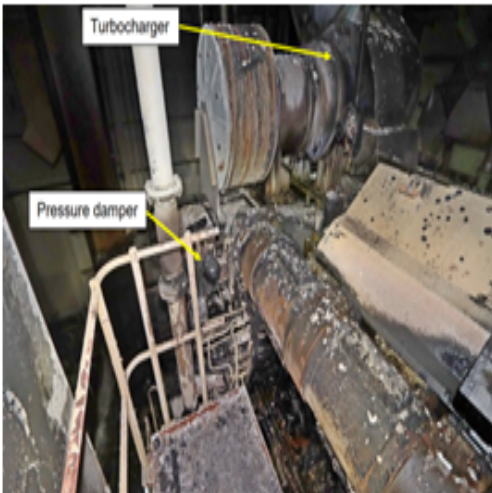
| A copper pipe that was part of the fuel oil pressure gauge supply pipework for one of the auxiliary engines fractured due to a missing metal spray shield. The fuel was sprayed onto the unprotected hot surfaces of the turbocharger and the pressure damper, which had temperatures of more than 400°C. The fuel ignited on the adjacent steel structure. Insulation on the exhaust pipes was damaged. The investigation is ongoing. | |
| Fire damaged area of auxiliary engine | Fractured copper pipe |

Referring to our initial case study above, making sure that the piping met the original specs, reinstalling the spray shield after maintenance, and using thermography to identify the exposed sections in the insulation around the turbocharger and exhaust manifold of the auxiliary engine would have prevented the fire from occurring.

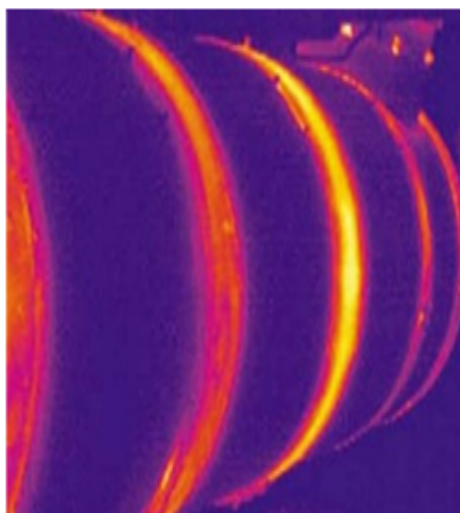
Thermo of the exhaust manifold of the main engine shows a max. temperature of 250°C.

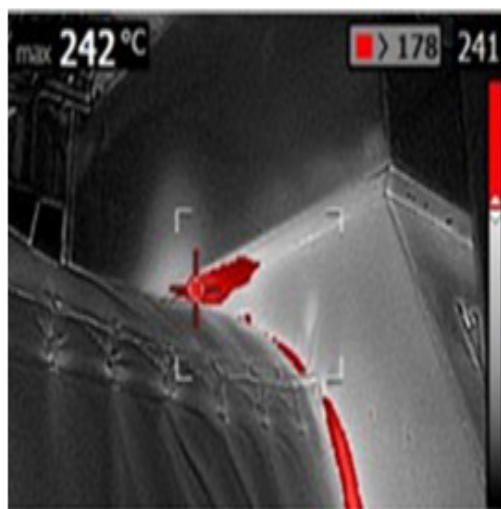
Exhaust manifold showing a max. tempetuare of 242°C.
