## Engine room fires are still a major concern

Published 13 February 2025

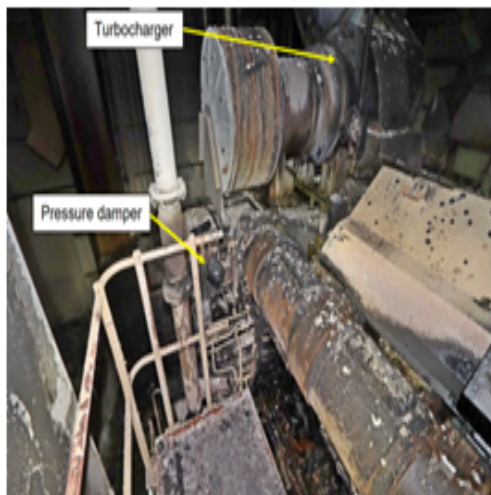
| Case study |
|---|
| A copper pipe that was part of the fuel oil pressure gauge supply pipework for one of the auxiliary engines fractured. Due to a missing metal spray shield the fuel sprayed onto the unprotected hot surfaces of the nearby turbocharger and the exhaust system which had temperatures of more than 400 °C. The fuel ignited causing extensive damage to auxiliary engines and power distribution cables. The vessel was out of service for 40 days to carry out repair works. |
| Investigation by experts showed that the copper pipe that fractured did not match the original design and had a lower wall thickness. There was no record of any previous repairs carried out to the fuel system pipework. The pipe assembly on the other three auxiliary engines appeared to be of original installation comprising of a steel pipe. The spray shield was removed during maintenance and not re-installed. Insulation was also suspected to be inadequate since exposed sections around the exhaust manifold and turbocharger were noticed on other three auxiliary engines. The investigators concluded that the heat shielding arrangements on the fire damaged auxiliary engine did not meet the relevant SOLAS regulations, II-2/2.2.6.1. |

Fire damaged area of auxiliary engine

Referring to our initial case study above, making sure that the piping met the original specs, reinstalling the spray shield after maintenance, and using thermography to identify the exposed sections in the insulation around the turbocharger and exhaust manifold of the auxiliary engine would have prevented the fire from occurring.

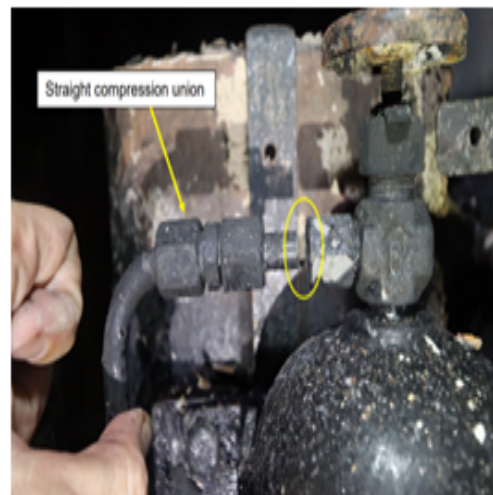
Fractured copper pipe

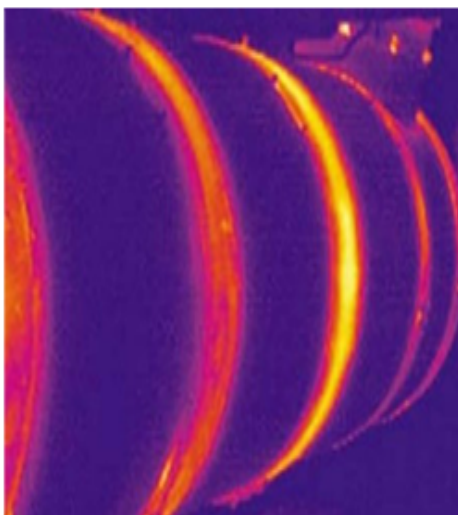
Thermo of the exhaust manifold of the main engine shows a max. temperature of 250°C.

Owners/managers should incorporate the use of thermography onboard for detection of hot surfaces and for checking insulation during normal operations. Owners should consider including thermographic examinations in new building specifications and have such tests carried out during sea trials. A thermographic examination of the engine room and the vessel's electrical installation should be carried out periodically with engines and electrical equipment running. It is important to note that spot thermometers have limited effectiveness, as they only measure the temperature at a single point.

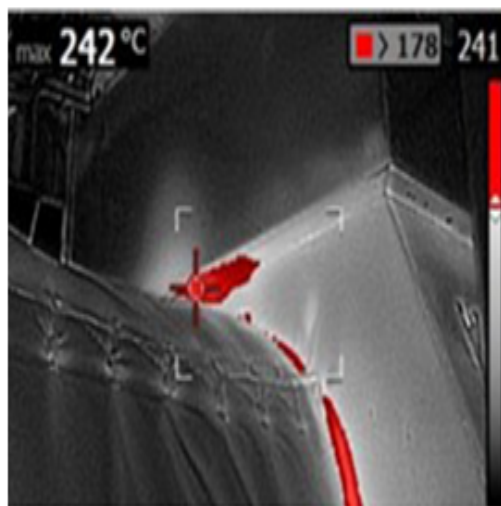
Exhaust manifold showing a max. temperature of 242°C.

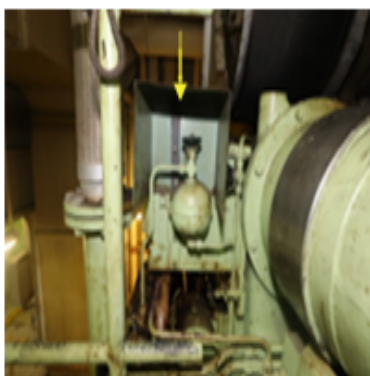
Spray shield around the pressure damper on auxiliary engine

*Spray shields :* The position and condition of spray shields for both high- and low-pressure flammable oil lines should be checked regularly, as should the drainage arrangements for jacketed fuel oil pipes. Where spray shields are not included in the original design and the area has been identified as a potential 'source of oil leakage', then the installation of spray shields should be considered. Particular attention should also be given to the immediate and proper refitting of spray shields and insulation materials upon completion of maintenance.

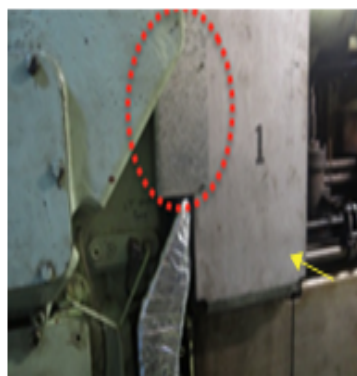
Shielding to protect the turbocharger

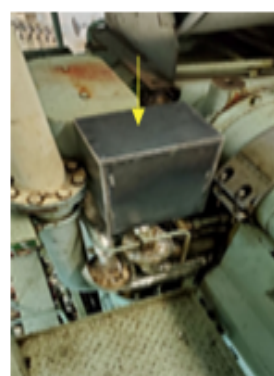
Guard fabricated to cover fuel system buffer (damping) tank
