Engine room fires are still a major concern

Published 13 February 2025

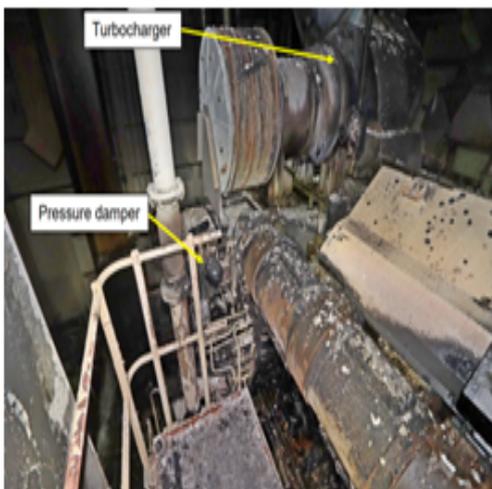
Fire damaged area of auxiliary engine

In the above case, there are two main aspects which need to be highlighted.

- First is the leakage of flammable oil; and
- Second is the inadequate protection to prevent highly flammable fuel from coming in contact with a source of ignition.

Referring to our initial case study above, making sure that the piping met the original specs, reinstalling the spray shield after maintenance, and using thermography to identify the exposed sections in the insulation around the turbocharger and exhaust manifold of the auxiliary engine would have prevented the fire from occurring.

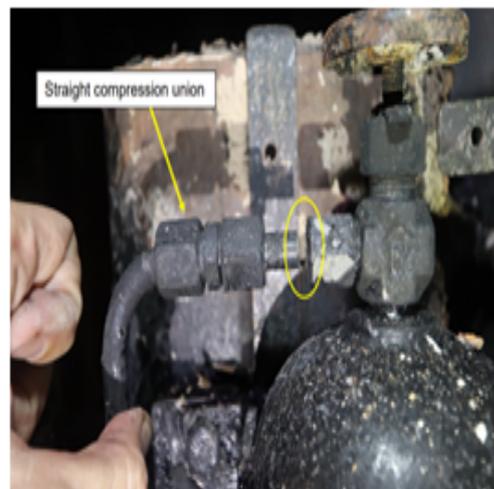
Fractured copper pipe

- Fatigue fracture of pipes. Such pipes are typically not well supported along their entire length, which causes excessive stress due to vibrations. Lack of support may be attributed to the design or failure to reinstall the holding brackets after maintenance.

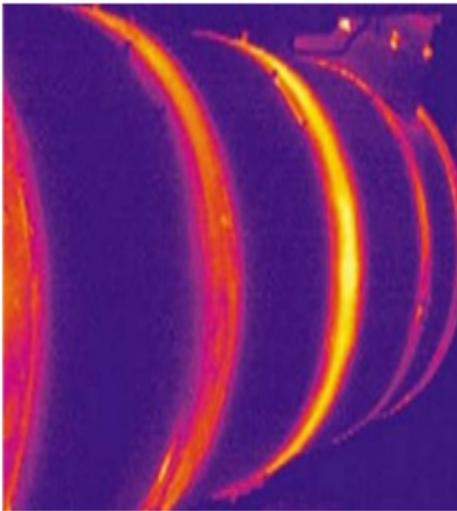
Thermo of the exhaust manifold of the main engine shows a max. temperature of 250°C.

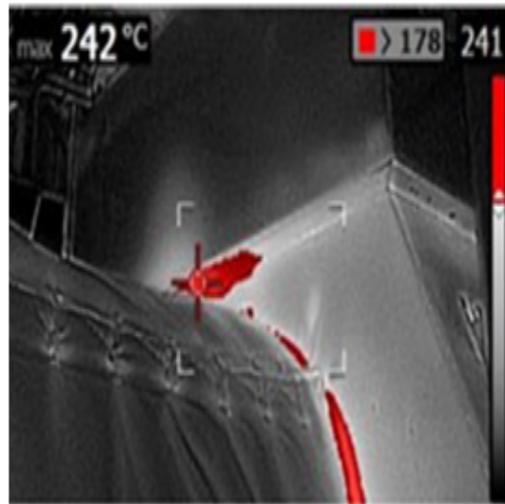
Exhaust manifold showing a max. tempetuare of 242°C.

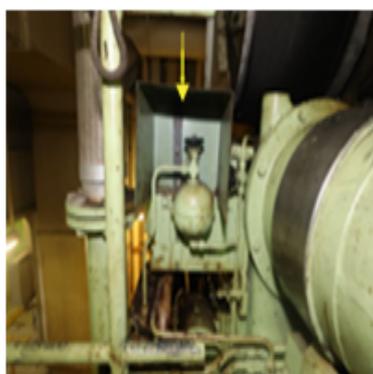
Spray shield around the pressure damper on auxiliary engine

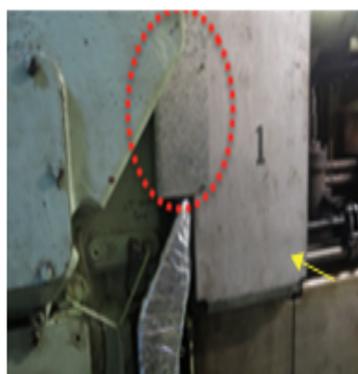
Shielding to protect the turbocharger

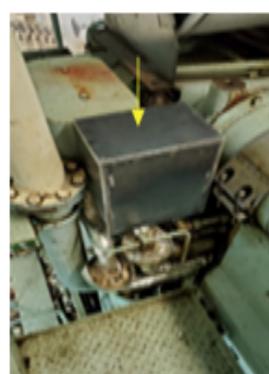
Guard fabricated to cover fuel system buffer (damping) tank
