## Caution necessary when loading Nickel Ore in the Philippines

Published 29 January 2026

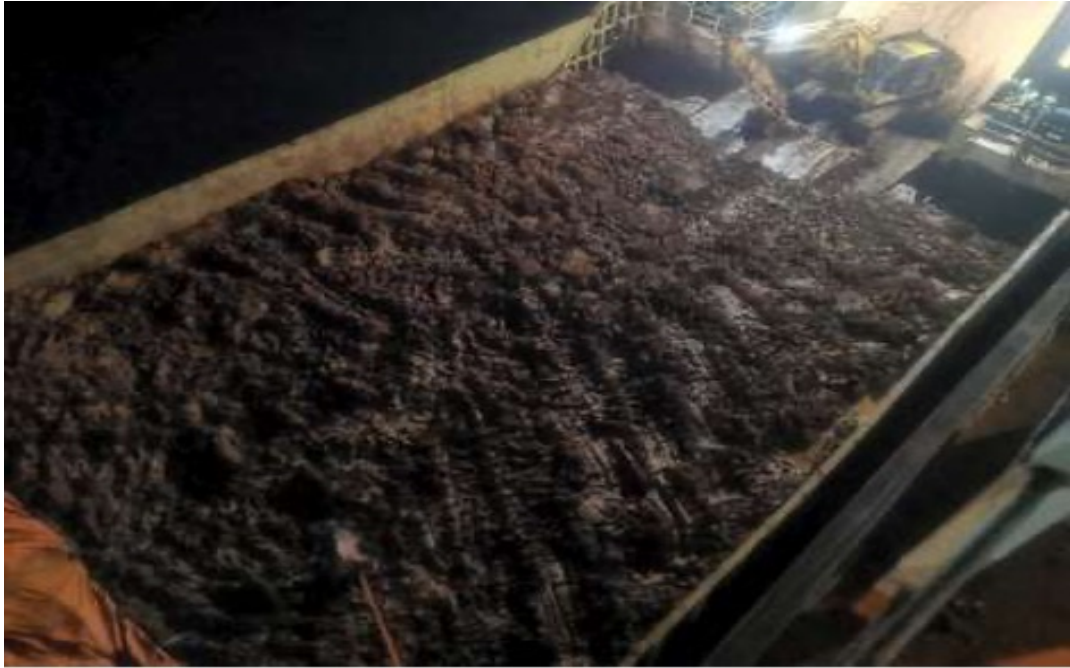
Nickel ore being loaded from barge

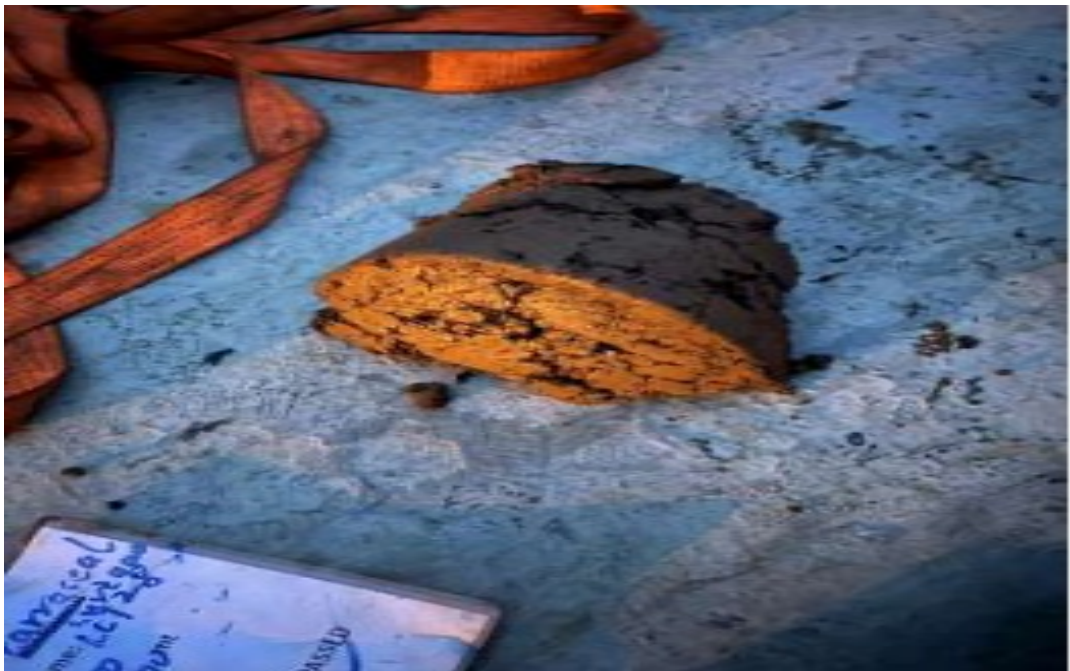
Can tests done by crew

Owners and crew are also reminded that can-tests are a very basic check and are not foolproof. They are not a substitute for independent laboratory tests. As the IMSBC Code states, even if cargo sample remains dry following the test the moisture content may still exceed the TML. Moreover, even if Group A cargo is deemed safe to carry, it remains important to monitor it throughout the voyage. In line with the IMSBC Code, the cargo surface should be inspected at regular intervals. If signs of liquefaction are observed, the vessel should consider diverting to a place of refuge.

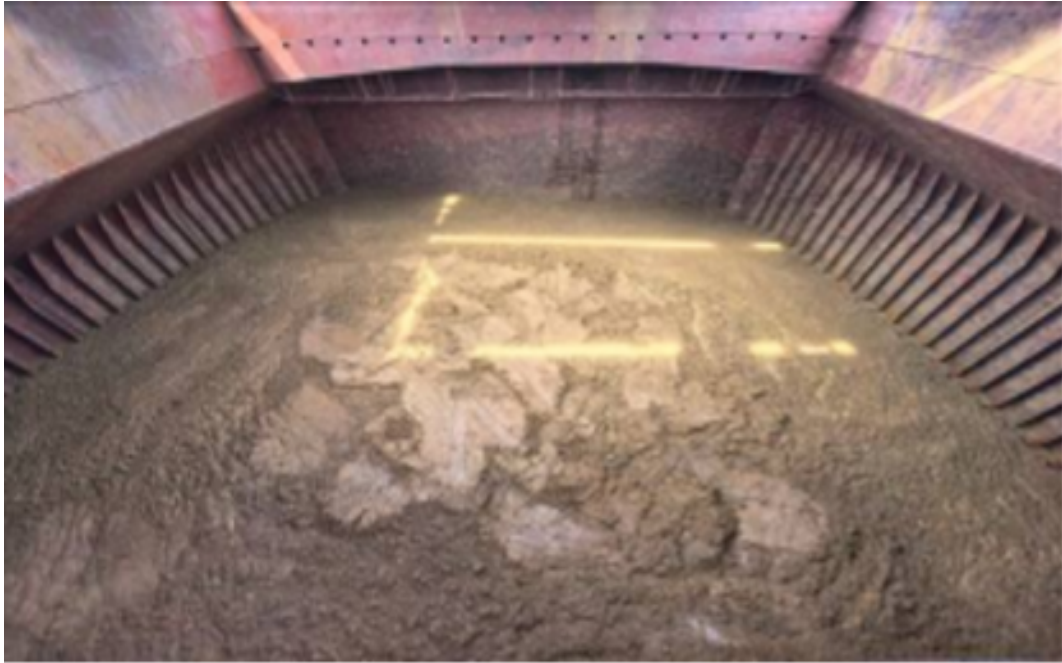
Last year, Gard handled a case involving a charterer client positioned mid-chain in the charterparty, where nickel ore liquefied in the vessel's holds three days after departing Surigao en route to China. The vessel was fortunately able to reach a port of refuge in Philippines. The shipper's documentation (the Shipper's Declaration, TML, MC, and FMP certificates) was found to be inaccurate. All certificates (TML, FMP and MC) had been prepared, approved, and reviewed solely by the mining company. The figures declared were TML 36.19%, FMP 40.21%, and MC 35.31%. Photographs of the incident, along with a [video](#) from inside the cargo holds, are provided below.

View of liquefied cargo in one of the holds

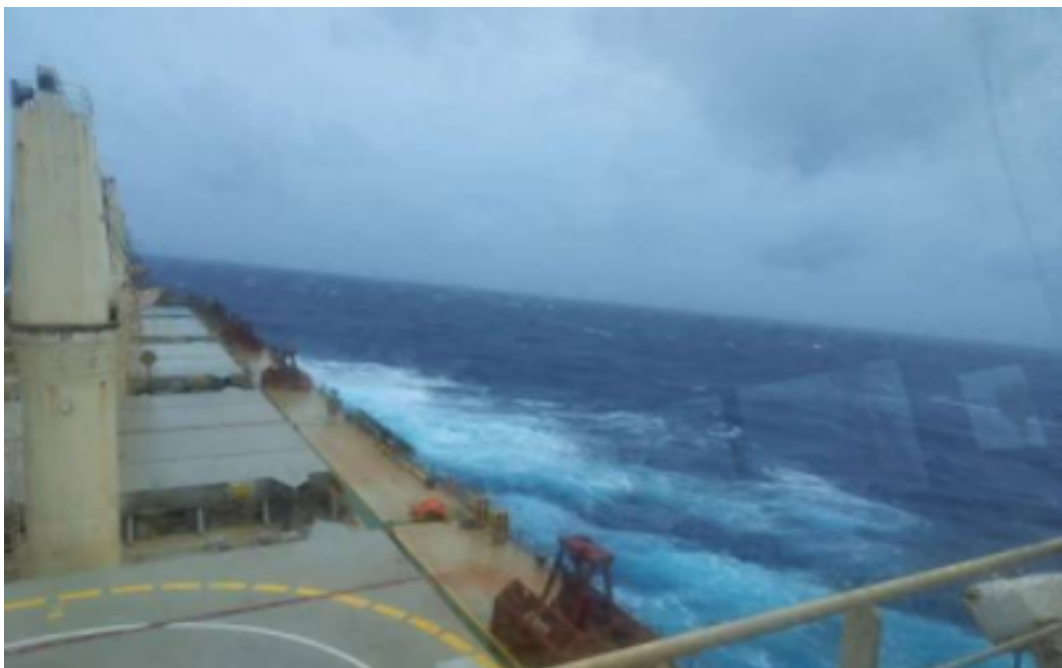
Vessel listing to port
