Caution necessary when loading Nickel Ore in the Philippines

Published 29 January 2026

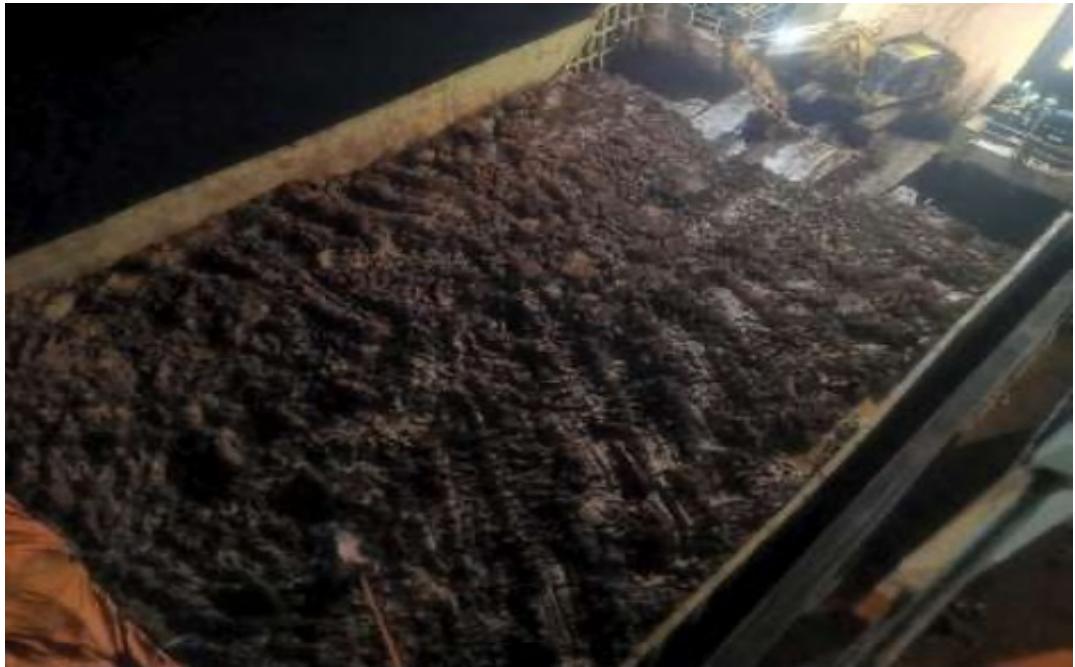
Infrastructure shortcomings: Mines commonly stockpile nickel ore in open, exposed areas on or near the foreshore. There are no dedicated jetties or port facilities at these locations. Loading is conducted offshore at anchor using barges, which may be uncovered. The ore is unprocessed, sourced from open-cast operations, and remains exposed to the elements throughout handling.

Nickel ore being loaded from barge

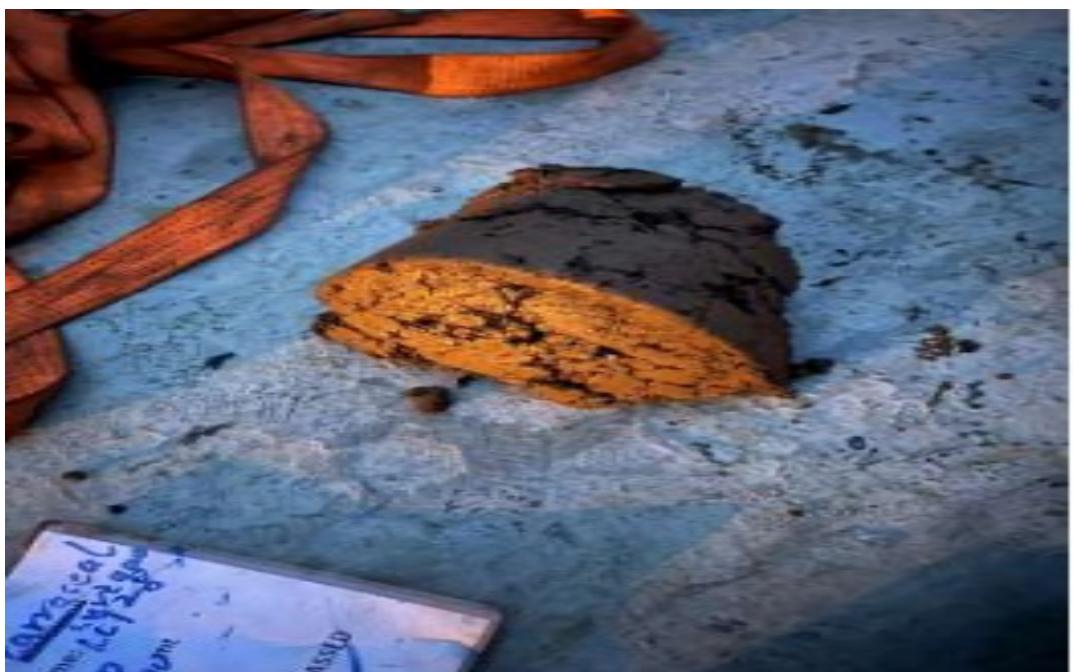
Can tests done by crew

Owners and crew are also reminded that can-tests are a very basic check and are not foolproof. They are not a substitute for independent laboratory tests. As the IMSBC Code states, even if cargo sample remains dry following the test the moisture content may still exceed the TML. Moreover, even if Group A cargo is deemed safe to carry, it remains important to monitor it throughout the voyage. In line with the IMSBC Code, the cargo surface should be inspected at regular intervals. If signs of liquefaction are observed, the vessel should consider diverting to a place of refuge.

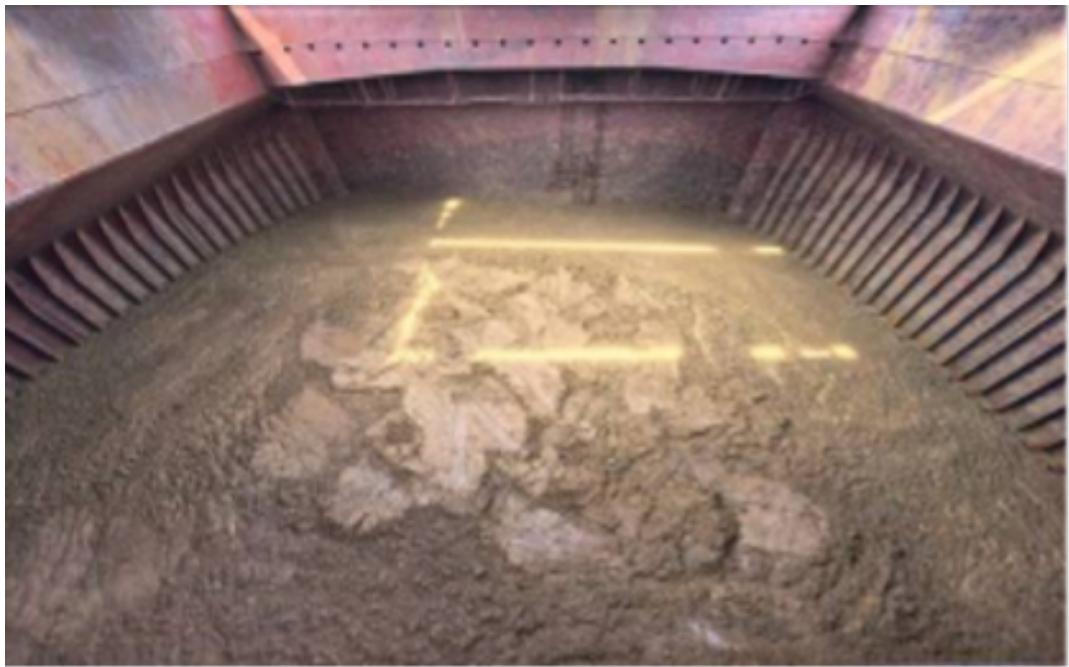
Last year, Gard handled a case involving a charterer client positioned mid-chain in the charterparty, where nickel ore liquefied in the vessel's holds three days after departing Surigao en route to China. The vessel was fortunately able to reach a port of refuge in Philippines. The shipper's documentation (the Shipper's Declaration, TML, MC, and FMP certificates) was found to be inaccurate. All certificates (TML, FMP and MC) had been prepared, approved, and reviewed solely by the mining company. The figures declared were TML 36.19%, FMP 40.21%, and MC 35.31%. Photographs of the incident, along with a [video](#) from inside the cargo holds, are provided below.

View of liquefied cargo in one of the holds

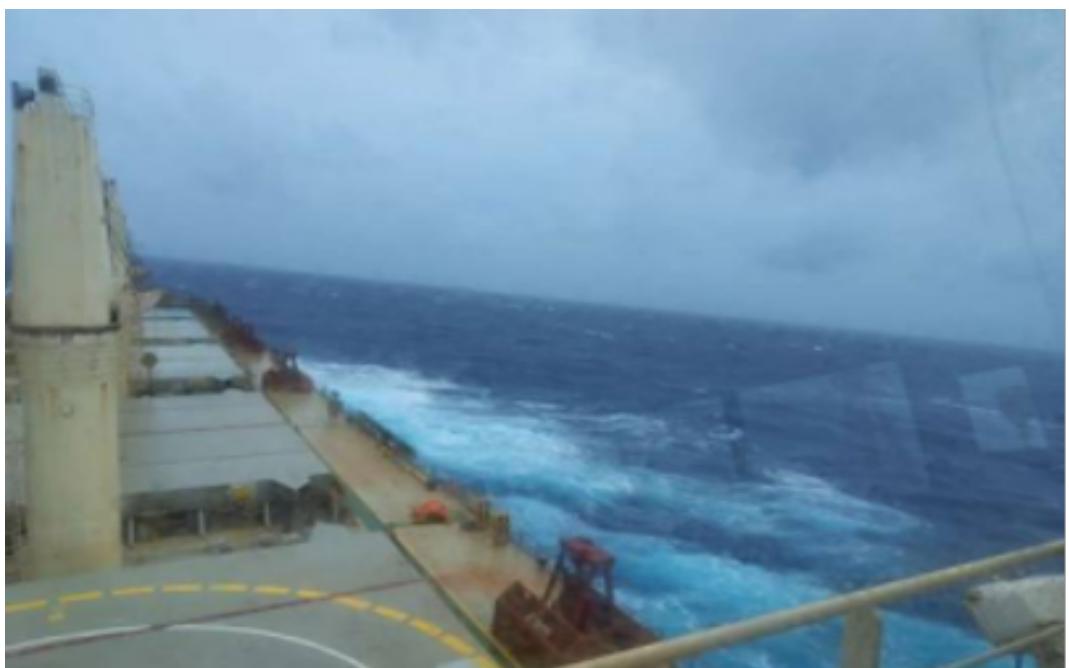
Vessel listing to port
