## Heat damage in soya bean cargoes – the importance of inspections

An increasing number of soya bean cargoes are reportedly loaded in a "bin-burned" condition. Important visible signs that fall under the phrase "apparent condition" can reveal at an early stage soya bean parcels that can be liable to self-heat.

Published 26 October 2016

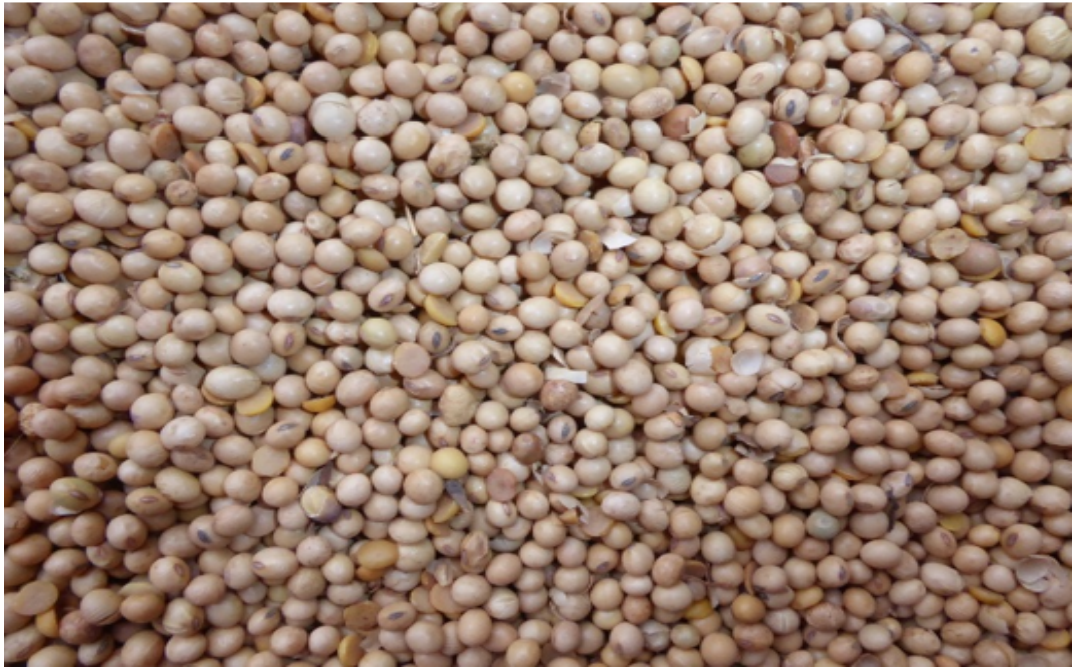
- Soya beans are pale yellow/brown by appearance (see photograph below). Although contracts allow for admixture of several percentage points of damaged and discoloured beans, including often 1 per cent burnt beans, seek advice if portions of the cargo visibly differ from normal with parts of discoloured or black beans.

*PHOTO 1: Sound cream coloured Brazilian soya beans.*

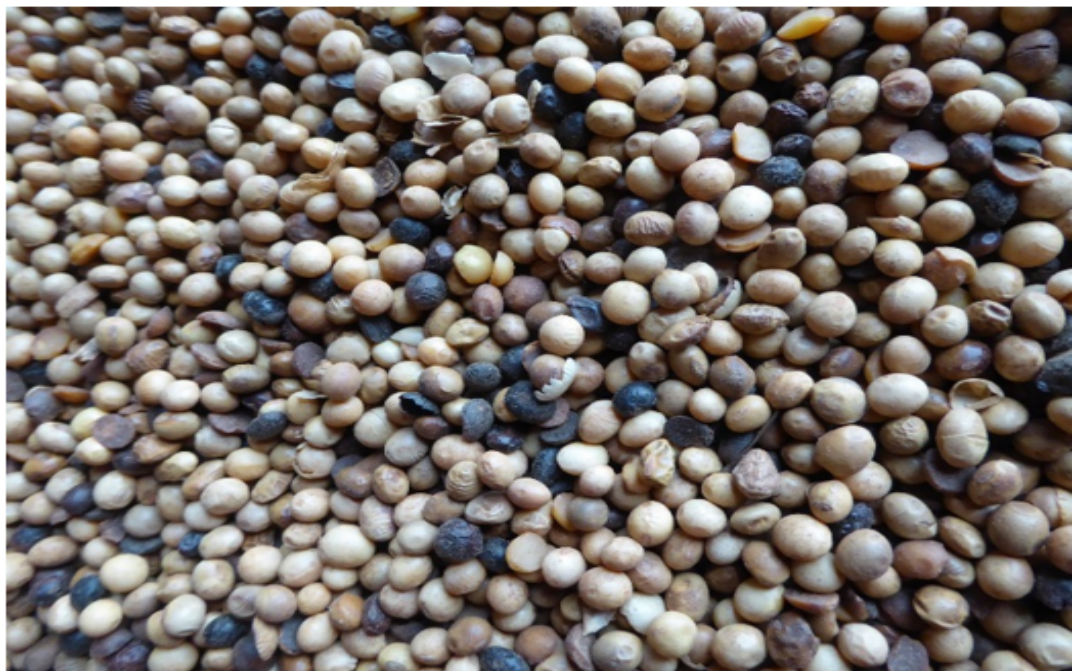
*PHOTO 2: When sound cream coloured soya beans are heated the beans become darker, brown or even black.*

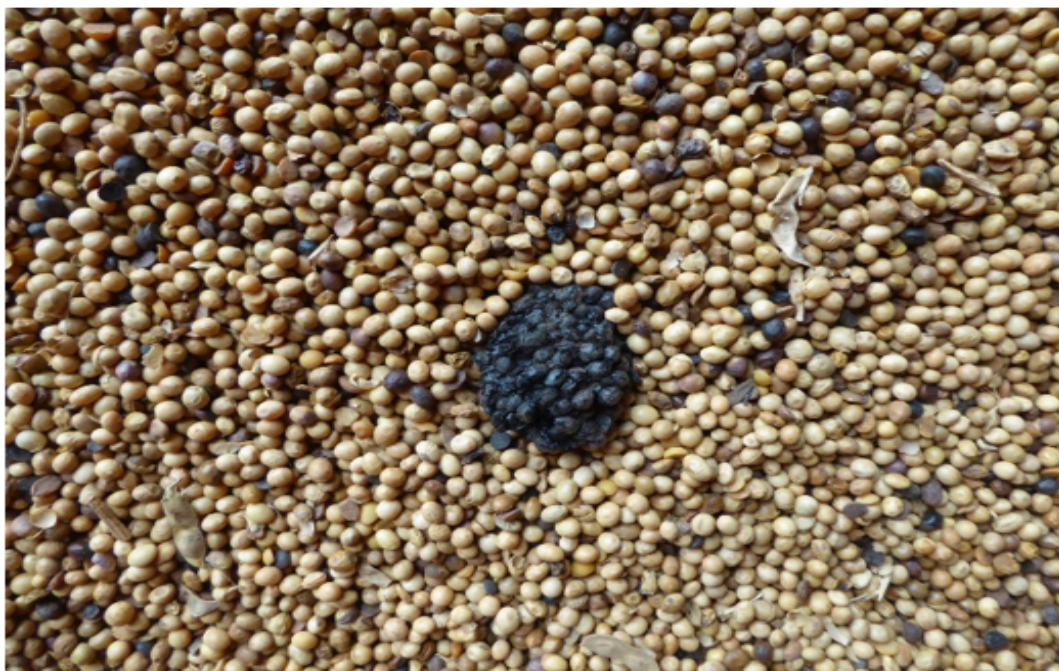
From the photographs below it is clear that the blackened bin-burned beans stand out when compared to the unaffected normal yellow or pale brown beans. The bin-burn phenomenon occurs when over-moist beans are put into storage without sufficient aeration for long periods of time. The process starts as microbiological self-heating but, as the organisms causing microbiological metabolic self-heating die due to the effect of 'self-pasteurization', it is followed by oxidative heating of the oil contained in beans to produce the high temperatures necessary to produce the blackened bin-burned beans. Where such deterioration occurs, farmers and silo operators may break-up the affected, severely heat-damaged cargo to mix it with sound cargo delivered to the export terminals at the ports. Modern sale contracts typically allow for some 1 per cent of burnt beans. The incidence of blackened beans for the Paranagua cargo in question was significantly above this level. It rendered the affected parcels clearly out of conformity with the "normal good order and appearance" condition of soya beans that Masters expect. The presence of the distinct areas of excessive black beans was considered to present a significant risk of claims in China, which was the destination for the shipment. The photograph introducing the article illustrates how bin burned cargo can appear at the time of discharge. The Master rejected the affected parcels although they were already on board and requested they be replaced with beans in apparent good order and condition.

*PHOTO 3: Small lumps of heat damaged soya beans dispersed sporadically throughout the cargo is consistent with the soya beans having undergone self-heating prior to loading or 'bin-burn'.*

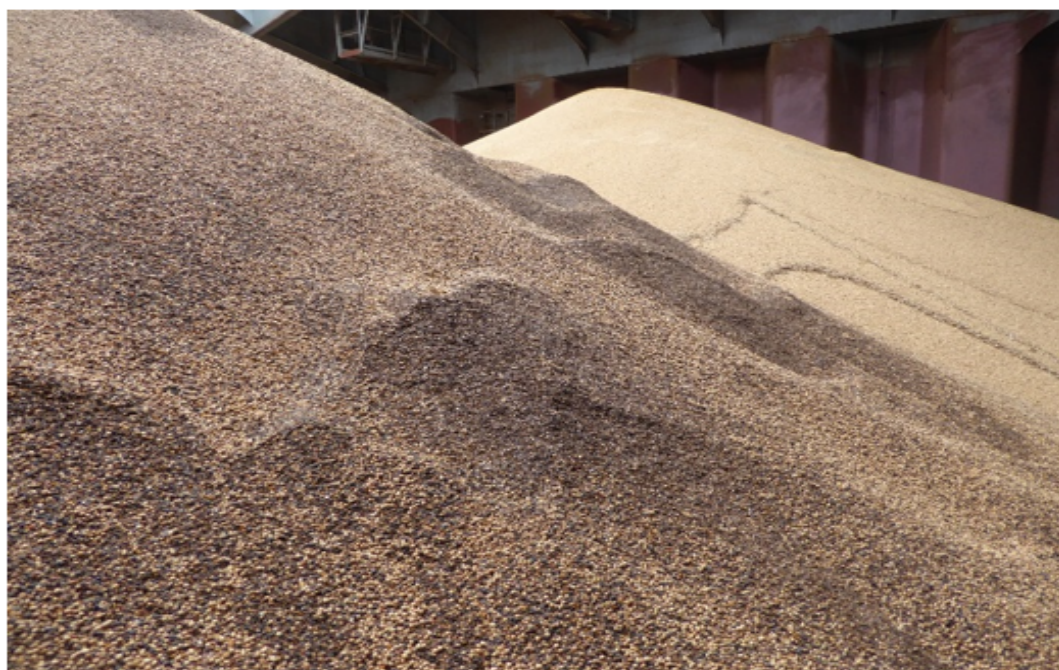
Case study – self-heating In the following example one of our Members loaded soya beans in Brazil in July 2016. The Master stopped the loading when an abnormal presence of blackened beans became apparent in the loaded stow. The Member sought advice from grain scientists and it became clear that the blackened beans (see photographs below) was due to the so-called "bin-burned" phenomenon.

*PHOTO 4. Pre-shipment heat damage (or bin-burned) soya beans in the foreground, with sound beans in the background, all loaded in a single hold.*

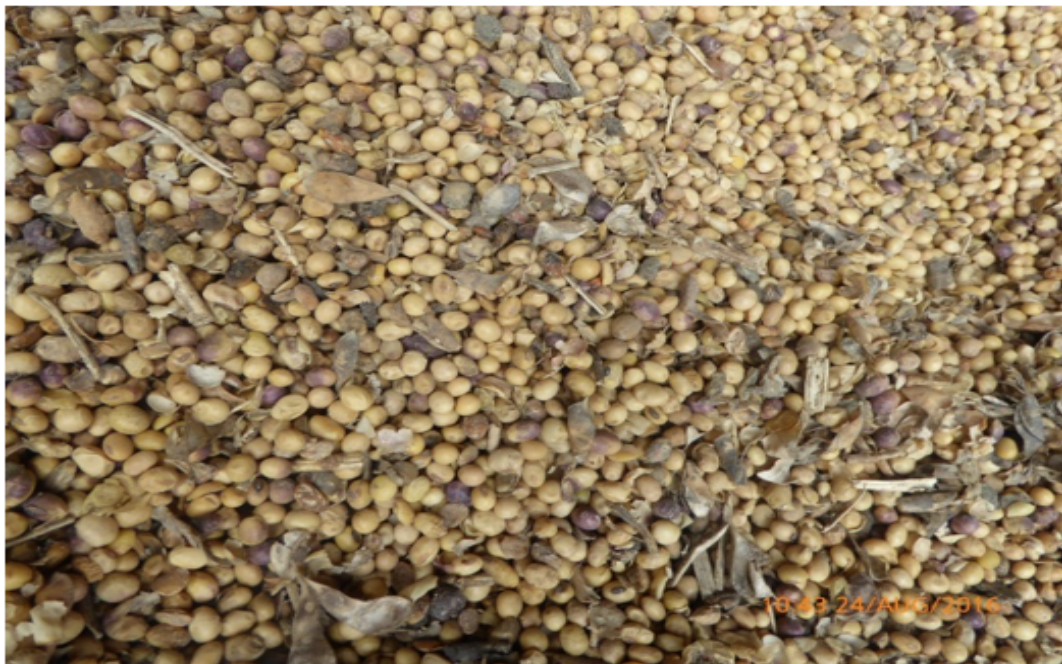
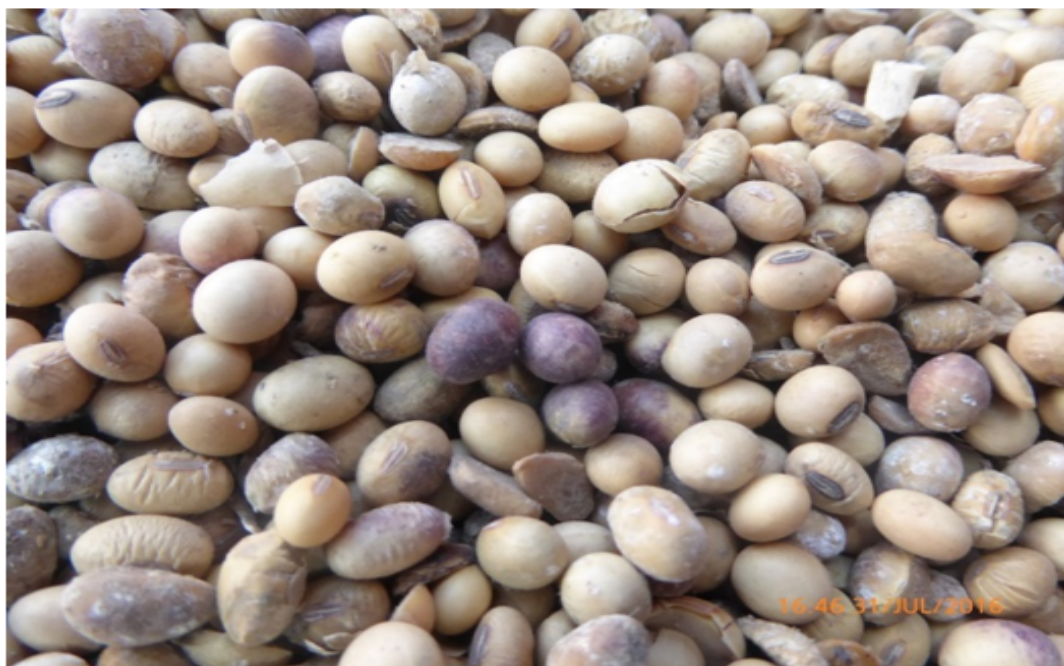
**Case study - purple beans** An unrelated matter involving soya beans is the presence of purple beans. A Chinese receiver initially raised allegations of losses caused by the vessel. Please see below photographs showing affected beans. Gard obtained advice from grain experts to the effect that red/purple soya beans are caused by a fungal disease ( *Cercospora* leaf blight) due to field infection by the *Cercospora kikuchii* fungus. Affected plants produce beans that show a prominent purple stain over part of the outer hull. However, the fungus does not develop after harvest in storage - neither in silos nor in vessels' holds. It follows therefore that the red/purple beans found in the cargo were already present at the time of loading and the condition of the beans was unrelated to the transportation by sea.

*PHOTOS 5 and 6: Examples of purple beans on plants affected by the Cercospora kikuchii fungus in the field.*
