2016
7th October

PANDIMAN PHILIPPINES Inc. P&I Correspondent in the Philippines

WARNING OF WET NICKEL ORE CARGO IN BULK FROM SURIGAO PHILIPPINES

Loading of Nickel Ore Surigao, Philippines, concerns of cargo being beyond TML

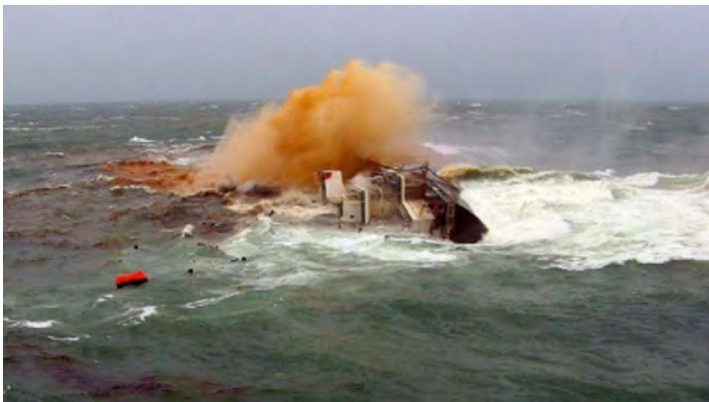
The consequences of a nickel ore cargo liquefying can be catastrophic

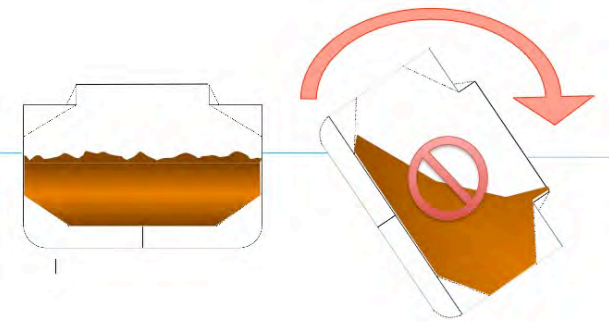
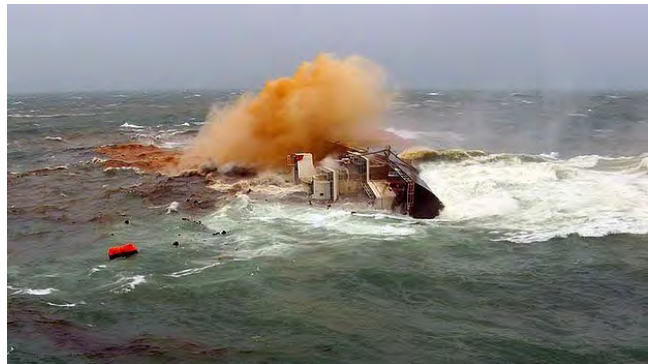
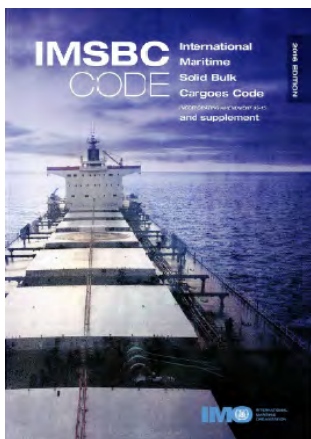
Nickel ore, when the moisture content is above the TML, (Transportable Moisture Limit) the cargo can liquefy with catastrophic results. The liquefaction of a nickel ore cargo is not like free-surface effect of a liquid but is when due to vibration and movement a solid now acts like a liquid, it is a dynamic shift. The effects of liquefaction is so dramatic that in discussions with sole survivors off two vessels we undertook search and rescue in the South China sea, the vessels rolled over and capsized in less than 30 seconds.

A picture speaks a thousand words;

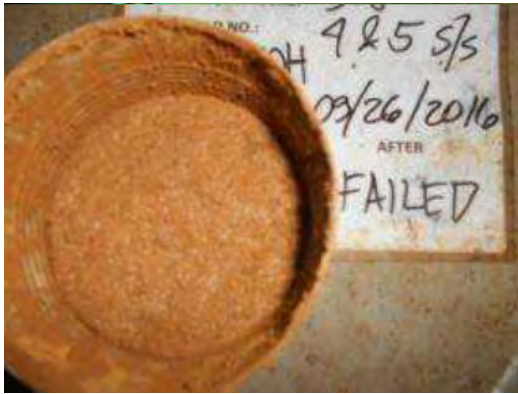
This is a simple test and as the term implies (can test) a metal can is suitable, such as a coffee tin, paint tin (but must be clean). Take about 1 to 2 kg of the ore and place it in the tin, repeatedly slam the can the bulk code says 25 times, **if the ore remains the same** then there are no obvious signs of moisture, if it shows any signs of liquefying (very obvious will be where free water appears on top **or takes on a shiny flat appearance**) then the cargo should be **rejected and not loaded**.

A failed test – flat pancake appearance- - FAIL carry out laboratory analysis of cargo

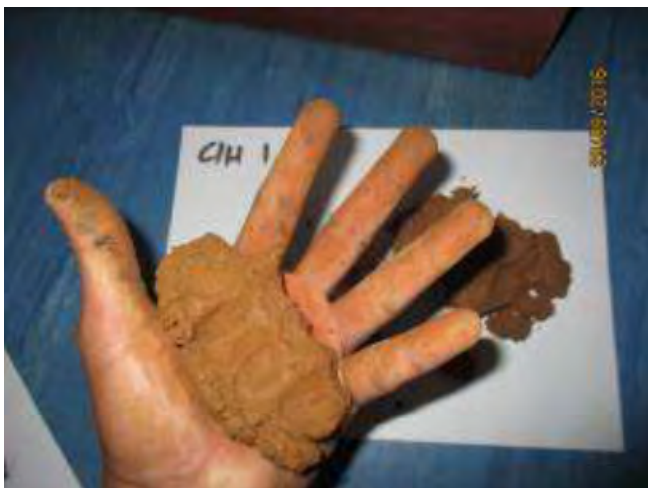
Grab Test

This is when a sample of cargo is placed in the hand, the sample is compressed, if on opening the hand the sample retains its shape this is evidence of High moisture – FAIL carry out laboratory analysis of cargo

When a sample can be molded and retains a shape we say it has “Plasticised”, to have the ability to do this then moisture must be present.

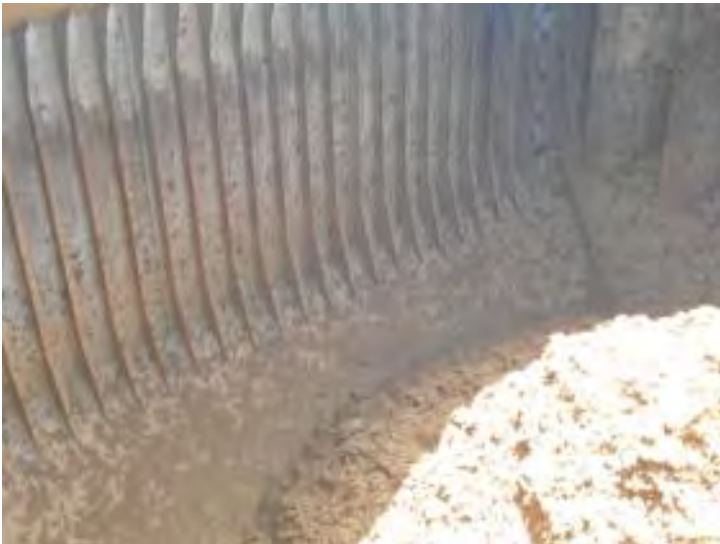
Splatter

Any sign of splatter in the hold, large or small this indicates high moisture – FAIL - carry out laboratory analysis of cargo
