## In this bulletin...

### MARS 202547

## Another ro-ro loading fatality

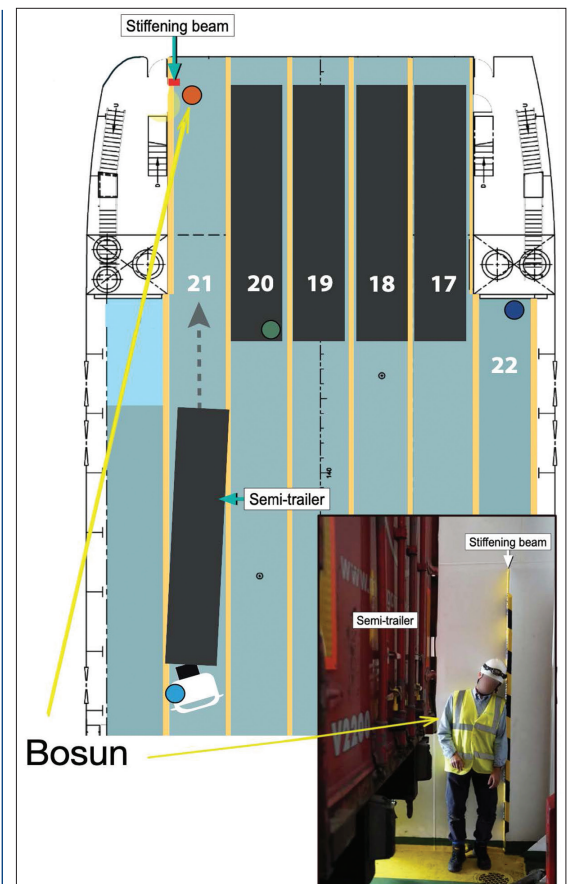
A ro-ro vessel was in port and the vessel's crew, assisted by shoreside tractor unit drivers, was loading semi-trailers onto the upper vehicle deck. The bosun, acting as a banksman [directing traffic], was marshalling a tractor unit as it pushed a semi-trailer into a tight corner stowage space. He positioned himself on a painted walkway at the rear of lane 21 to guide the trailer. The walkway was located inside the vehicle lane.

The tractor unit driver lost sight of the banksman as he was backing up, but, following a routine but unsafe workaround practice common at the port, continued the manoeuvre even after doing so. The driver assumed the bosun had moved to a safe position behind an adjacent trailer. However, the semi-trailer was at a slight angle, causing its rear to encroach upon the painted walkway where the bosun was standing. The bosun was trapped and crushed against a steel stiffening beam protruding from the vessel's superstructure.

- **False sense of security:** Painted walkways that are not physically segregated from vehicle lanes can create a false sense of security and do not provide adequate protection. This lesson was also highlighted in a previous fatal accident.
- **Breakdown of visual contact:** The fundamental safety principle of maintaining visual contact between the banksman and the vehicle driver was violated. The driver continued manoeuvring after losing sight of the bosun.

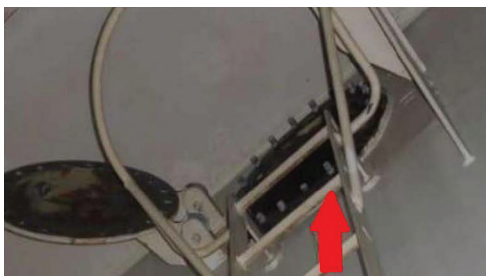
After-peak tank access manhole 5m above steering gear compartment deck

Flooded trunk containing emergency fire pump

The after-peak access manhole is about 4.5 metres above the deck. The manhole cover was in place, but the cover's securing nuts were not fully tightened, allowing major leakage.

The company investigation found that the manhole covers of the various tanks had been undone for inspections during drydock. After the inspections were complete, they should have been fully secured for operations. However, the cover of the after-peak access, situated at a height, was forgotten. Also, the bilge level alarm for the space was found defective.

- Alarms should never be turned off and should be verified at regular intervals. Bilge level alarms should be rectified as soon as a fault is detected.
- Post drydock checks and verifications are critical. What sailor does not have a story about minor or even major deficiencies left uncorrected after leaving drydock?

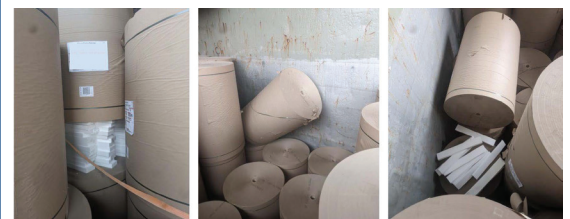
A general cargo vessel was in port and discharging rolls of paper. The rolls were chocked with polystyrene packing, and at one point during the discharge one of the rolls toppled. The roll was 1.4 metres in diameter, 2.2 metres high and weighed 2.6 tonnes. Fortunately, no one was injured in the incident.

It is likely that the polystyrene chocking was used to raise the height of the roll in the layer, allowing another layer of rolls to be stacked on top.

As stowed

After the collapse

- Polystyrene is not a suitable material to be used as weight bearing dunnage. Only robust weight bearing materials should be used for dunnage.
- Good awareness from the stevedores prevented a more serious incident. Awareness of dangers is everyone's responsibility.

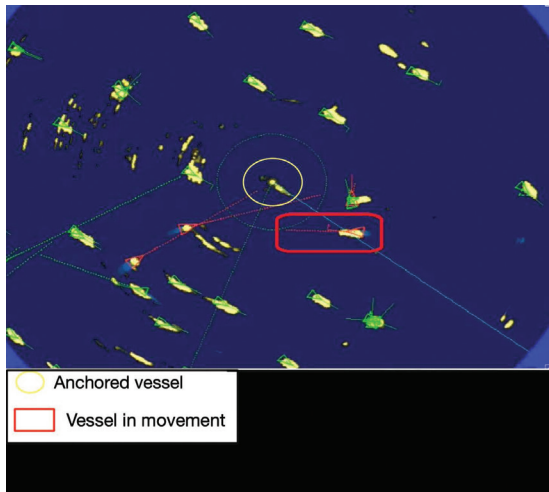
The OOW noticed a vessel underway approaching ahead at about 3 knots and on what appeared to be a collision course (see diagram). The Master came to the bridge and together with the OOW they attempted to communicate with the approaching vessel. The engines were ordered, and the ship's horn was used to attract attention but to no avail. The approaching vessel did not respond and continued its manoeuvre, coming ever closer.

Port traffic control also tried to contact the moving vessel, but to no avail. Some 18 minutes after being identified as on a collision course, the moving vessel struck the anchored vessel on its port bow. Minor damage was sustained at the port forward bulwarks and associated brackets connected to the forecastle deck.

- An attentive anchor watch is just as important as a watch underway. In this case, however, it still could not prevent the turn of events that was beyond the control of the anchored vessel.
- Information from the moving vessel was unavailable to the contributor – it is assumed the team on the bridge wished to anchor to port and behind the already anchored vessel.
- When in a crowded anchorage or other situations that require delicate manoeuvring, call tugs to assist.
