Updated guidance on pilot transfer arrangements

Published 14 February 2022

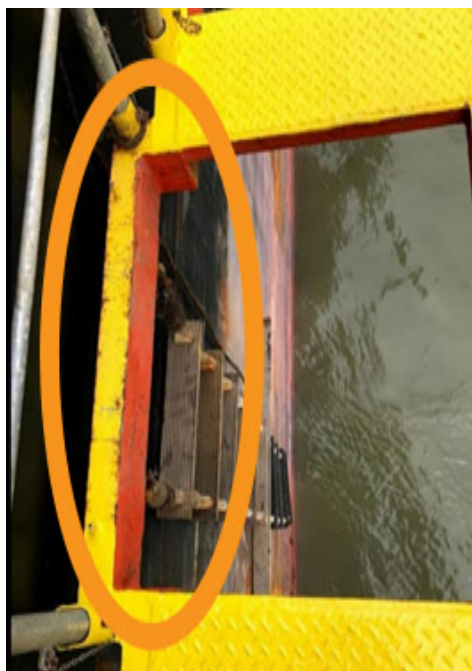
A pilot ladder hanging from a cross beam near the bottom of the platform (see image on the left below) is a typical example of an unsafe transition through the trapdoor arrangements reported by various pilot associations:

- It makes the transition from the pilot ladder onto the accommodation ladder difficult due to uneven step height;

- Pilots cannot make use of the side ropes to make the transition and instead have to use the cross beam and the stanchions for support when embarking and disembarking; and
- The pilot ladder is not secured to the side of the hull.

Left: One example of a trapdoor arrangement deemed unsafe by pilots in some ports. Pilot ladder secured to the beam of the trapdoor and not extending above the platform. Right: Photograph of a trapdoor arrangement complying with current SOLAS regulations.

- Those operating older vessels with trapdoor systems not complying with current SOLAS rules and regulations may wish to consider modifying them to the satisfaction of Class and Flag to avoid issues with pilots refusing to board and possibly also port state control.

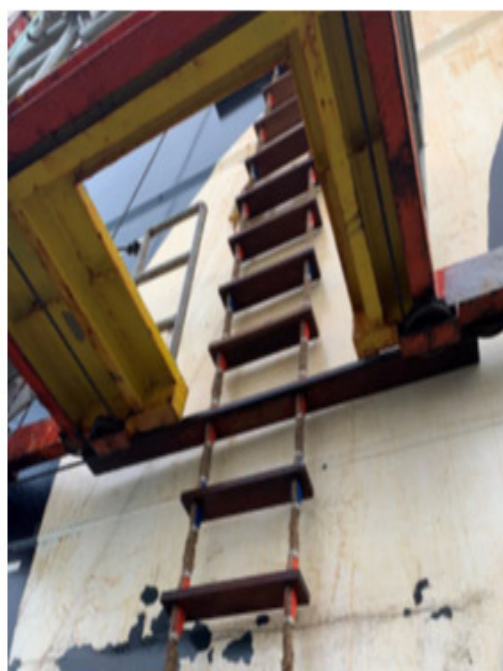
An example of a combination arrangement using trapdoor arrangement complying with current SOLAS regulations is shown in the image on the right below.
