## Updated guidance on pilot transfer arrangements

Published 02 September 2024

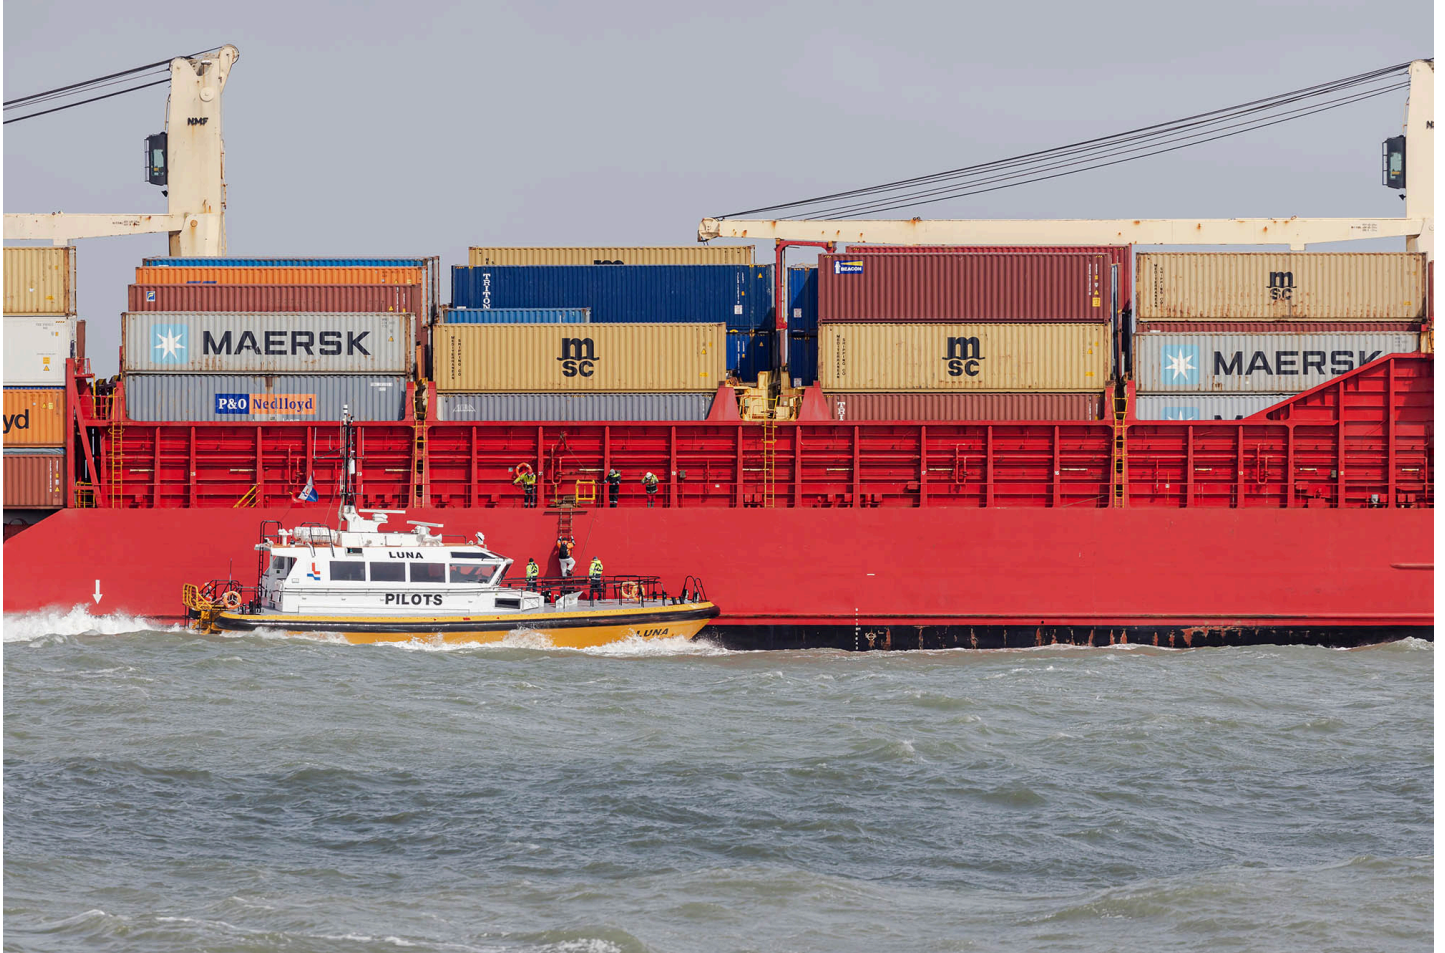
A pilot ladder hanging from a cross beam near the bottom of the platform (see image on the left below) is a typical example of an unsafe transition through the trapdoor arrangements reported by various pilot associations:

- It makes the transition from the pilot ladder onto the accommodation ladder difficult due to uneven step height;
- Pilots cannot make use of the side ropes to make the transition and instead have to use the cross beam and the stanchions for support when embarking and disembarking; and
- The pilot ladder is not secured to the side of the hull.

*Left: One example of a trapdoor arrangement deemed unsafe by pilots in some ports. Pilot ladder secured to the beam of the trapdoor and not extending above the platform.*

*Right: Photograph of a trapdoor arrangement complying with current SOLAS regulations.*

- Those operating older vessels with trapdoor systems not complying with current SOLAS rules and regulations may wish to consider modifying them to the satisfaction of Class and Flag to avoid issues with pilots refusing to board and possibly also port state control.
