## Updated guidance on pilot transfer arrangements

The International Chamber of Shipping (ICS) and the International Maritime Pilots Association (IMPA) recently published an updated version of their 'Shipping Industry Guidance on Pilot Transfer Arrangements' in an effort to make pilot transfer arrangements safer.

Published 14 February 2022

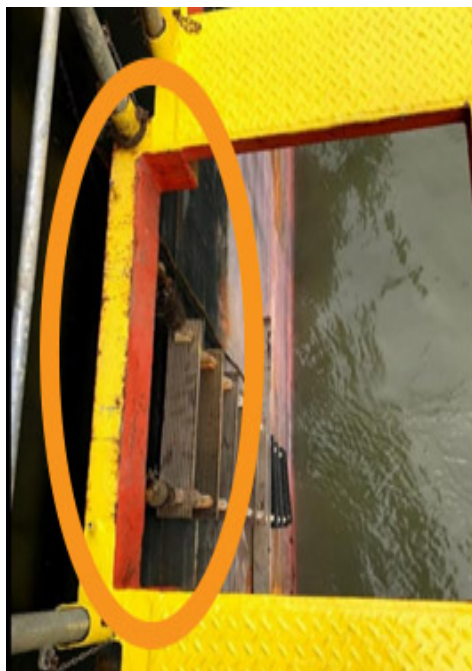
A pilot ladder hanging from a cross beam near the bottom of the platform (see image on the left below) is a typical example of an unsafe transition through the trapdoor arrangements reported by various pilot associations:

- It makes the transition from the pilot ladder onto the accommodation ladder difficult due to uneven step height;
- Pilots cannot make use of the side ropes to make the transition and instead have to use the cross beam and the stanchions for support when embarking and disembarking; and

- The pilot ladder is not secured to the side of the hull.

*Left: One example of a trapdoor arrangement deemed unsafe by pilots in some ports. Pilot ladder secured to the beam of the trapdoor and not extending above the platform. Right: Photograph of a trapdoor arrangement complying with current SOLAS regulations.*

- Those operating older vessels with trapdoor systems not complying with current SOLAS rules and regulations may wish to consider modifying them to the satisfaction of Class and Flag to avoid issues with pilots refusing to board and possibly also port state control.

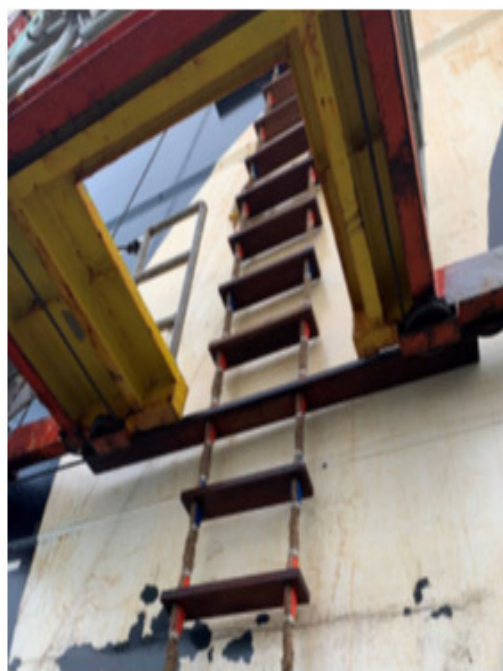
An example of a combination arrangement using trapdoor arrangement complying with current SOLAS regulations is shown in the image on the right below.
