## Pilot transfer operation: A safer step aboard

Published 23 October 2026

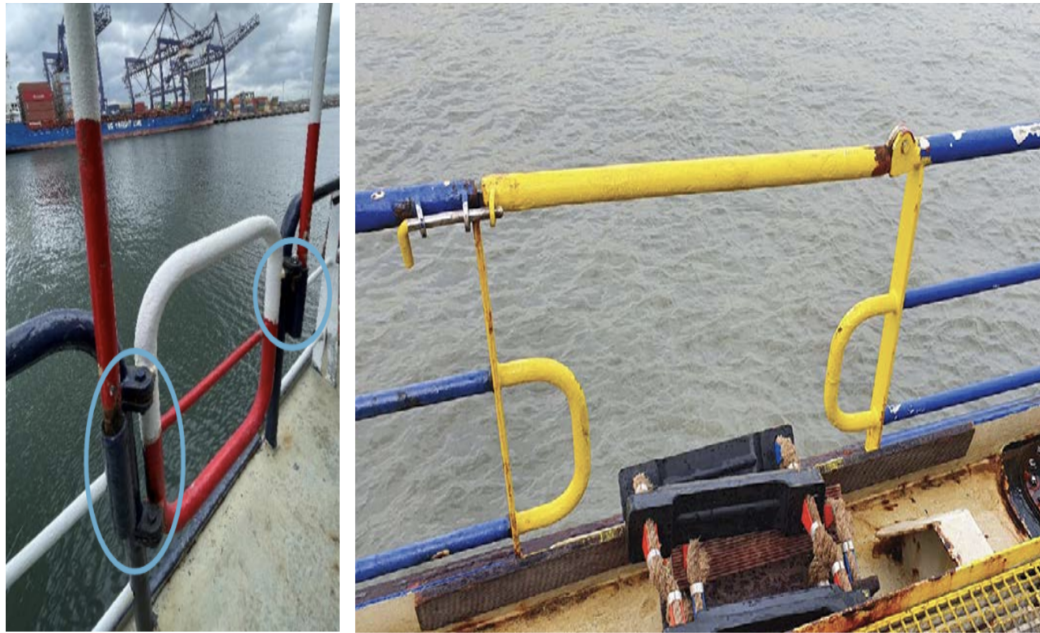
In one such case, a pilot fell approximately three metres onto a pilot boat and suffered a fractured ankle after losing their grip on a handhold stanchion. MAIB's preliminary assessment found that the stanchions were not fit for purpose, as their design prevented the pilot from gaining a firm grip when reaching the top of the ladder.

The examples below, taken from the [MAIB Annual Report 2022](#), show non-compliant handhold stanchions at the transition from the pilot ladder to the deck.
