What is the cause of most bunker spills?

Overflow incidents account for the majority of bunker spills seen by Gard.

Published 11 December 2024

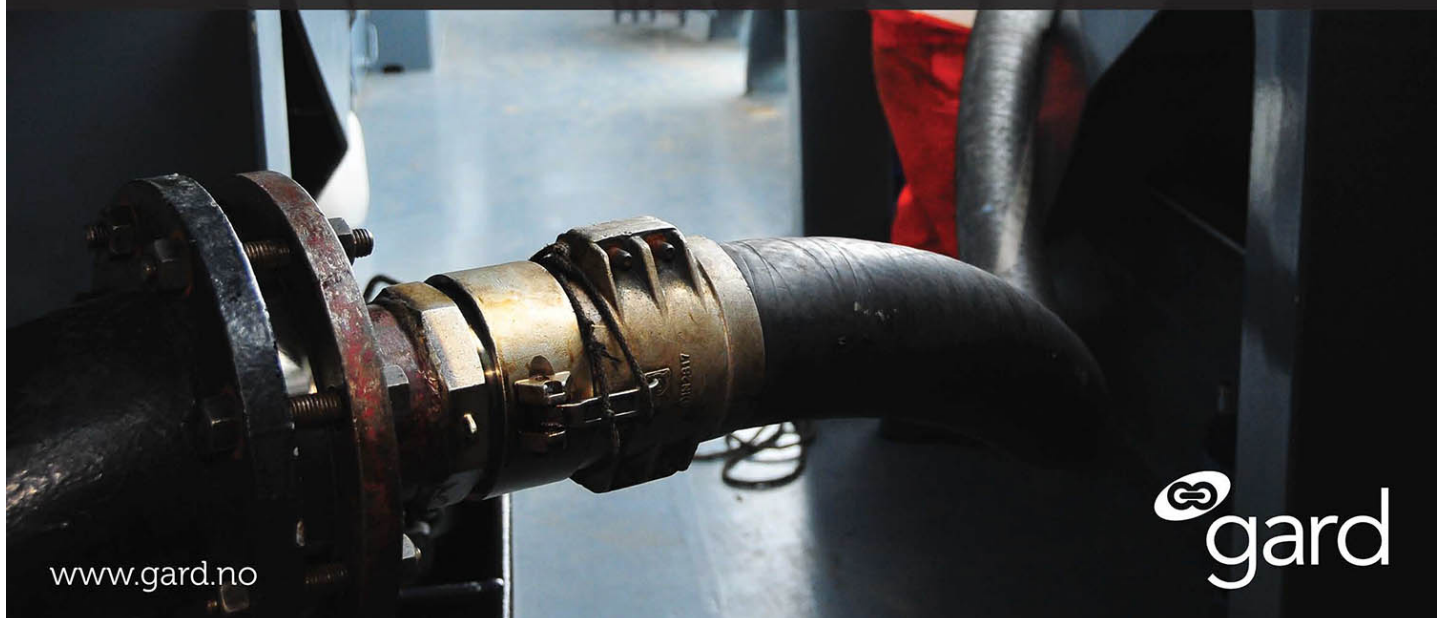
To prevent bunker spills, actively monitor:

- Agreed loading rate
- Tanks being loaded
- Tanks not being loaded
