The importance of blackout awareness and prevention

Correct operation and maintenance of equipment, combined with tried-and-tested emergency procedures and crew training, are essential to prevent blackouts on ships and to mitigate their potential consequences.

Published 17 June 2025

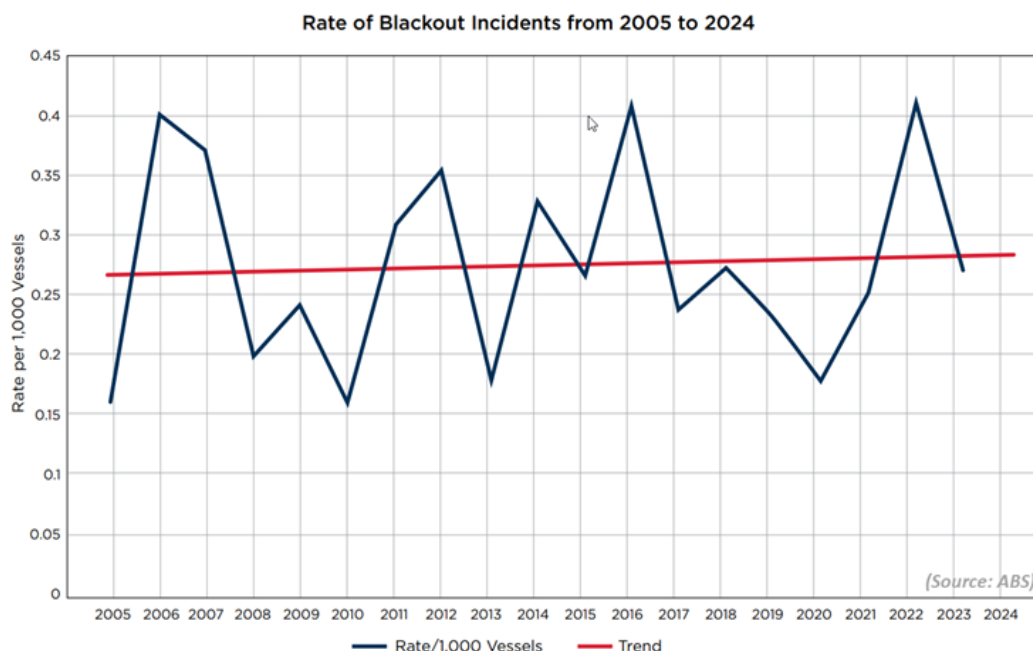
Realistic accident statistics for blackouts on ships are difficult to obtain because most blackouts are probably not reported as "accidents". However, there seem to be some indications of an increase in event frequency. The figure below is created by the classification society [American Bureau of Shipping \(ABS\)](#) and shows a rising trend in the rate of reported blackouts in the world maritime fleet between 2005 and 2024. Similarly, research by [Det Norske Veritas \(DNV\)](#) found that in 2019, the media reported 12 power loss events on cruise ships that resulted in full or partial blackout while in transit or manoeuvring, a significant increase from four events in the previous year.
