Heat damage in soya bean cargoes - the importance of inspections

Published 26 October 2016

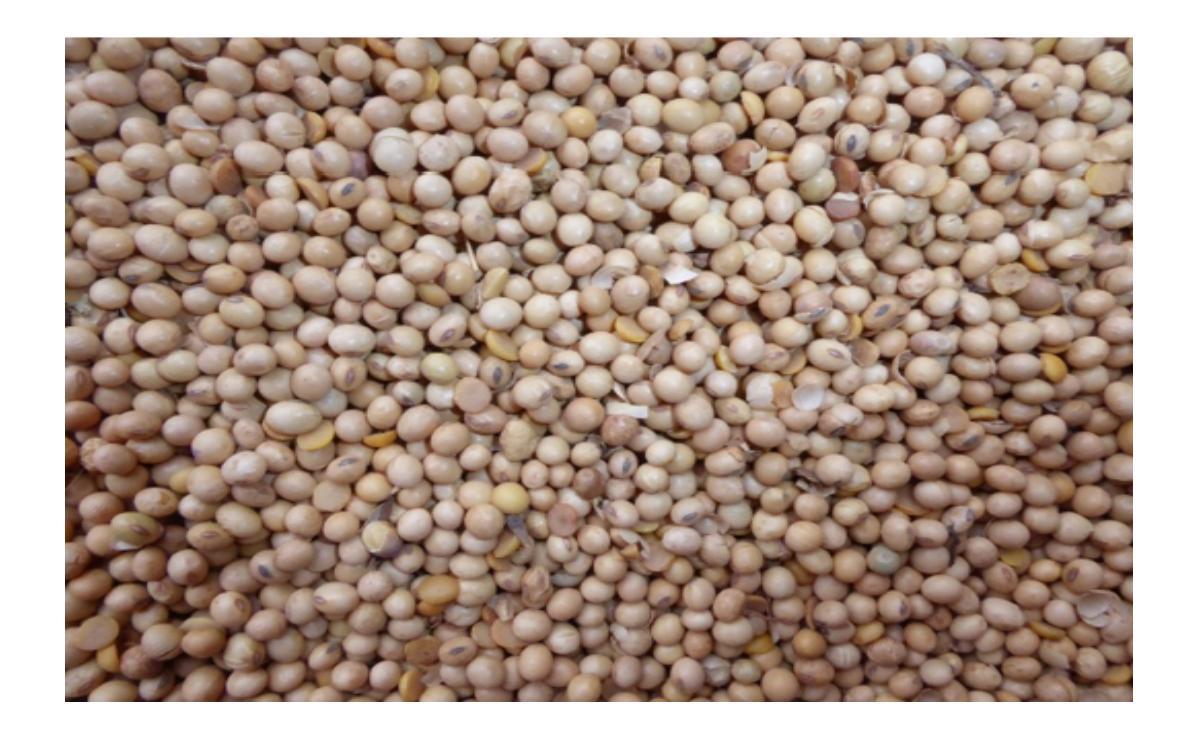
PHOTO 1: Sound cream coloured Brazilian soya beans.

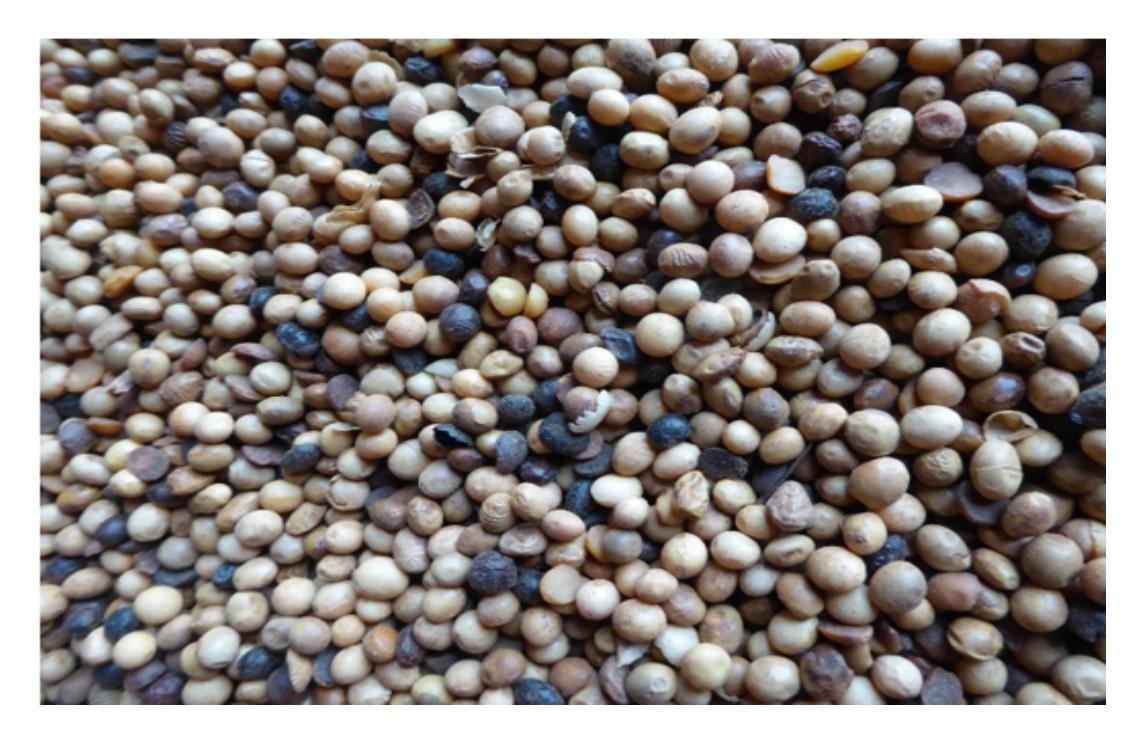
PHOTO 2: When sound cream coloured soya beans are heated the beans become darker, brown or even black.

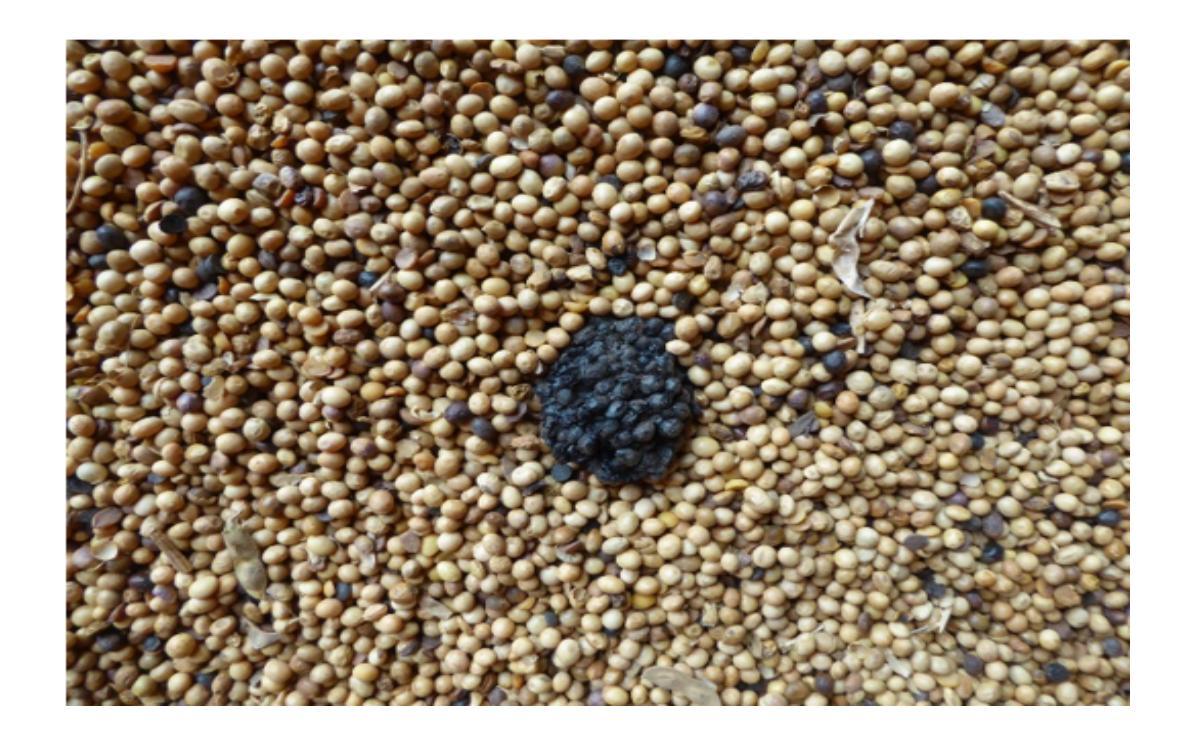
From the photographs below it is clear that the blackened bin-burned beans stand out when compared to the unaffected normal yellow or pale brown beans. The binburn phenomenon occurs when over-moist beans are put into storage without sufficient aeration for long periods of time. The process starts as microbiological selfheating but, as the organisms causing microbiological metabolic self-heating die due to the effect of 'self-pasteurization', it is followed by oxidative heating of the oil contained in beans to produce the high temperatures necessary to produce the blackened bin-burned beans. Where such deterioration occurs, farmers and silo operators may break-up the affected, severely heat-damaged cargo to mix it with sound cargo delivered to the export terminals at the ports. Modern sale contracts typically allow for some 1 per cent of burnt beans. The incidence of blackened beans for the Paranagua cargo in question was significantly above this level. It rendered the affected parcels clearly out of conformity with the "normal good order and appearance" condition of sova beans that Masters expect. The presence of the distinct areas of excessive black beans was considered to present a significant risk of claims in China, which was the destination for the shipment. The photograph introducing the article illustrates how bin burned cargo can appear at the time of discharge. The Master rejected the affected parcels although they were already on board and requested they be replaced with beans in apparent good order and condition.

PHOTO 3: Small lumps of heat damaged soya beans dispersed sporadically throughout the cargo is consistent with the soya beans having undergone self-heating prior to loading or 'bin-burn'.

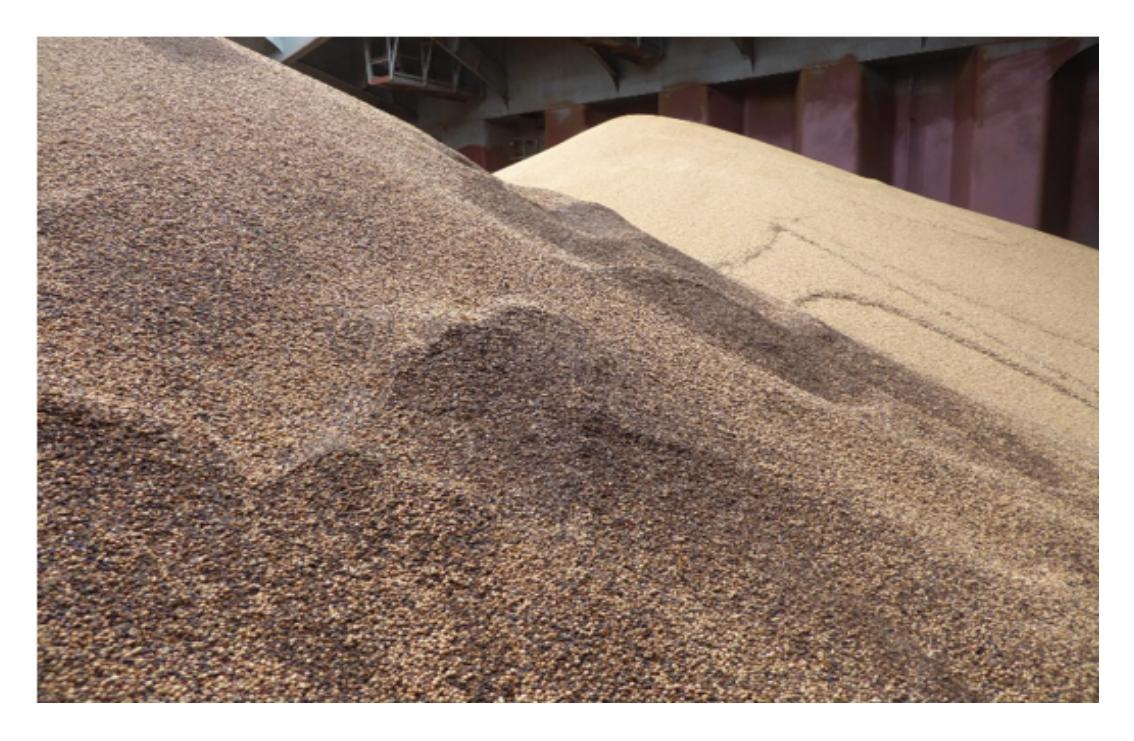
Case study – self-heating In the following example one of our Members loaded soya beans in Brazil in July 2016. The Master stopped the loading when an abnormal presence of blackened beans became apparent in the loaded stow. The Member sought advice from grain scientists and it became clear that the blackened beans (see photographs below) was due to the so-called "bin-burned" phenomenon.

PHOTO 4. Pre-shipment heat damage (or bin-burned) soya beans in the foreground, with sound beans in the background, all loaded in a single hold.

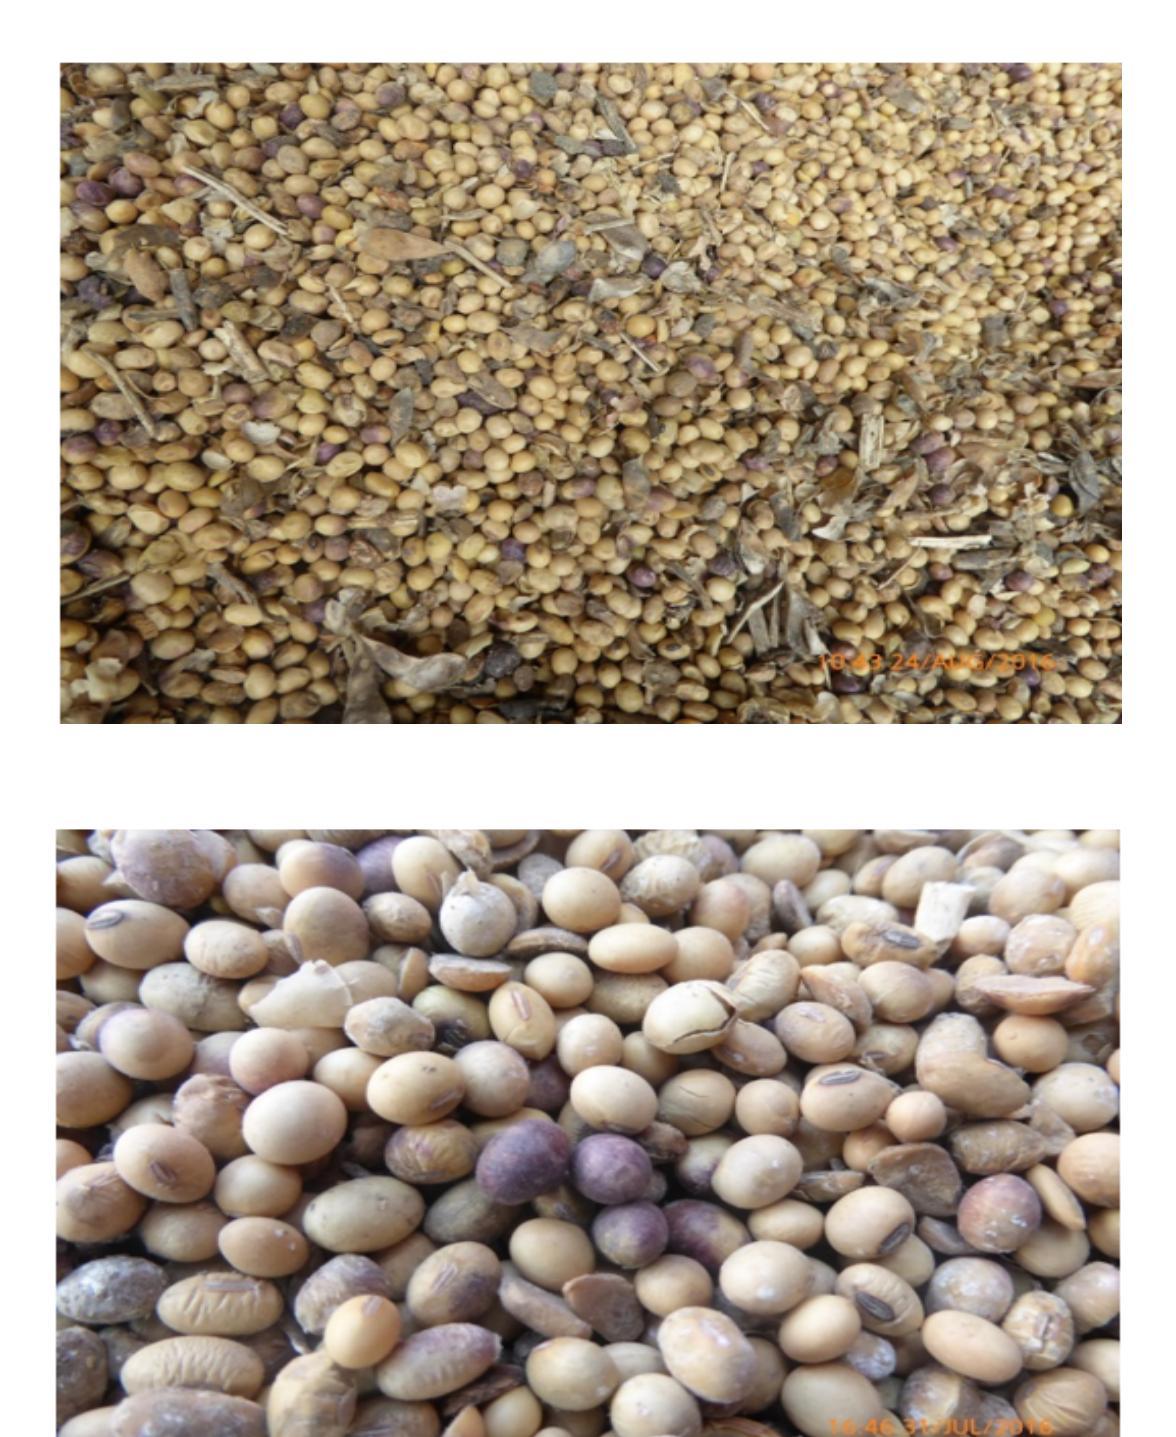
Case study - purple beans An unrelated matter involving soya beans is the presence of purple beans. A Chinese receiver initially raised allegations of losses caused by the vessel. Please see below photographs showing affected beans. Gard obtained advice from grain experts to the effect that red/purple soya beans are caused by a fungal disease (*Cercospora* leaf blight) due to field infection by the *Cercospora kikuchii* fungus. Affected plants produce beans that show a prominent purple stain over part of the outer hull. However, the fungus does not develop after harvest in storage neither in silos nor in vessels' holds. It follows therefore that the red/purple beans found in the cargo were already present at the time of loading and the condition of the beans was unrelated to the transportation by sea.

PHOTOS 5 and 6: Examples of purple beans on plants affected by the Cercospora kikuchii fungus in the field.
