## Watch out for open manholes and displaced deck gratings

Open manholes and displaced gratings pose considerable hazards to crew on offshore installations as evidenced by two recent incidents reported by the US Bureau of Safety and Environmental Enforcement.

Published 01 August 2019

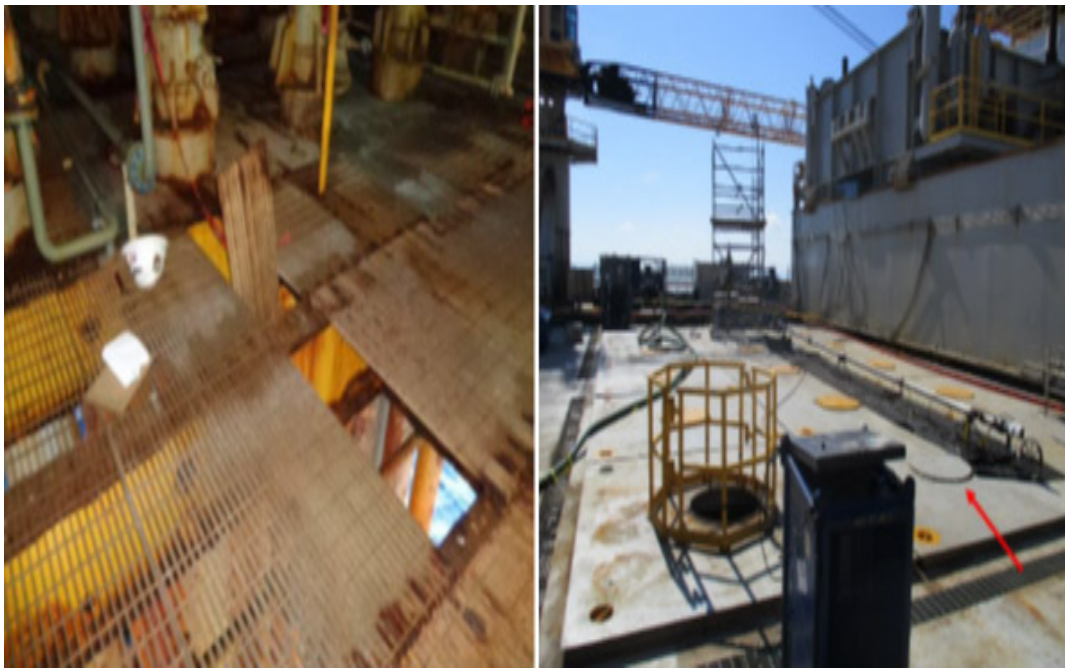
In the second incident a crew member had completed work on a well which was properly barricaded. At nighttime two employees went to replace the well access hatch cover over the well on the drill deck. It appears that each of the two employees inadvertently picked up the wrong hatch cover (identified in the second photograph below with a red arrow). Each employee grabbed one handle of the cover, which was the same color as the deck and had no well identifying information on it. This action unknowingly created an open hole; and as the employees moved the hatch, one of the employees stepped and fell through the hole to the deck below.

- Conduct a review of the facility to identify any open holes or surfaces that cannot support personnel and, if such an area or open hole is identified, ensure that it is properly barricaded and/or covered.

- Conduct a review of their facility to make sure that all grating and flooring sections are securely fastened to the underlying structural members. Access should be prevented to areas where the grating and flooring sections are not securely fastened to the underlying structural members or barricaded as described below.
