## Grounding incidents in the Indonesian archipelago

Published 07 July 2020

Written by Siddharth Mahajan

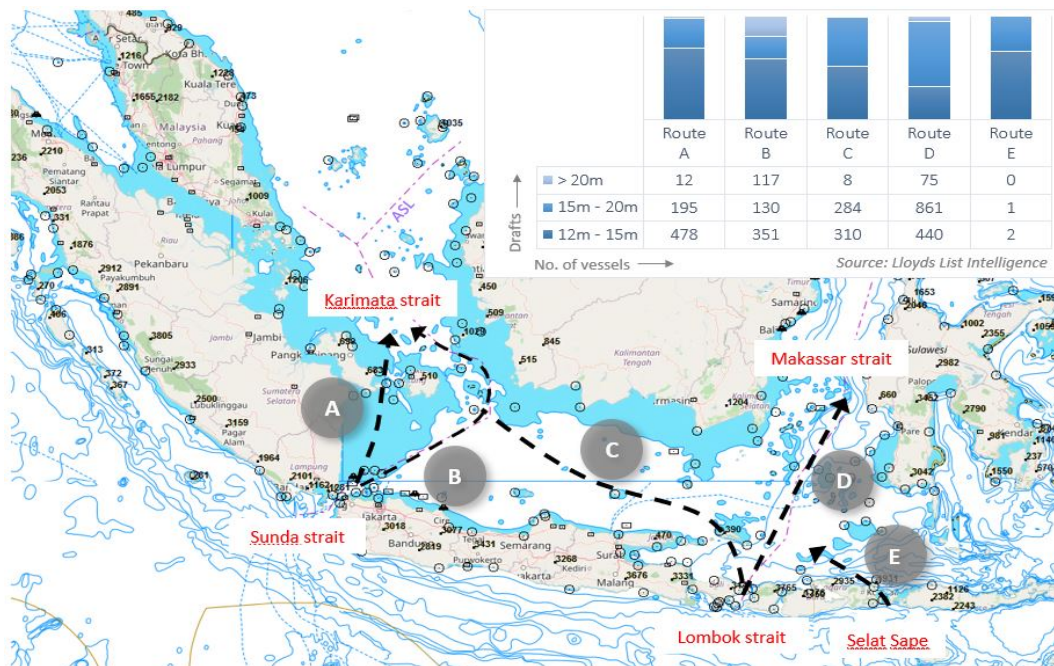
## Traffic flows for 2019 (vessels with draft $\geq 12$ m)

Thousands of vessels of various sizes enter and exit the Java sea each year using either the Sunda or Lombok Strait. We decided to analyze traffic flows for 2019 using historical AIS data of laden vessels having a draft of more than 12 metres entering this region through the aforementioned narrow straits.

Traffic data suggests that laden VLCCs and VLOCs also routinely use the passage through Sunda and Lombok Strait in addition to vessels having shallower drafts. The only exception was Selat Sape which was hardly used. Only 3 vessels in 2019 having a draft  $> 12$  meters transited through Selat Sape even though the charted depths are shown to be around 100 meters. We discuss more about this route in our third case study.
